Five-Year Evaluation of a Remote Screen System at Beal Lake, Arizona

Prepared by: Normandeau Associates

November 2010

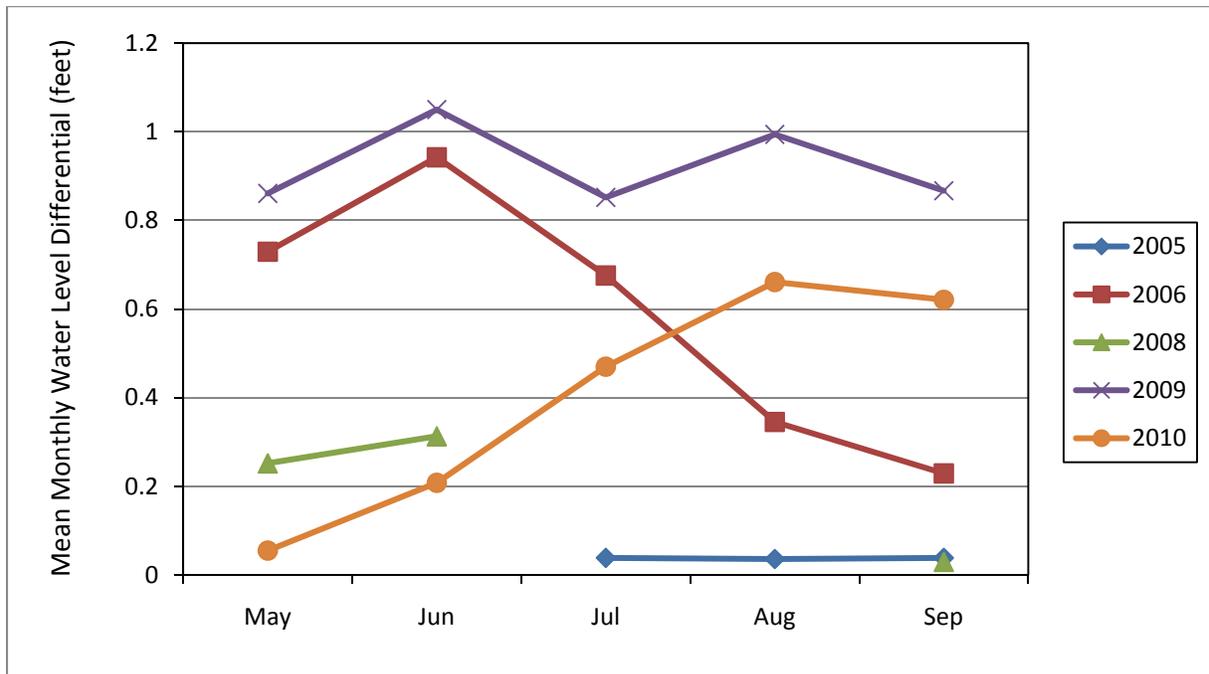
Mean monthly water elevations on either side of the rock structure remained near equilibrium only in 2005, when the difference in water elevations remained less than 0.1 feet from equilibrium throughout the summer (Figure 5). During subsequent years, the average monthly water elevation in the Topock embayment was higher than in Beal Lake, with differences ranging from about 0.3 to over 1.0 feet. In 2006, the water level differential peaked in June (0.94 feet), but decreased in the subsequent months; the monthly water level differential decreased from 0.68 feet in July to 0.23 feet in September, 2006. Mean monthly water level differences were comparatively low in 2008 during the months of May (0.25 feet) and June (0.31 feet), and reached equilibrium by September. The highest monthly water level differences occurred in 2009, when differentials of over 0.8 feet were consistently reported throughout the summer. In 2010, following the extensive maintenance effort, average monthly water level differentials increased throughout the summer from a low of 0.06 feet in May to a high of 0.66 feet in August (Figure 5).

Figure 5. Mean monthly differences in surface water elevation between the Topock side embayment and the Beal Lake embayment from 2005 to 2010. Data are presented as magnitude (in feet) of difference between each embayment. Data collected in 2007, and July and August 2008 was omitted from the analysis.

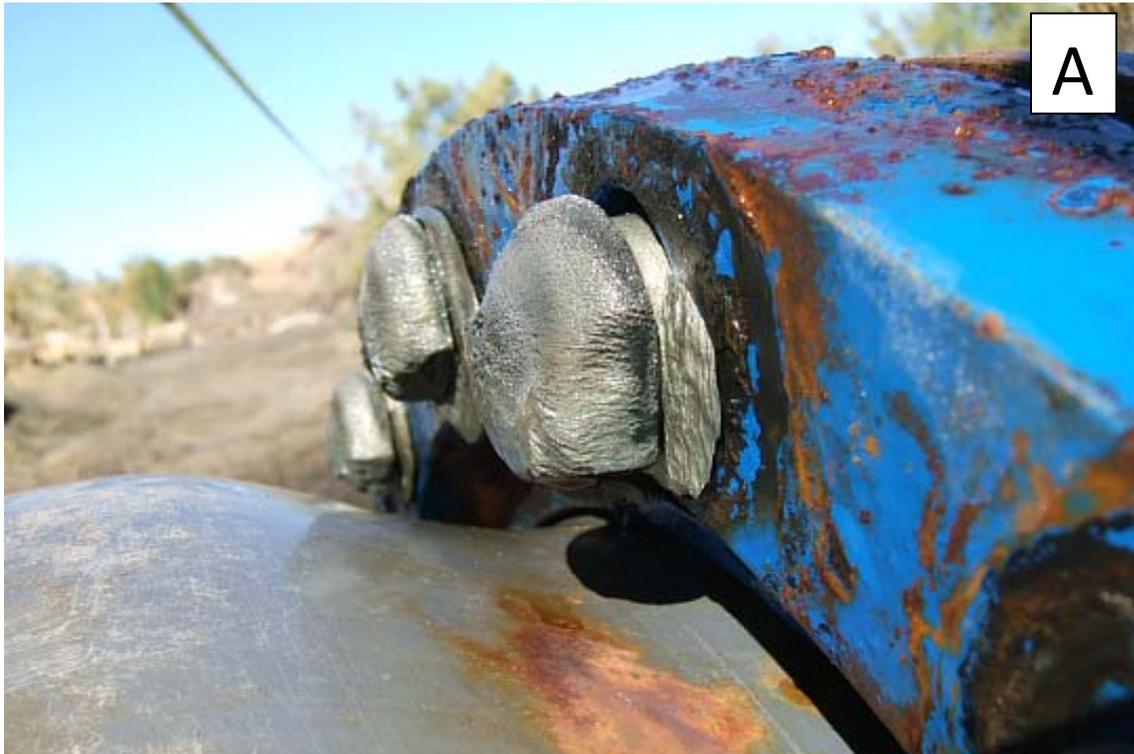
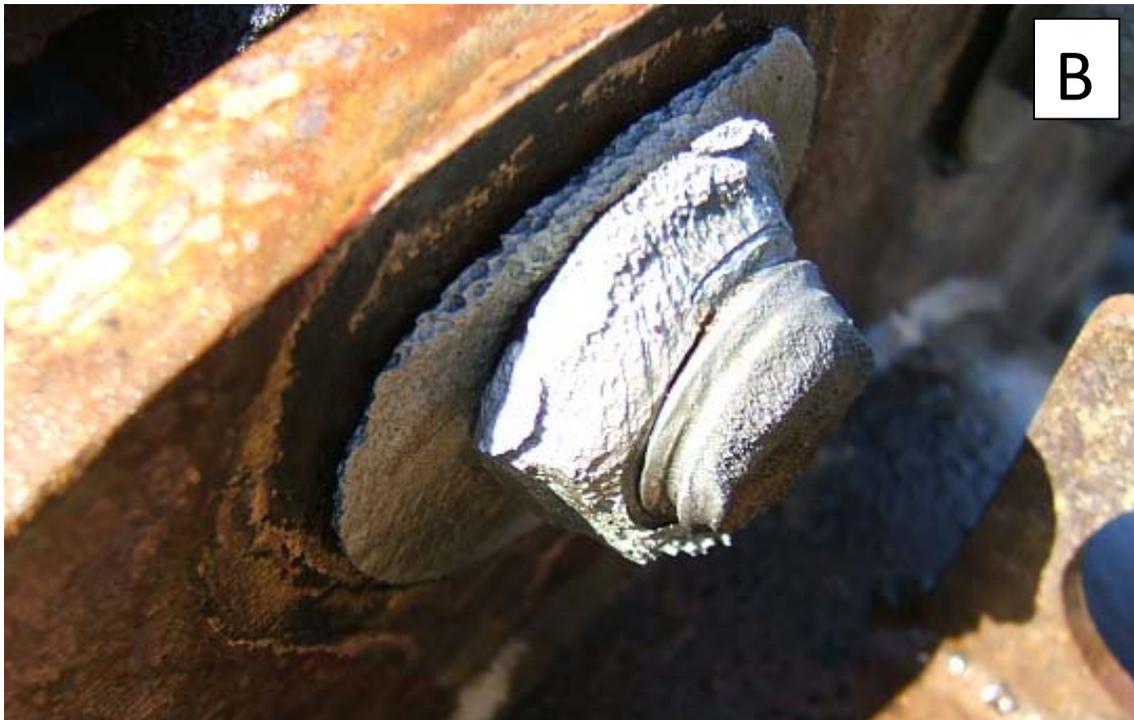
Once exposed, the bolts connecting the screens to the pipes and the air burst system were disconnected and the screens were removed from the pipes. The bolts, washers, and nuts connecting the screens to the pipes were extremely corroded (Figure 6). All of these original components were manufactured from galvanized steel and, in some cases, nearly 50% of the steel had been lost due to galvanic corrosion. The screens themselves were structurally sound and functional. No visible corrosion was noted on either the outside or the inside of the screens once they were removed. The gap width of the wedge-wire material was within the original 0.6 mm specification. However, a thin patina of carbonates had formed on the outer surface of the screens (Figure 7).

Future installations of screens on the lower Colorado River should use stainless steel components (i.e., bolts, nuts, washers) to attach the screens. The galvanized fasteners used in the original construction were heavily corroded. This may in part have been due to galvanic corrosion, which occurs when two dissimilar metals (in this case galvanized steel and nickel-copper alloy) form a natural battery when placed in contact with each other. The neoprene lined washers used to reinstall the screens in 2009 should insulate and reduce this interaction. However future applications may also consider installing zinc anodes on each of the screens, especially in applications where the water has high salinity.

Figure 6. Original fastening components used to attach the wedge-wire screens to the PVC pipes consisted of galvanized bolts (A), nuts and washers (B), which were highly corroded following five years of installation.

After a thorough rinsing, the screens were reinstalled in their original location using stainless steel bolts, nuts, and washers. The washers used to reattach the screens to the pipes were equipped with a neoprene backing to reduce corrosion. To increase flow through the screen system, Reclamation installed an additional set of new screens on the fourth pipe of the screen system that had been previously capped.

- Future installation should not use galvanized fasteners to attach the screens to the pipes, and an inspection of the structural components screen system should be conducted annually. Future maintenance efforts and extensive cleaning should be scheduled on an as-needed basis.

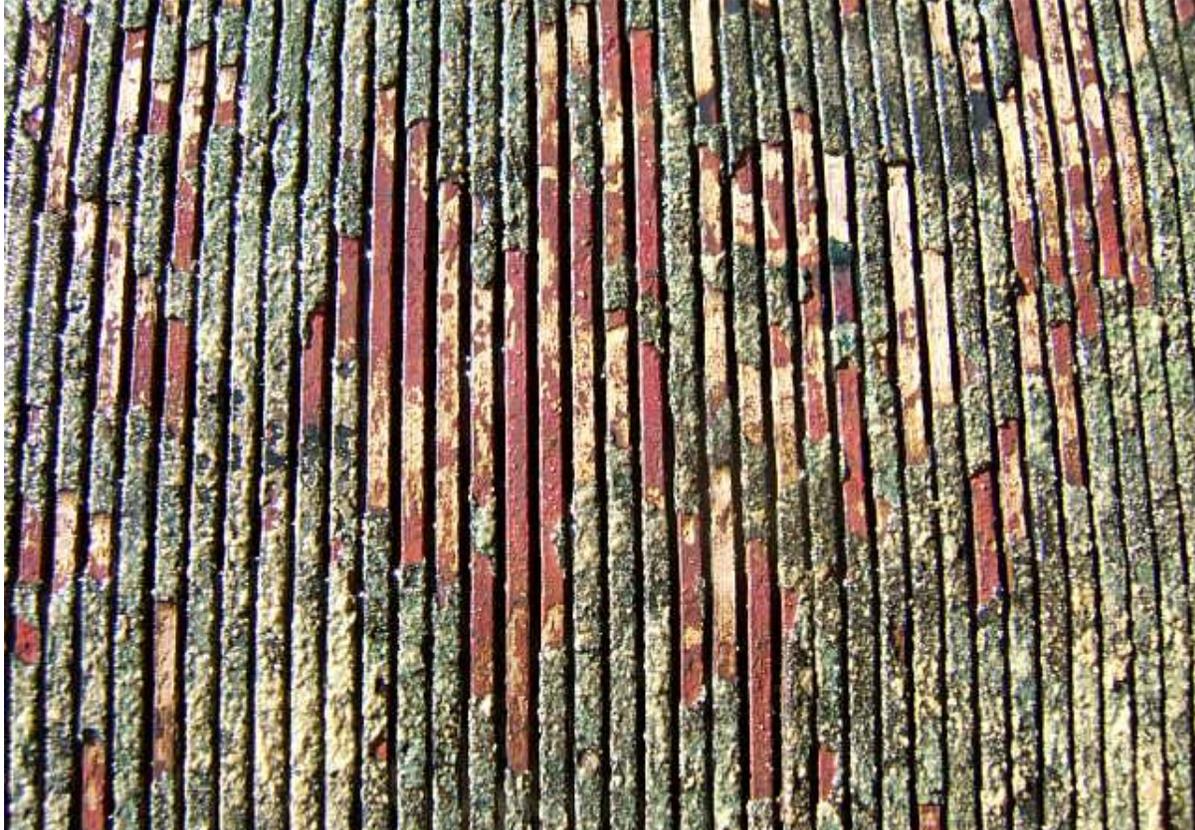
The hard deposits found on the surface of the screens were likely a combination of calcium and magnesium carbonates, which are common and naturally occurring minerals in the hard water of

the Colorado River, and copper carbonate from the screens. Under normal applications, the build-up of a patina is controlled by the natural flow of water over the screen surface. However, the low flow conditions at Beal Lake combined with the layer sediment and other material on the screens, likely contributed to the build-up of these carbonates on the surface of the screens. The diluted solution of muriatic acid was effective in removing the patina, however it is not recommended that this be a common maintenance solution; rather routine cleaning of the screen to remove sediment and increase flow should reduce or eliminate this problem.

Figure 7. A thin patina of carbonates (most likely calcium and magnesium, which are common and naturally occurring minerals in the hard water of the Colorado River, and copper from the screens themselves) had formed on the outer surface of the wedge-wire screens.

Once removed from the pipes, the screens were transported to the maintenance yard of the Havasu National Wildlife Refuge for cleaning. Spraying the screens with a high-pressure washer proved to be ineffective at removing the patina and, due to the relatively soft alloy used to construct the screens, Reclamation staff was reluctant to use mechanical or abrasive means to clean the screens. Therefore, the screens were hand sprayed with a commercially available solution of muriatic acid and allowed to soak for approximately 45 minutes. After soaking, the

muriatic acid solution and mineral deposits were removed from the screens using a high-pressure washer.

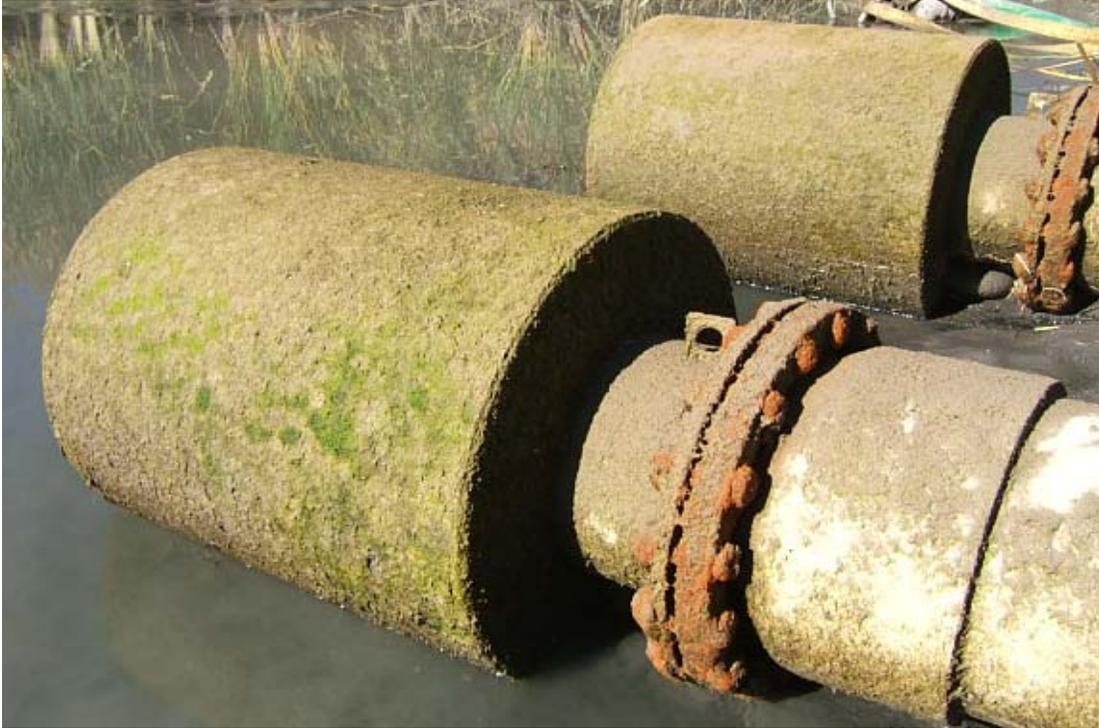
When initially exposed for cleaning, the screens were covered with a layer of sediment, organic matter, and algae approximately 0.5 inch thick (Figure 8). The sediment appeared to provide a medium that allowed algae and other biological organisms to grow (Figure 9). This combination of sediment and organic material was not strongly affixed to the screens and was easily removed with a high pressure washer before screen removal. Based on samples taken, much of the organic material on the screens was comprised of decomposed matter which could not be identified; however some organisms were identified and included Annelida (*Oligochaeta*), Cnidaria (*Cordylophora caspia*), Ecotrocta (*Plumatella sp.*), Porifera (*Dorsilla radiospiculata*), and insects classified as Diptera (*Chironomidae*) (Table 1). Several forms of algae were also identified from samples collected from the outside of the screens including *Spirogyra sp.*, and *Cladophora sp.*, and cyanobacteria classified as *Lyngbya* and *Scytonema*.

relatively high, ranging from about 0.8 to 1.2 feet. This large difference was most likely attributed to the thick layer of material that had formed on the outside of the screens and inside the pipes. Extensive biofouling has been shown to significantly reduce the surface porosity, and thus flow capacity, of wedge-wire screen material (Hanson 1979). Based on the estimated flow capacity, the screen system is capable of delivering approximately 4 times more flow than is needed to compensate for the highest estimated evaporation rate from Beal Lake (Normandeau 2006). However, this estimate was derived shortly after installation and when the screen surfaces and pipes were not obstructed by debris fouling.

Figure 8. Wedge-wires screens covered with fine sediment and algae.

- The screens at the rock structure should be cleaned routinely on an established schedule. Cleaning events during the peak evaporation season (May – September) should occur at a minimum bi-weekly and screens should be cleaned on at least a monthly basis during the remainder of the year. Cleaning events should consist of scrubbing and pressure washing the surface of the screens as well as flushing each pipes (by manipulating water levels in the Topock embayment using the irrigation pump; see Normandeau 2006) a minimum of three times.

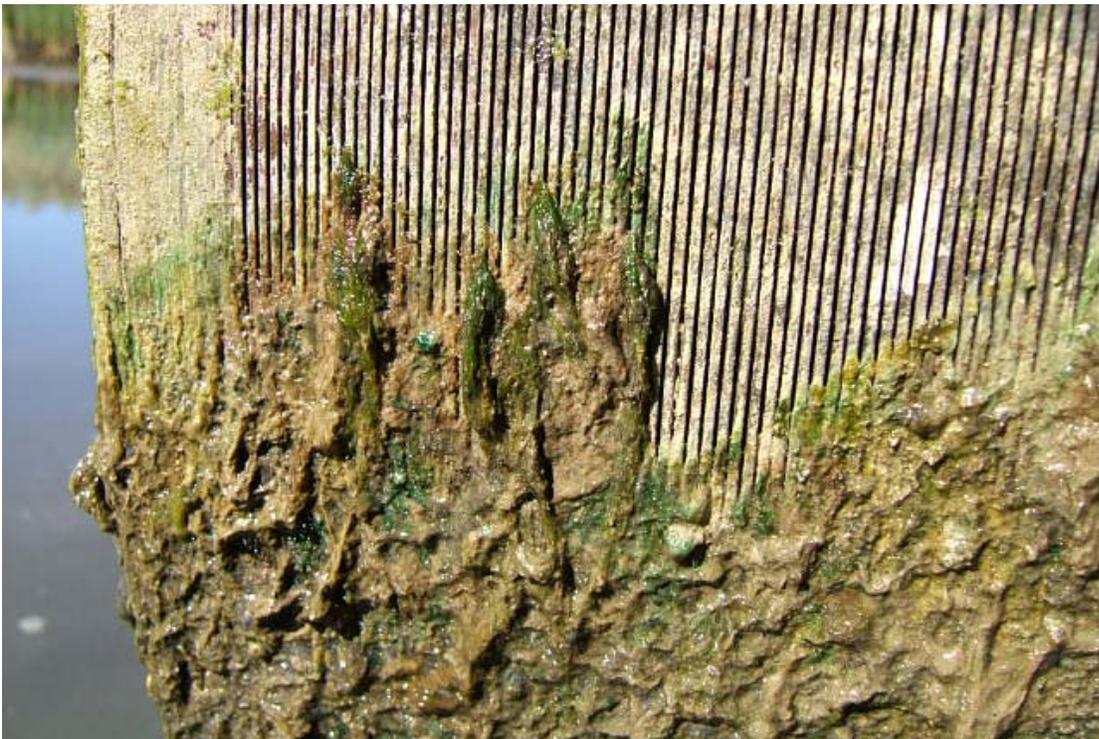
Figure 9. A partially cleaned screen showing attached algae which penetrated the intersitial spaces of the screen.

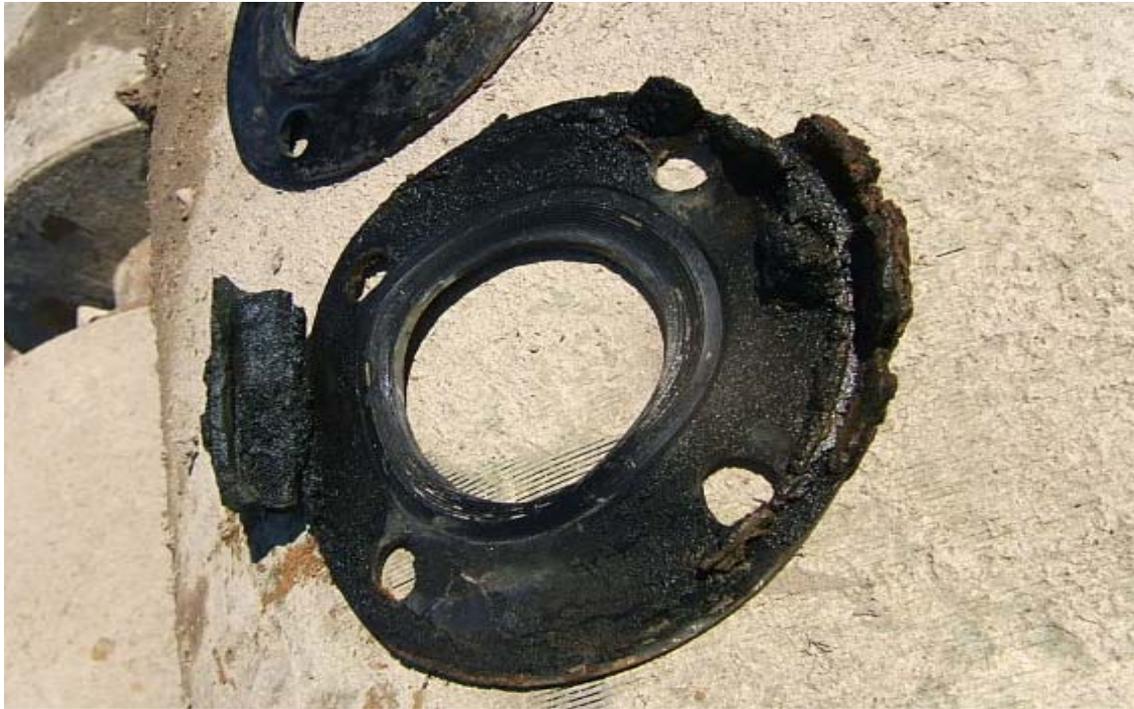
A close inspection of the PVC pipes revealed that they were structurally intact and had no signs of damage. The flanges connecting the screens to the PVC pipes were also undamaged and structurally sound. The original gaskets that were installed between the PVC pipes and the screens were brittle and partly deteriorated (Figure 10). The original gaskets were replaced with new gaskets when the screens were reinstalled.

Figure 10. Gaskets which were originally installed between the PVC pipes and the wedge-wire screens were brittle and partly deteriorated.

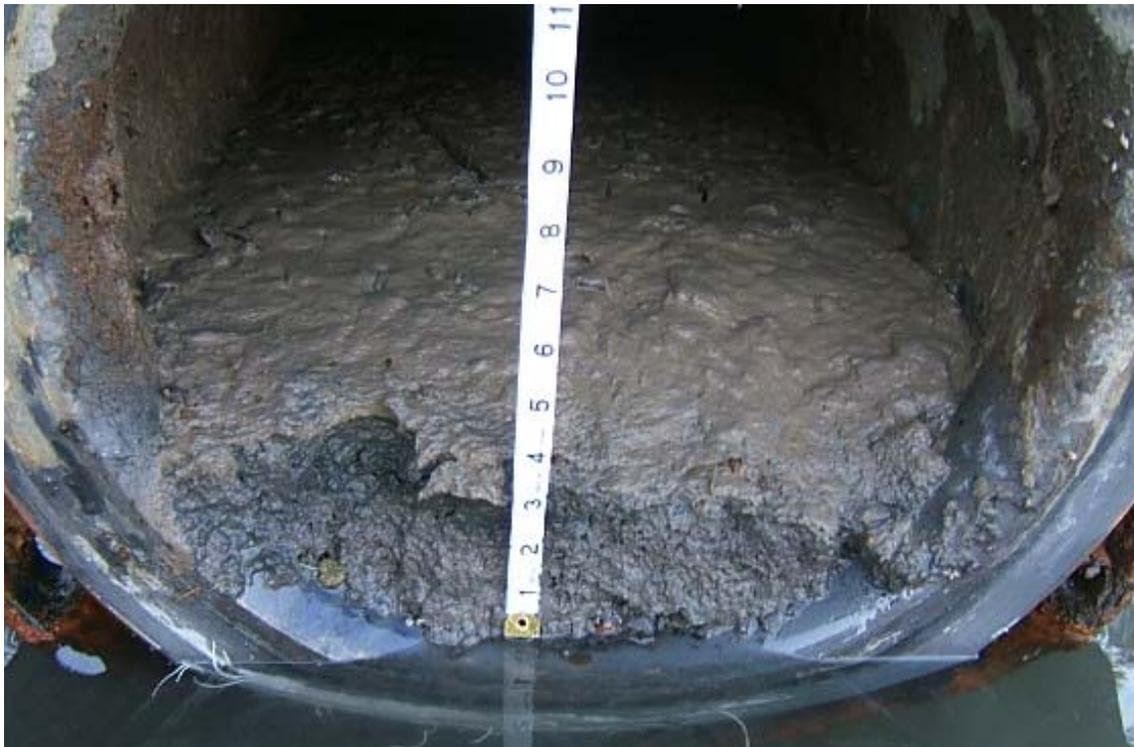
Examination of the pipes revealed that a considerable amount of organic and inorganic material had settled on the inside of each pipe, and formed a layer approximately 4 inches thick (Figure 11). This material was a gelatinous mixture of living mollusks, their empty shells, decomposed organic material, and fine sediment. Two genera of mollusks were identified; which included *Corbicula* and *Dreissena*. Also found on the inside of the pipes were dense colonies of the freshwater sponge Porifera (*Dorsilla radiospiculata*), as well as the sessile Cnidaria (*Cordylophora caspia*), and both colonies and statoblasts of Entoprocta (Table 1). Many of the organisms found inside the pipes were also found on the inside of the screens. The inside of the pipes were cleaned using a portable “hydro-jet” hydraulic sprayer.

Figure 11. Organic and inorganic material that had settled and formed a layer approximately 4 inches thick on the inside of each PVC pipe.

- A system to remove material from inside the pipes using suction should be investigated; this would allow removal of large debris (i.e, mollusk shells) from inside the pipes without requiring removal of the screens.
