Lower Colorado River Multi-Species Conservation Program

Imperial Ponds Conservation Area 2010 Final Annual Report

October 2011

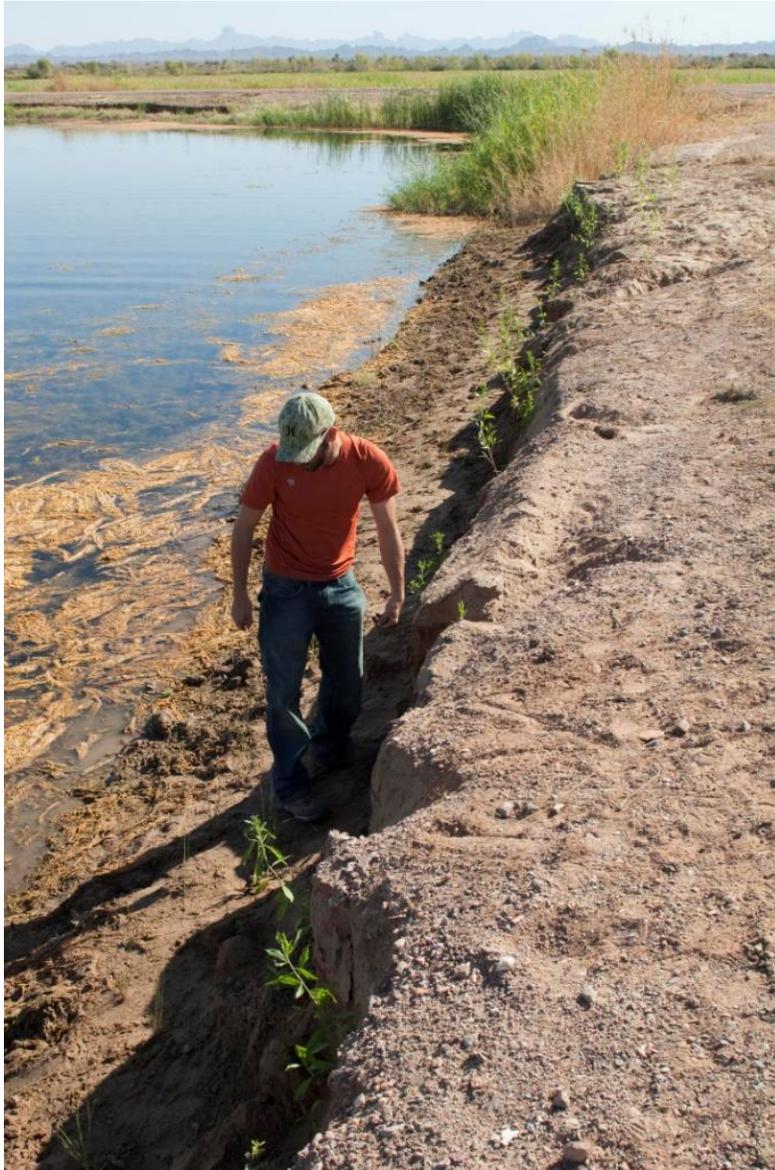
Figure 2.—Plantings around ponds.

Planting around Ponds 1, 2, 3, 5, and 6 began on October 4, 2010, by contractor Fred Philips Consulting, LLC, with a labor crew of 10 laborers and 1 foreman (figure 2). The crew installed 30,772 plants along the shorelines, working a total of 800 hours over a 10-day period to complete the planting outlined in the contract. Planting numbers for the individual ponds are listed below in tables 1–5.

In October 2010, Reclamation contracted with Fred Phillips Consulting, LLC, to plant native vegetation along the shoreline of the Imperial Ponds. This was done to improve bank line stabilization and preclude the establishment of less desirable *Phragmites*. Excluding *Phragmites* and planting more desirable marsh plant species lowers maintenance costs associated with removal of *Phragmites* while preventing the bank line from eroding. The following information comes directly from the report of the planting effort from Fred Phillips Consulting, LLC:

Commencing October 4, 2010, a labor crew of ten people and one foreman installed 30,772 plants along the shorelines of the ponds at the Imperial Ponds Conservation Area. All planting areas were properly installed with the number of plants directed by the contract with the exception of planting Plan #3 on Pond 6. This area was deemed inappropriate for planting prior to installation by representatives at the Bureau of Reclamation and Fred Phillips Consulting. The work was transferred to an early action installation of sandbar willow (*Salix exigua*) poles on April 22, 2010. Sandbar willow poles were planted along established areas on Pond 1 and Pond 2.

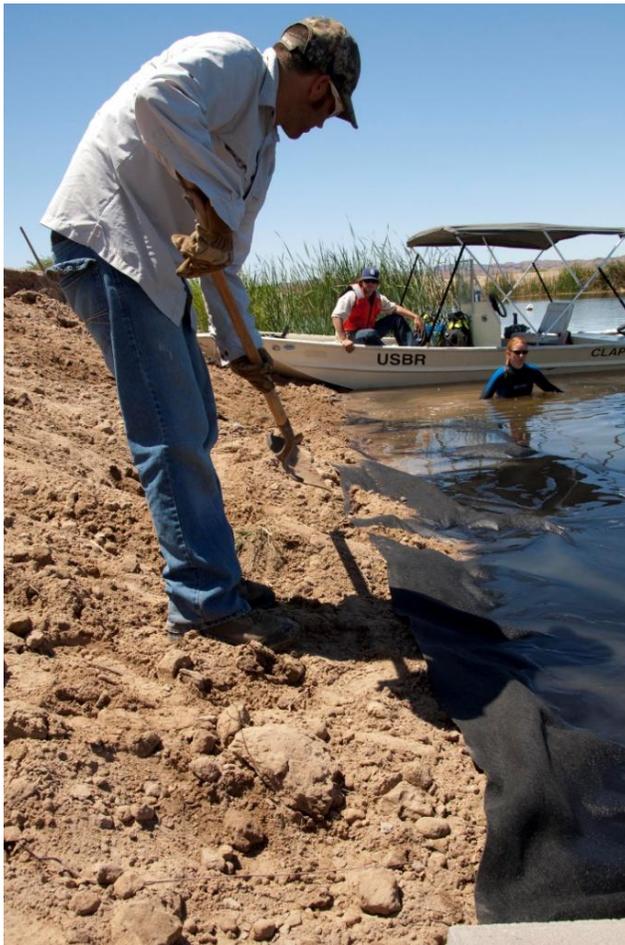
Figure 3.—Pond 1 spawning bed construction.

Construction of six spawning beds was completed in Pond 1. This effort was to support the creation of native fish habitat. The design of these spawning beds was

intended to evaluate the use of geotextiles as a vegetation barrier, a prototype gradation of gravels and rock, and site fidelity of razorback suckers to a particular spawning location (figure 3).

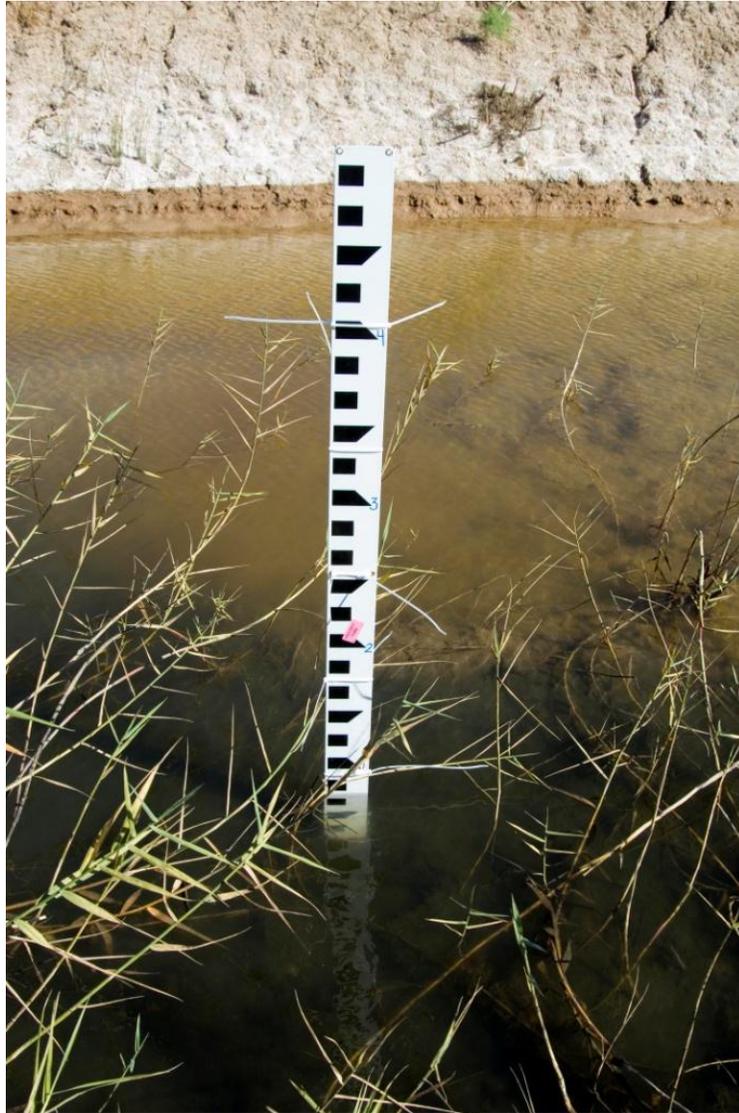
Figure 4.—Staff gauge.

Staff gages were purchased and installed throughout the site to monitor and manage water levels in the ponds (figure 4). A series of surveyed benchmarks were placed in 2009 as reference points for positioning the staff gages relative to actual elevations. Data loggers, consisting of water quality multi-probes and pressure transducers, were purchased in fiscal year (FY) 2010. The water quality multi-probes were installed in the ponds to record hourly temperature, pH, dissolved oxygen, and specific

conductivity. Pressure transducers are scheduled to be installed in the ponds during FY11, which will record hourly water elevations. In the future, this instrumentation is planned to tie into a data telemetry system.

Staff gages were purchased and installed throughout the site to monitor and manage water levels in the marsh units. A series of surveyed benchmarks were placed in 2009 as reference points for positioning the staff gages relative to actual elevations. Data loggers, consisting of water quality multi-probes and pressure transducers, were purchased in FY10. In FY10, water quality multi-probes were installed in the ponds to record hourly temperature, pH, dissolved oxygen, and specific conductivity. Pressure transducers are scheduled to be installed in the ponds during FY11, which will record hourly water elevations. In the future, this instrumentation is planned to tie into a data telemetry system.
