Comprehensive Conceptual Restoration Plan

Hart Mine Marsh,

Cibola National Wildlife Refuge

**Comprehensive Conceptual Restoration Plan
for the
Cibola National Wildlife Refuge's
Hart Mine Marsh
September 2007**

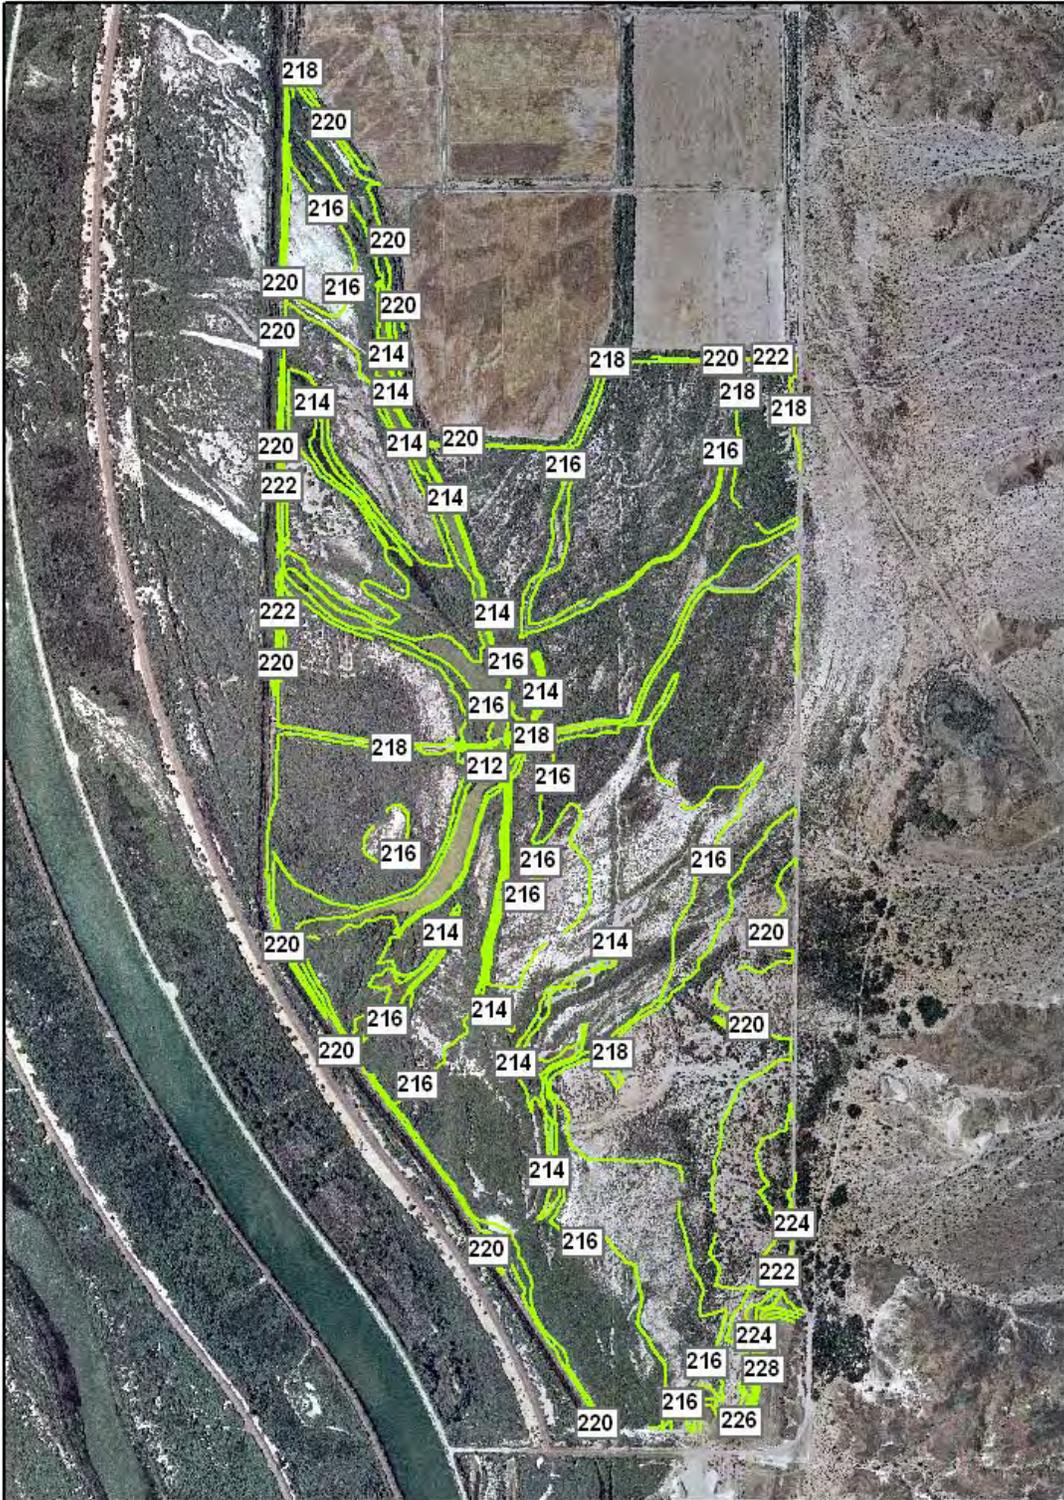
Figure 3. Two foot contour interval topographic map of the Hart Mine Marsh. Contours were estimated from Reclamation survey points and aerial photography. Many areas on this map have no survey points, thus contours are for general reference only and not intended for construction or design purposes.

The density of the available survey data is considered too low to produce a map with sufficient accuracy for specific design calculations (e.g., cut /fill volumes, final subunit designations, precise elevational management targets, etc.). An important near-term objective is to develop a better topographic characterization, perhaps through additional vegetative clearance and a subsequent LIDAR flight and refined digital terrain model prior to engineering design.

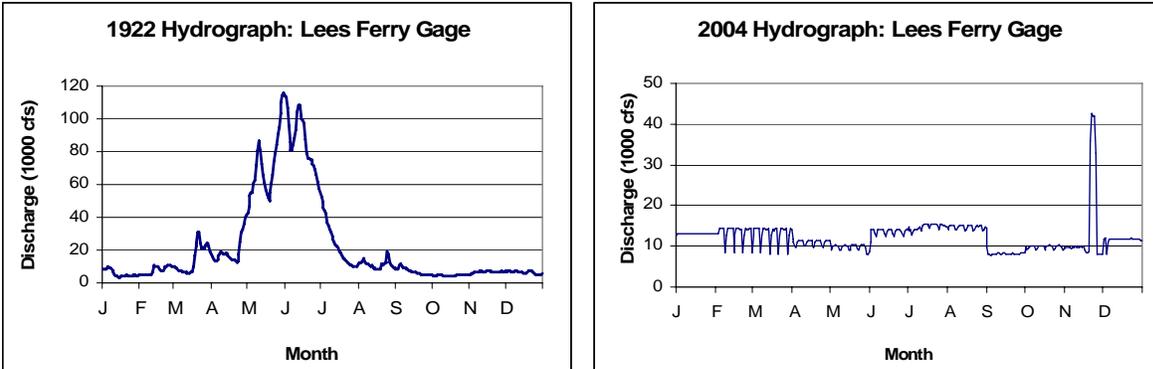
Figure 4. A comparison of LCR hydrographs before and after the construction of the LCR's major dams. The effect of upstream dams on the hydrograph is clearly visible.

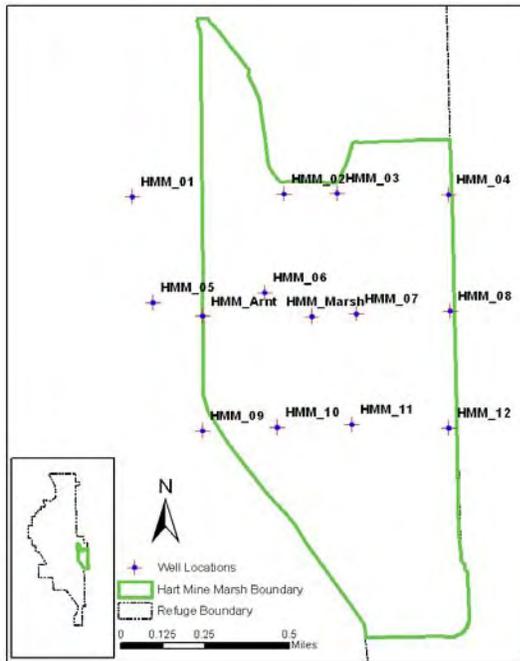
Figure 5. Location of shallow groundwater monitoring wells. Note: **HMM_Arnt** and **HMM_Marsh** are monitoring stations measuring the surface water elevation of the Arnett Ditch and the Hart Mine Marsh.

To characterize the project area's groundwater system, in 2006 the Service and Reclamation installed 12 shallow groundwater monitoring wells (Figure 5). For the most part, groundwater flow paths are south to southeast. The groundwater hydrology of the Hart Mine Marsh is controlled by river elevations, the Unit 2's irrigation ditch, and to a lesser extent, the Arnett Ditch. Relative proximity to these controls largely determines the magnitude of impact upon the marsh's groundwater hydrology. For example, groundwater levels in areas closer to the lower Colorado River are highly controlled by river levels, while groundwater levels in areas closer to Unit 2 are more controlled by irrigation practices and by ditch water levels.

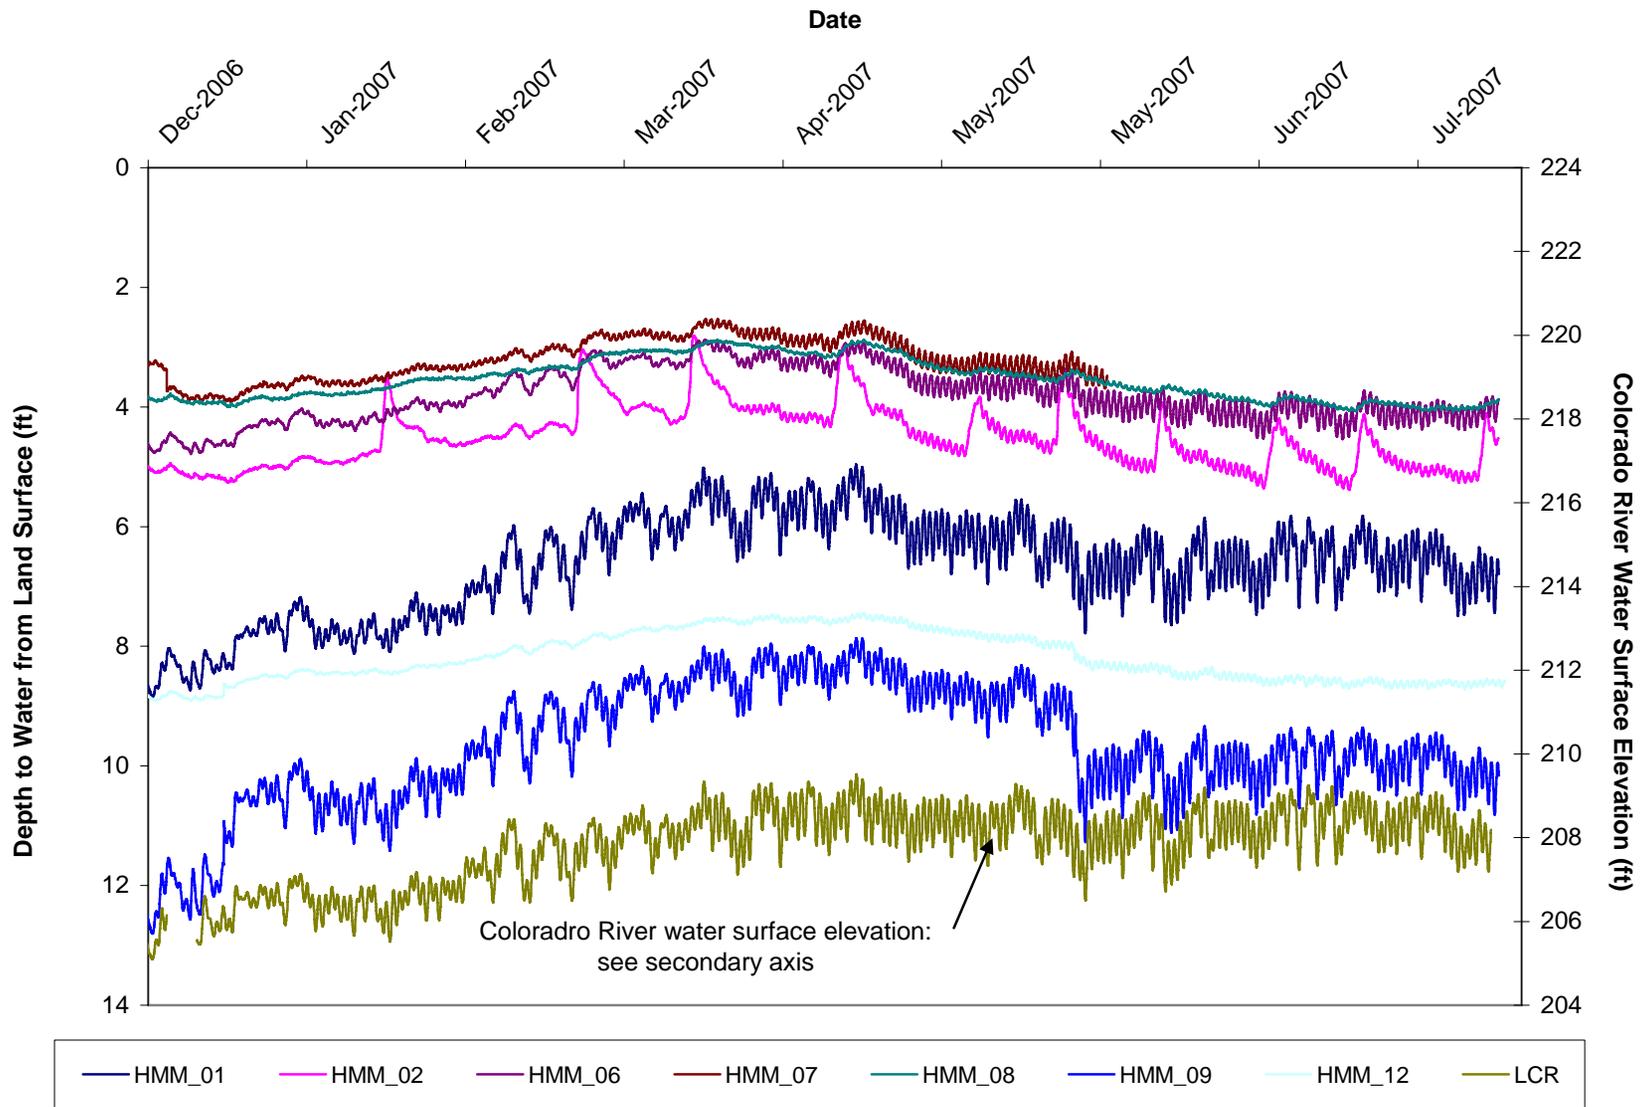
Figure 6. Depth to groundwater from land surface of selected monitoring wells and Lower Colorado River water surface elevations. River levels are shown on the right axis. Several monitoring wells closely follow the shape of the river's hydrograph, demonstrating the effects of river levels on groundwater dynamics.

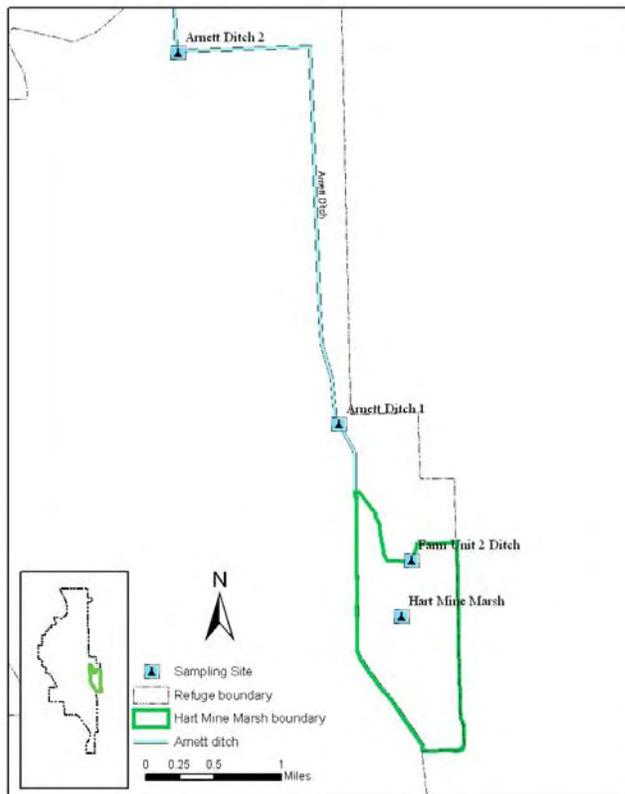
Figure 7. Location of water quality sampling sites.

While resources and time constraints did not allow for a robust site characterization, conditions were assessed by surface water grab samples and by a multi-parameter water quality probe. Grab samples were collected twice, once during August, 2006, and once during May, 2007. Readings were taken with the water quality probe concurrent with grab samples. Sample collection was timed to assess the relative difference in water quality at the beginning (May) and the end (August) of the irrigation season. An additional sample using the water quality probe was taken October, 2006. Grab samples were sent to an analytical laboratory and analyzed for nutrient levels, anion and cation levels, and chlorinated and organophosphorous pesticides (see Appendices A and B for results). To address Reclamation's concern that the initial Arnett Ditch sampling site was not representative, an additional Arnett Ditch site was added (see Figure 7 for sampling locations).

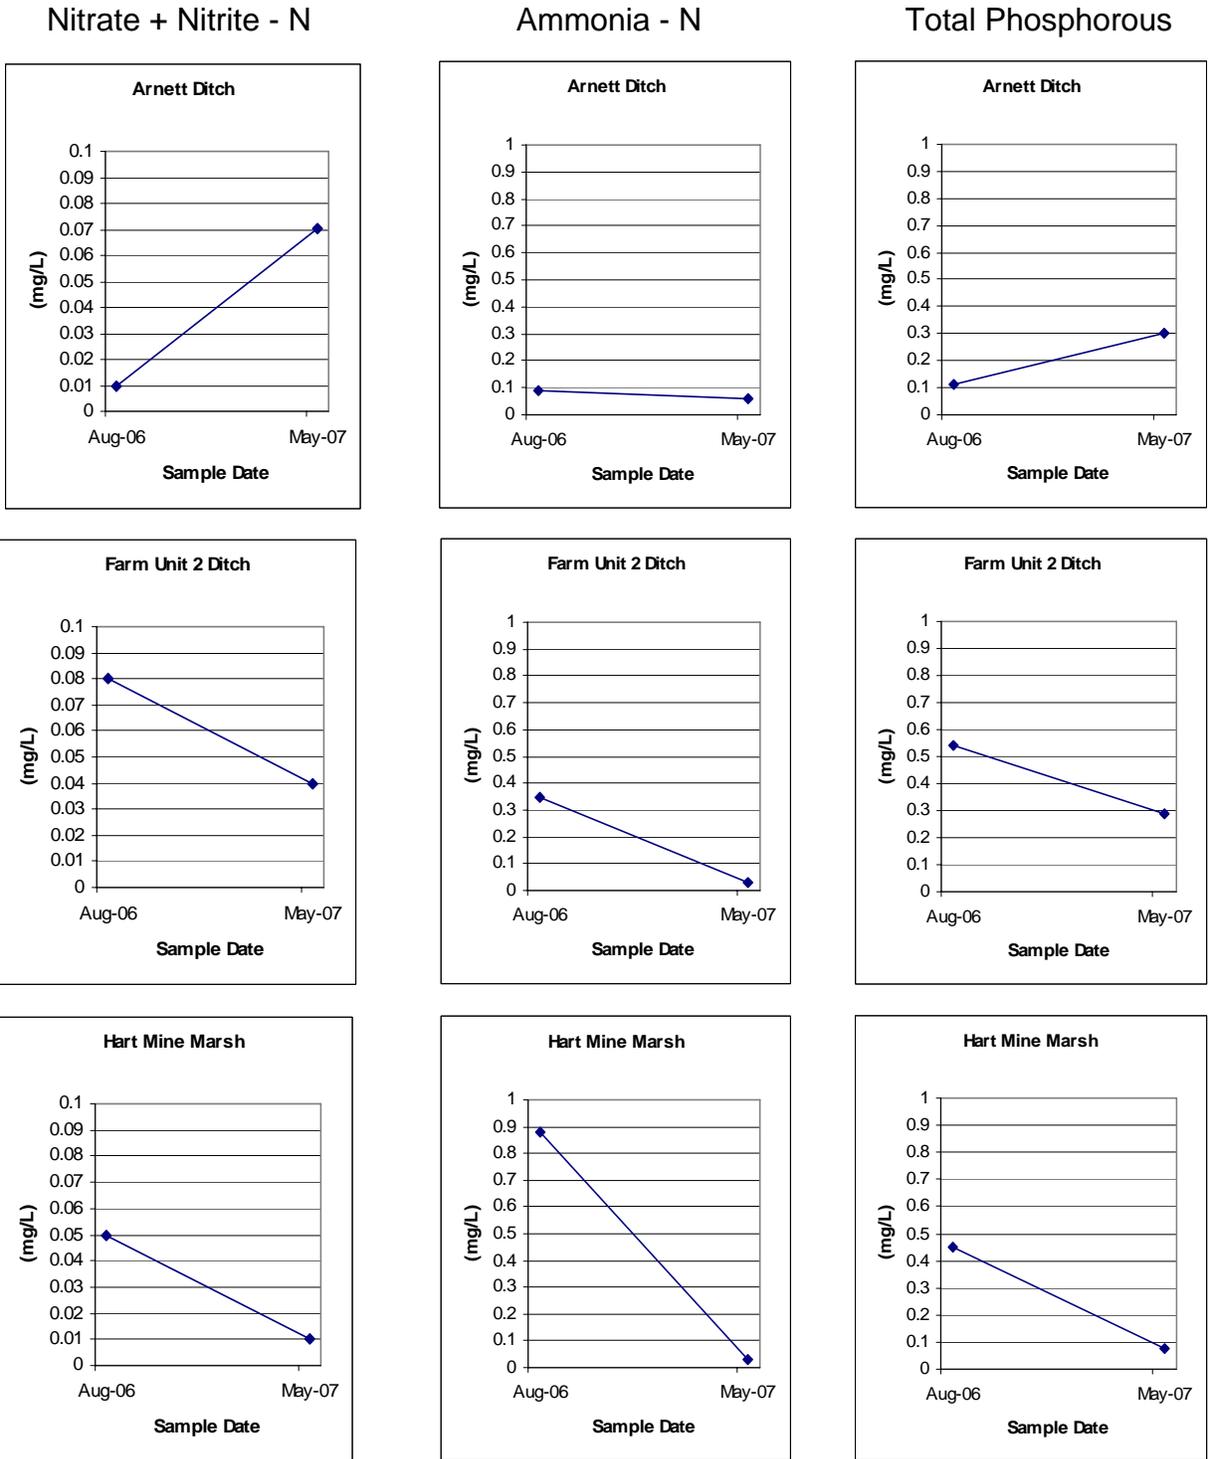
Figure 8. Seasonal variability of nutrient concentrations.

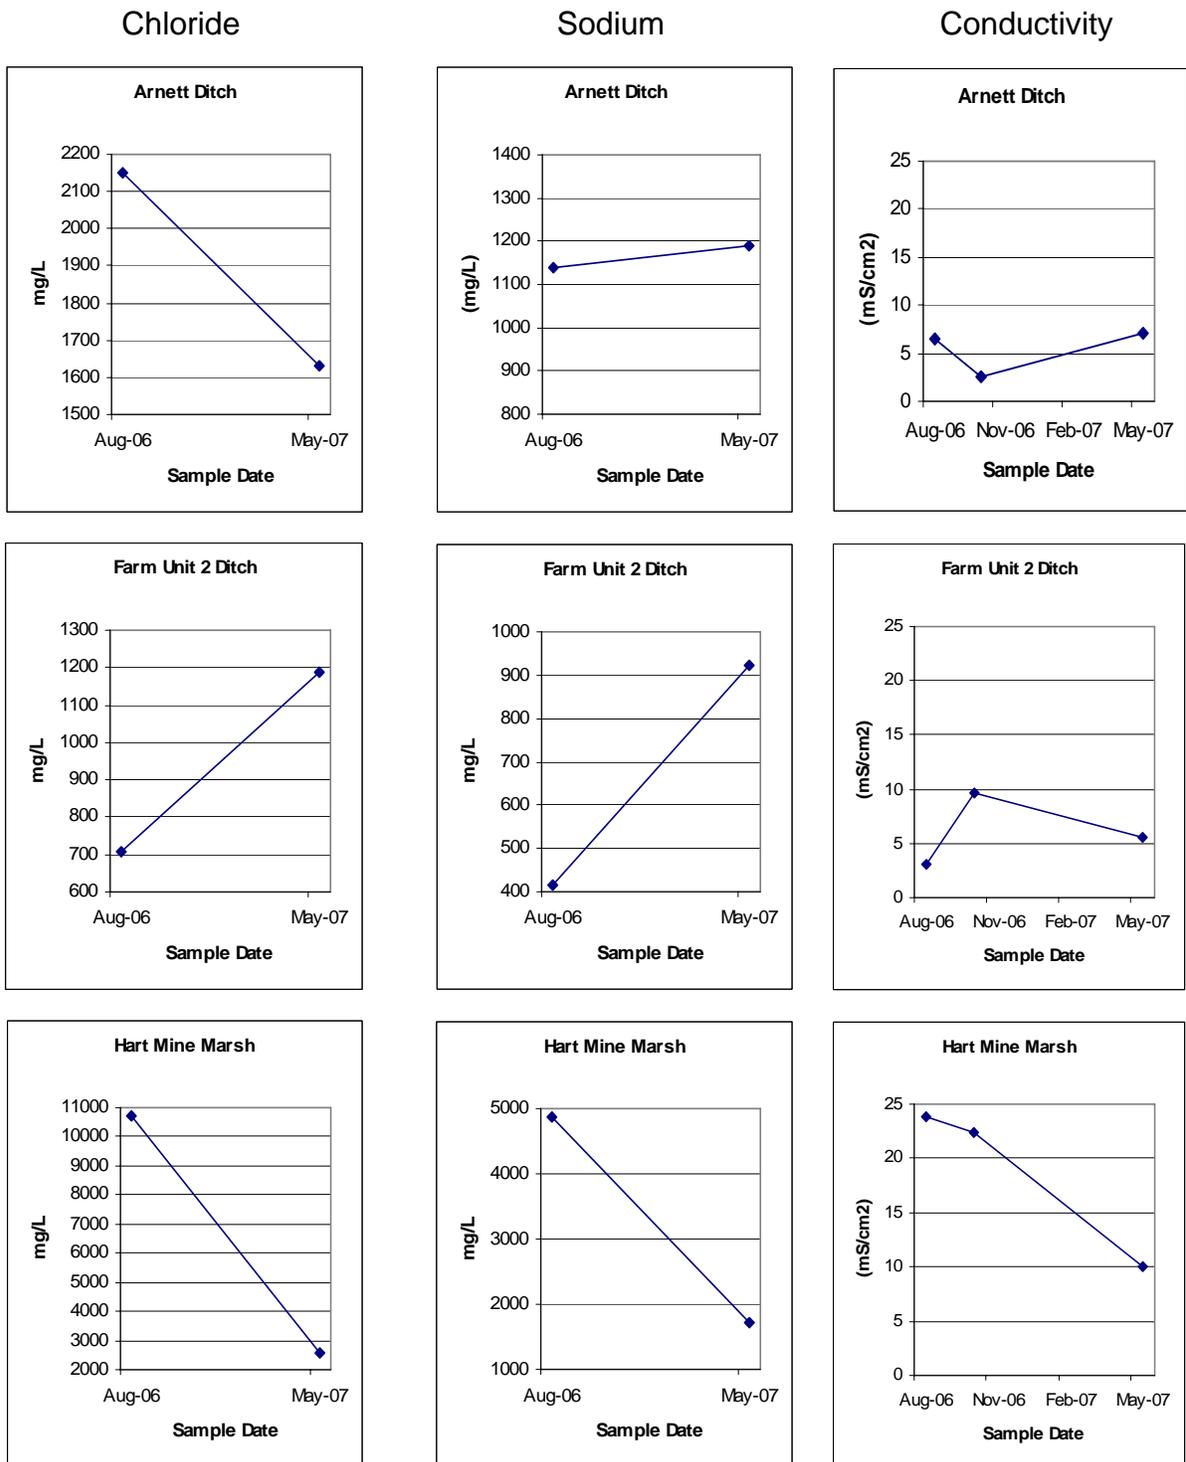
Figure 9. Seasonal variability of selected anions, cations, and conductivity.

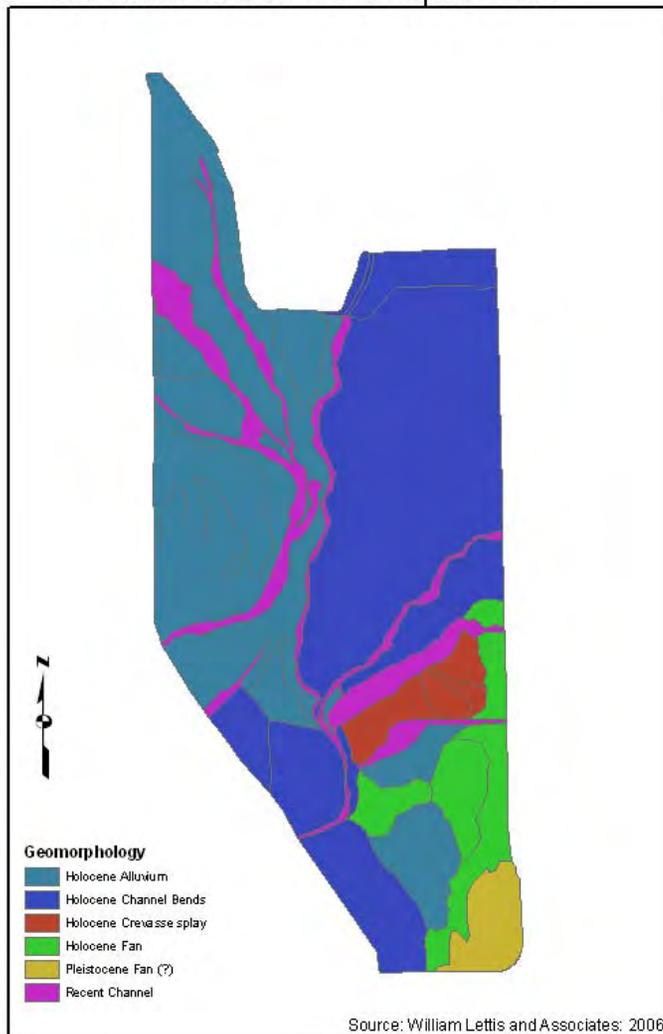
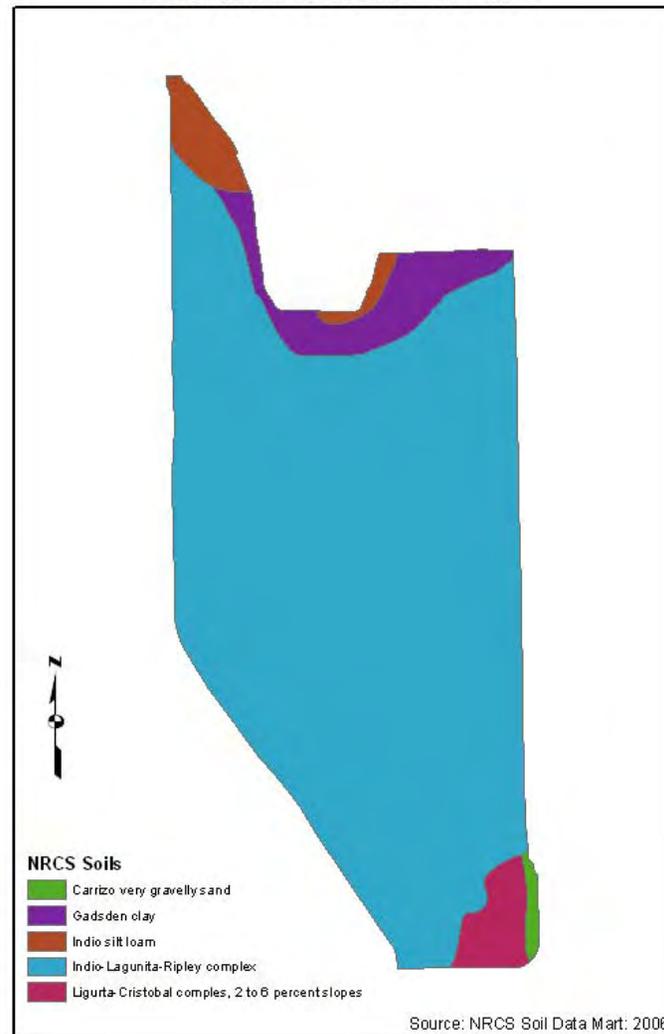
Hart Mine Marsh Geomorphic Units

Figure 10. A comparison of the geomorphology and soils of the Hart Mine Marsh

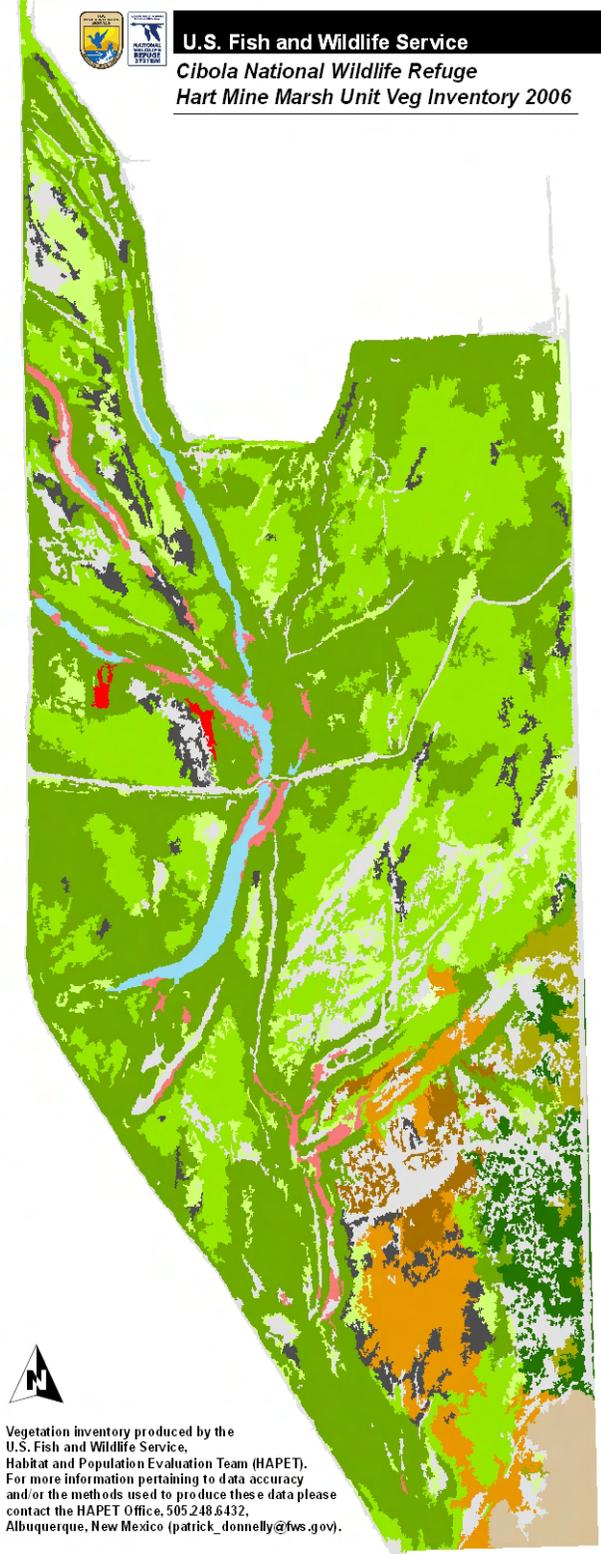
Vegetation inventory produced by the U.S. Fish and Wildlife Service, Habitat and Population Evaluation Team (HAPET). For more information pertaining to data accuracy and/or the methods used to produce these data please contact the HAPET Office, 505.248.6432, Albuquerque, New Mexico (patrick_donnelly@fws.gov).

A total of 8 different plant communities were identified and associated with 3 distinct landforms occurring in the project area. The majority of the Hart Mine Marsh Unit encompasses the historic Colorado River floodplain. Over 80% of this area has been invaded by mixed and monotypic stands of salt cedar (*Tamarix ssp.*). The densest and most robust stands of salt cedar were found in the areas adjacent to active water channels and in lower elevation areas that appeared to pool surface water. Areas directly adjacent to open water or currently active channels contained areas of tall emergent plant communities dominated by cattail (*Typha ssp.*) and bulrush (*Schoenoplectus ssp.*). See Appendix A for a table of vegetation communities and acreages.

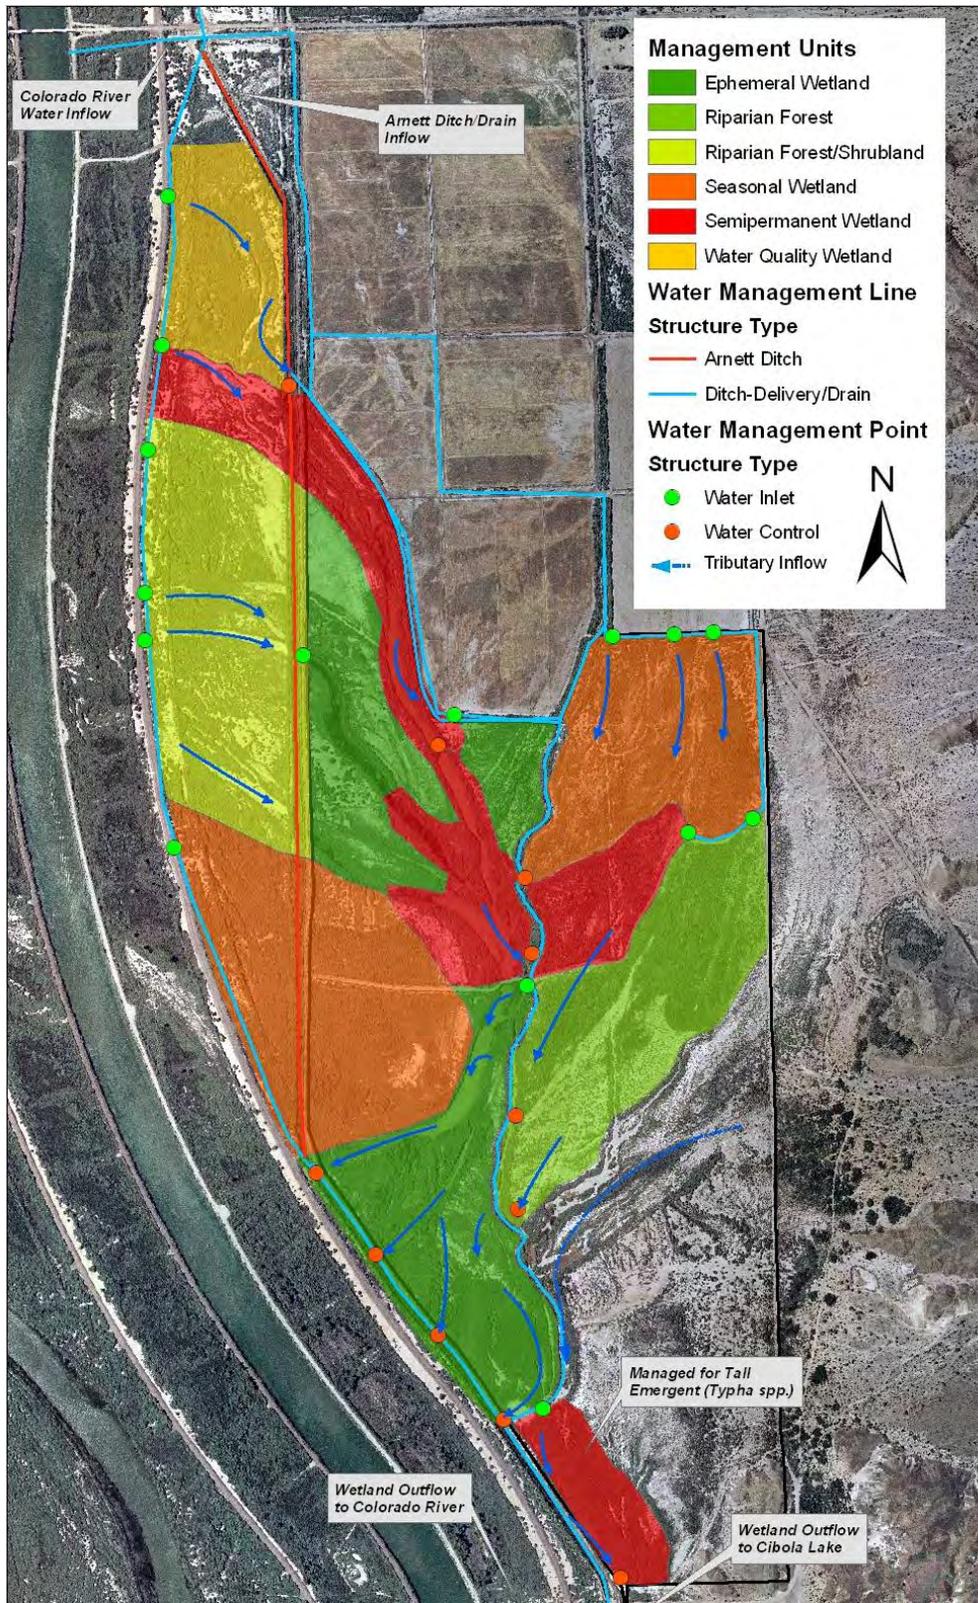
Figure 12. Conceptual Site Plan, describing potential habitat types and infrastructure improvements at the Hart Mine Marsh. This site plan is conceptual in nature and for discussion purposes only. It does not imply a Service or LCR MSCP commitment to developing the specific habitat types, nor the potential infrastructure components, in the specified locations, but a rather, a general commitment to a mosaic of habitats and a robust infrastructure.

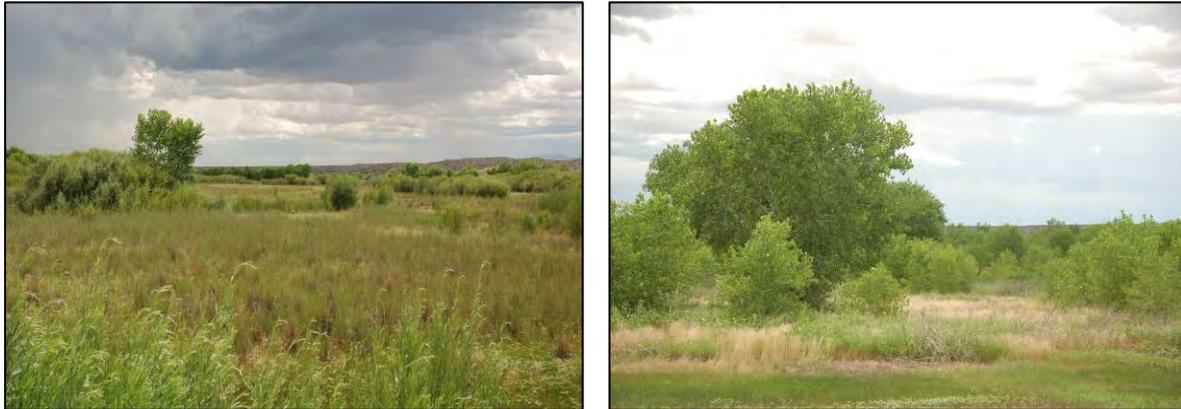
Figure 13. Examples of habitat mosaics at Bosque del Apache National Wildlife Refuge (NM). Habitat restoration of this type may be possible at the Hart Mine Marsh.

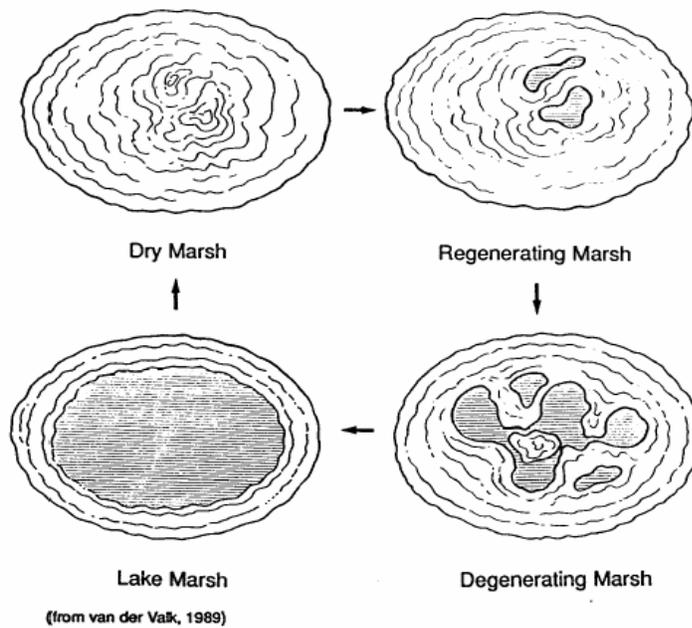
Figure 14. The four stages of a semipermanent wetland during a standard wet and dry cycle. Lines represent vegetation zones that become apparent in the regenerating marsh stage, while areas filled with black represents open water (adapted from van der Valk 1989).

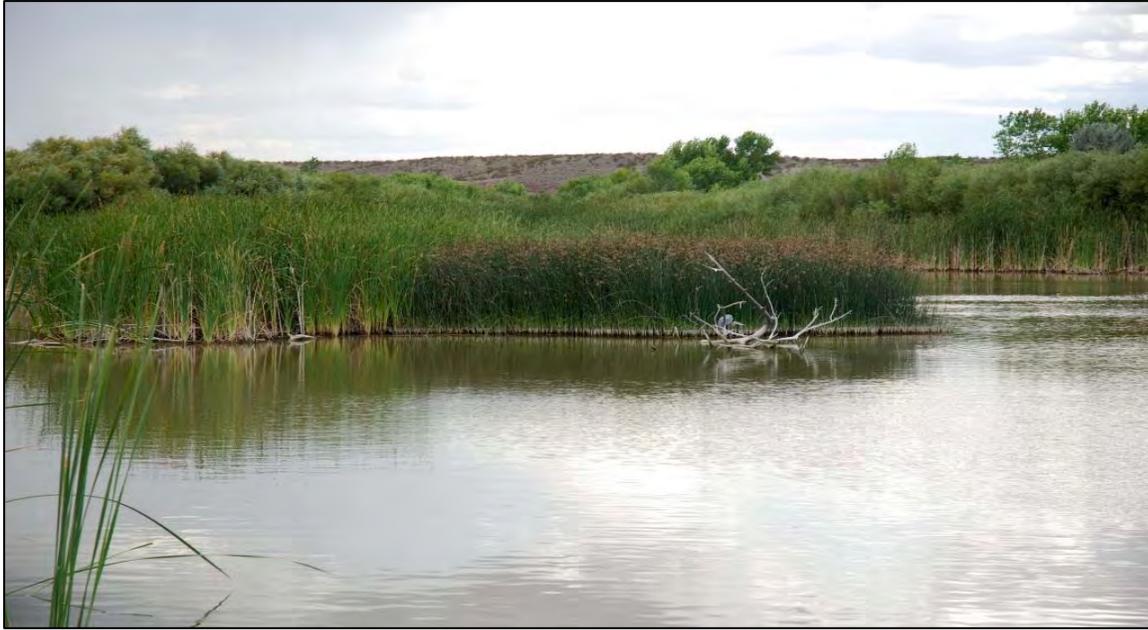
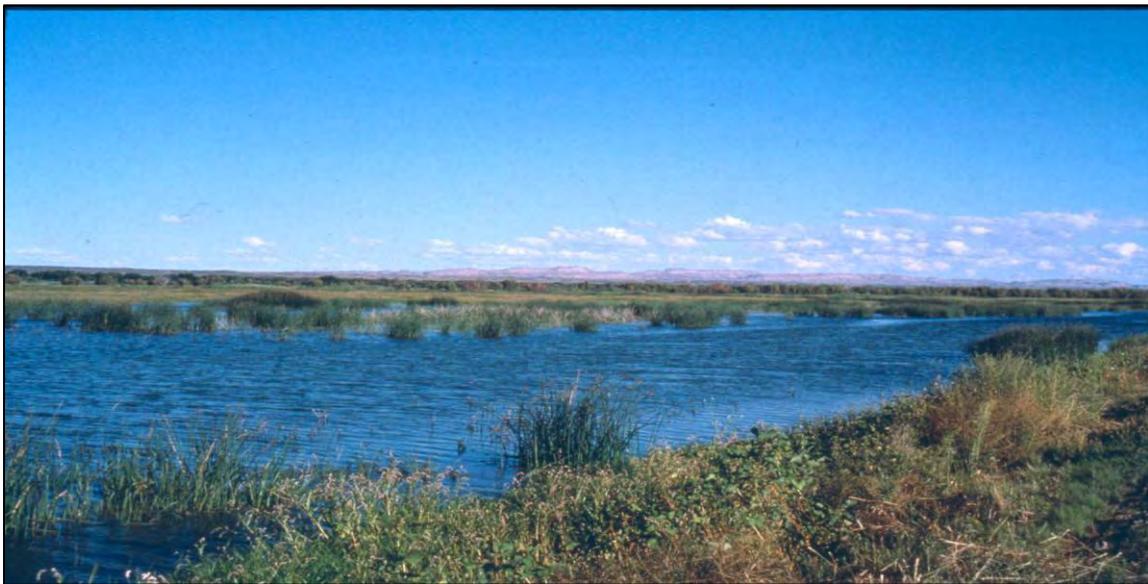
Figure 15. Two examples of the vegetative communities and structure associated with managed semipermanent wetlands that are possible at the Hart Mine Marsh.

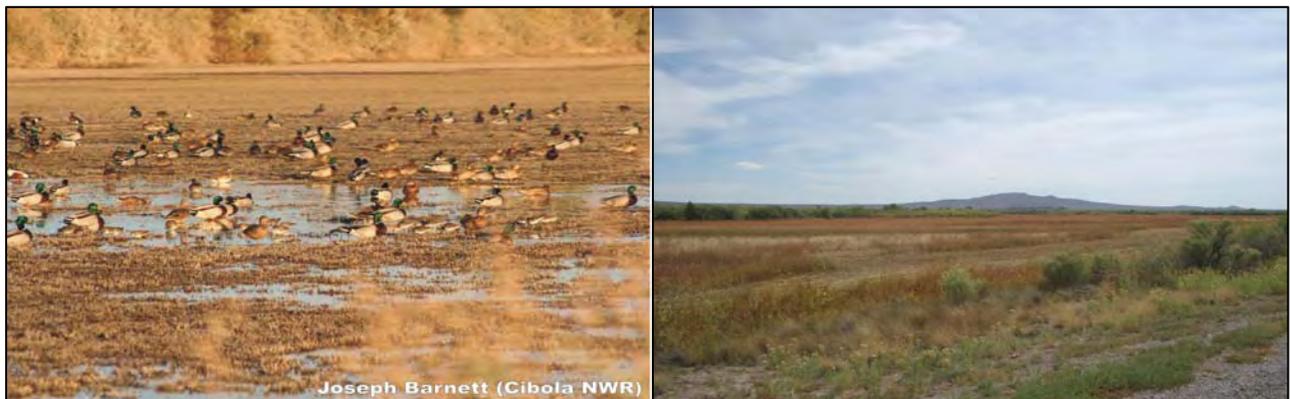
Figure 16. Two different seasonal wetlands during the winter (left) and fall (right). Note the extensive utilization of migratory waterfowl and the diverse vegetative communities.

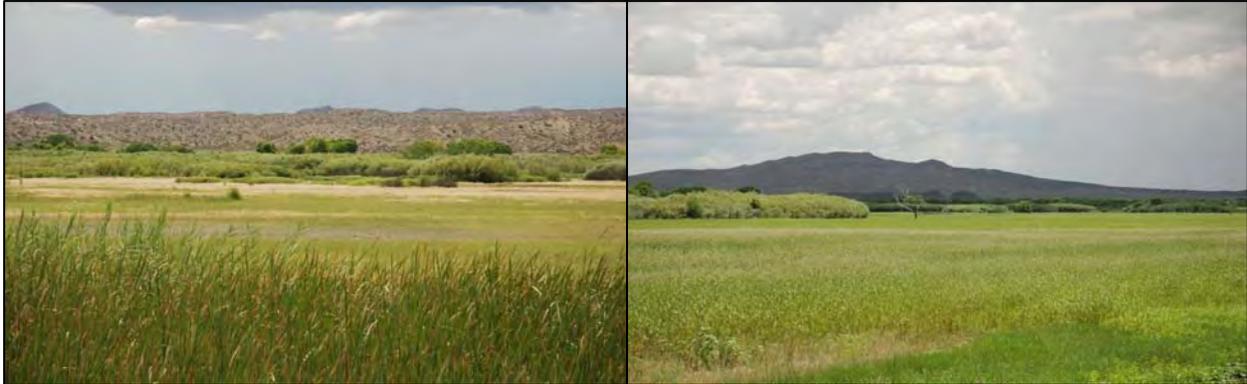
Figure 17. An ephemeral saltgrass wetland at Bosque del Apache National Wildlife Refuge.

Ephemeral wetlands occur in areas where groundwater occurs close to the surface and that experience seasonal variation in the groundwater hydrograph. In many riparian systems of the Southwest this type of wetland was historically extensive. Ephemeral wetlands (Figure 17) are also a product of summer precipitation that occurs in basins and pans where surface water temporarily pools. High evaporation rates during the summer often result in higher salinity levels in the soil associated with ephemeral wetlands. Common plant communities are saltgrass (*Dystichlis spicata*) meadows that transition to alkali (*Sporobolus airoides*) or giant sacaton (*Sporobolus wrightii*) as well as catch-fly Gentian (*Eustoma exaltum*), yerba mansa (*Anemopsis californica*), and saltmarsh fleabane (*Pluchea camphorate*), depending on the timing of wetting and drying. These species are highly used by many native insects. Where the wetting period is short compared to the dry period, both pickleweed (*Allenroffea occidentalis*) or arrowweed (*Pulchea purpurescnes*) may occur in large stands depending on soil salinity levels.

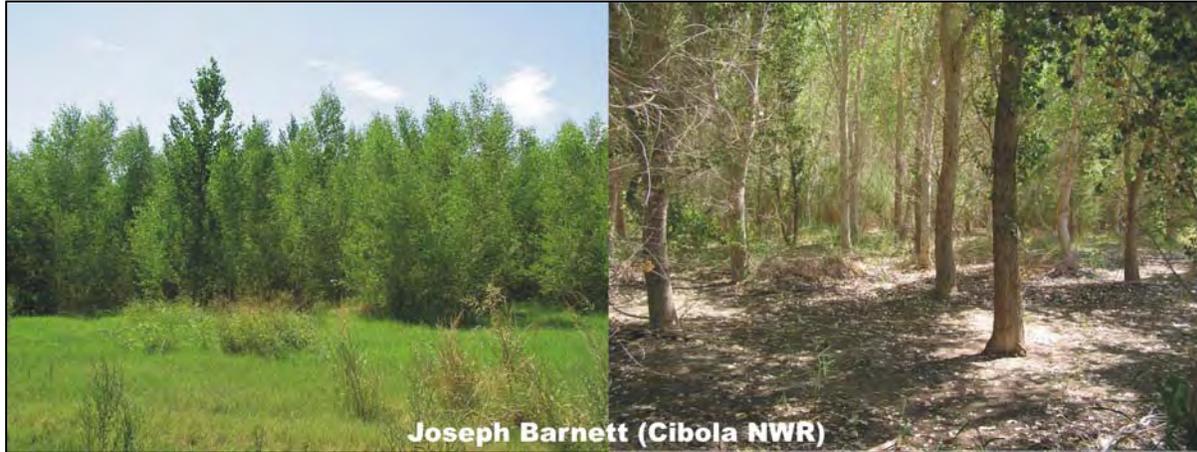
Figure 18. Two examples of dense forest. The first is of a young dense forest, and the second is of a mature canopy forest.

As cottonwoods mature and provide more shade to the floodplain surface, coyote willow thins out and other, more shade-tolerant, understory species are more common including seepwillow (*Baccharis salicifolia*). These mid-age to mature “canopy” forested areas provide food, roosting and nesting opportunities for a number of bird species including woodpeckers, with the Gila woodpecker (*Melanerpes uropygialis*) known to nest on the refuge, bald eagle (*Haliaeetus leucocephalus*), and assorted hawks (Figure 18). Small mammals, snakes and lizards would be frequent foragers in these forests.

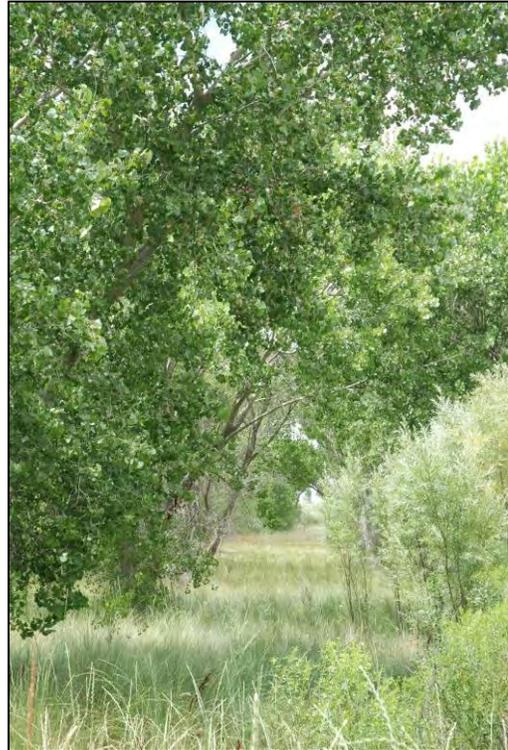
Figure 19. An example of an open forest.

Open forests (Figure 19) are found in many riparian areas due to both anthropogenic alterations to the system and natural system functions. Historically, high flows would remove some of the dense plant material established on the lower terraces of the floodplain. These scoured areas, if not reestablished with a new cohort of native trees, would initially become established with

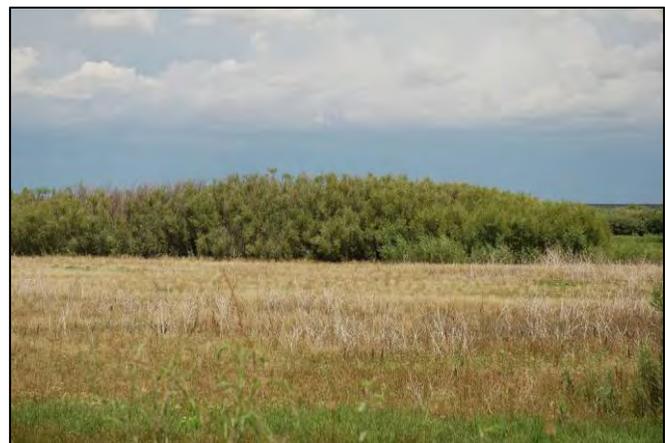
Figure 20. Dense willow shrubland, adjacent to shallow groundwater.

The first type of shrubland is the dense coyote willow stand. These shrubs form dense monotypic stands adjacent to open water or shallow groundwater. They are distinguished from young mixed stands mentioned above as young dense forests because they typically occur as a dense clump of a single species, expanding in size but consistent in height, i.e. there is no diversity in structure for this habitat type (Figure 20). Historically, these shrubs would be found on point bars or islands within the river's active channel or adjacent to the river's edge. These shrubs are now often found along ditch

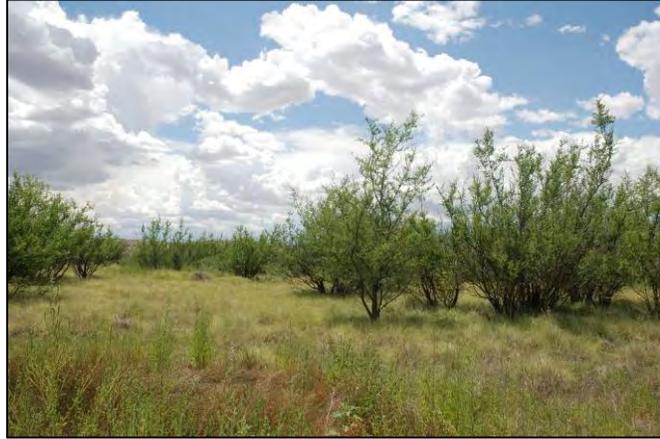
Figure 21. Screwbean mesquite shrubland associated with more mesic conditions.

The second type of shrubland is usually associated with plants that require a shallow groundwater table, tolerate higher soil salinity levels, and have fine-grained soil texture (Figure 21). Velvet (*Prosopis velutina*) and screwbean mesquite (*Prosopis pubescens*), and iodinebush (*Allenrolfea occidentalis*) occur in these areas along with alkali sacaton (*Sporobolus airoides*) and some *Muhlenbergia* grass species. Wildlife species found on the refuge and would presumably be attracted to this type of habitat include the hermit thrush

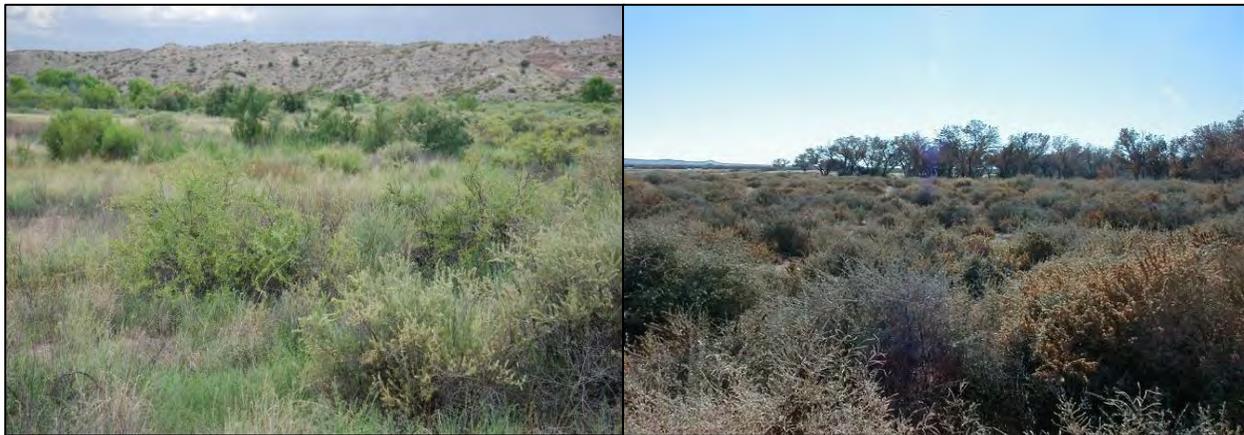
Figure 22. Two examples of shrublands associated with more xeric conditions.

The third type of shrubland is found in courser-grained floodplain soils. Honey mesquite (*Prosopis glandulosa*), wolfberry (*Lycium sp.*) and sand sage (*Artemisia filifolia*) are three plant species associated with this shrubland type. Grass species would be similar to those found in upland areas adjacent to the Hart Mine Marsh (Figure 22). Wildlife use of both these more xeric

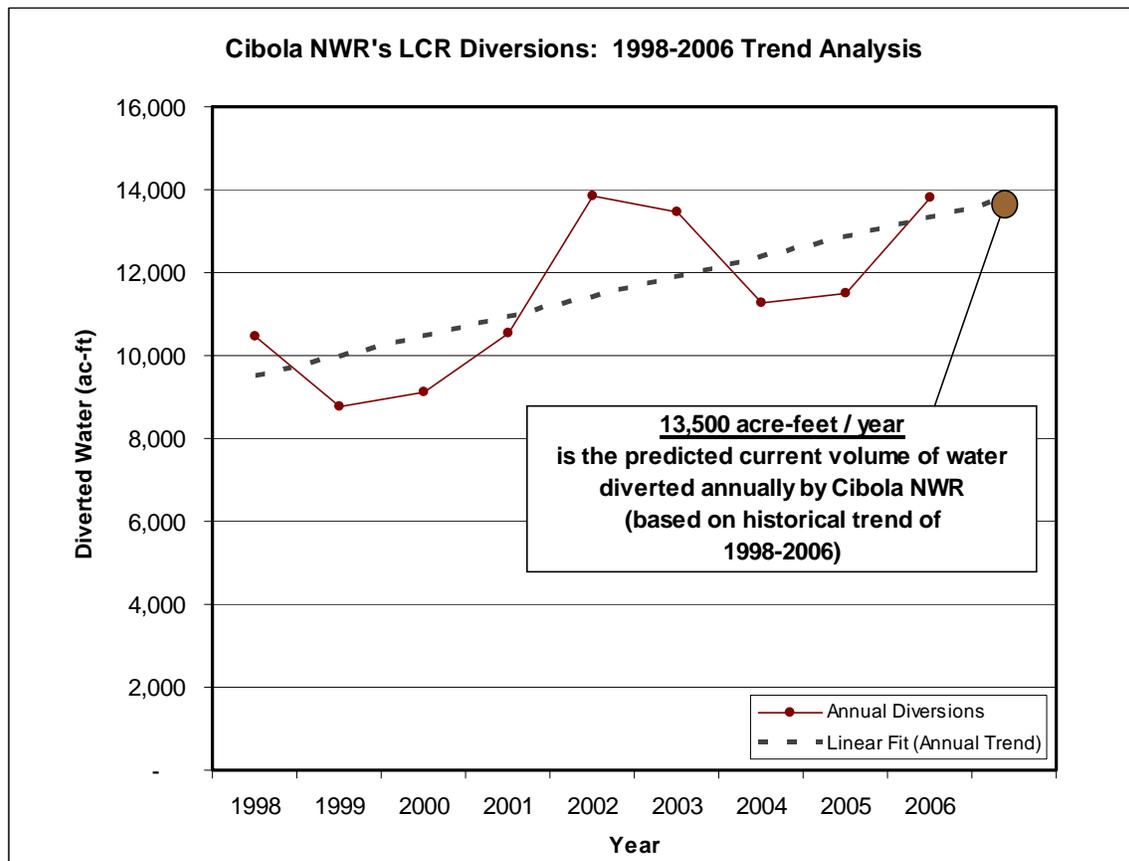
Figure 2. Cibola NWR's lower Colorado River water diversions from 1998 to 2006 showing an overall increase in use due to the addition of new habitat units.

Data Source: Consumptive Use values: *USBR--Colorado River Accounting and Water Use Reports (Arizona, California and Nevada) (1998-2005)*, while all other data comes from Service gages at each refuge units (note: all 2006 values are provisional).

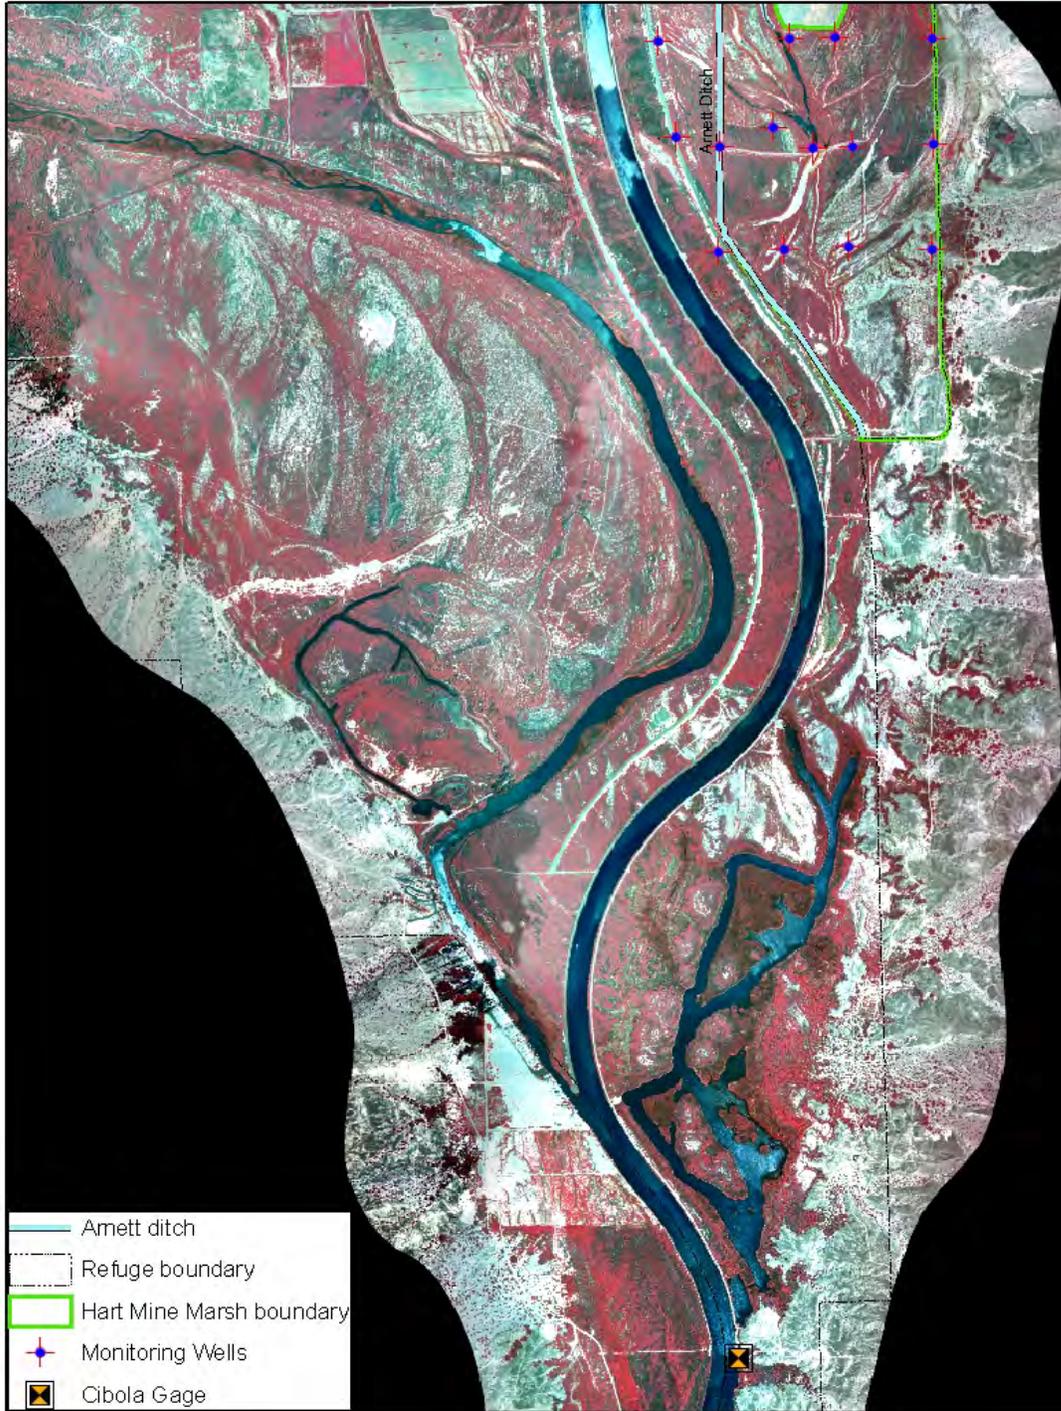
Figure 3. Location of monitoring wells and surface water dataloggers. The USBR's Cibola Gage is located at the lower extent of the image.
