Comprehensive Conceptual Restoration Plan

Hart Mine Marsh,

Cibola National Wildlife Refuge

**Comprehensive Conceptual Restoration Plan
for the
Cibola National Wildlife Refuge's
Hart Mine Marsh
September 2007**

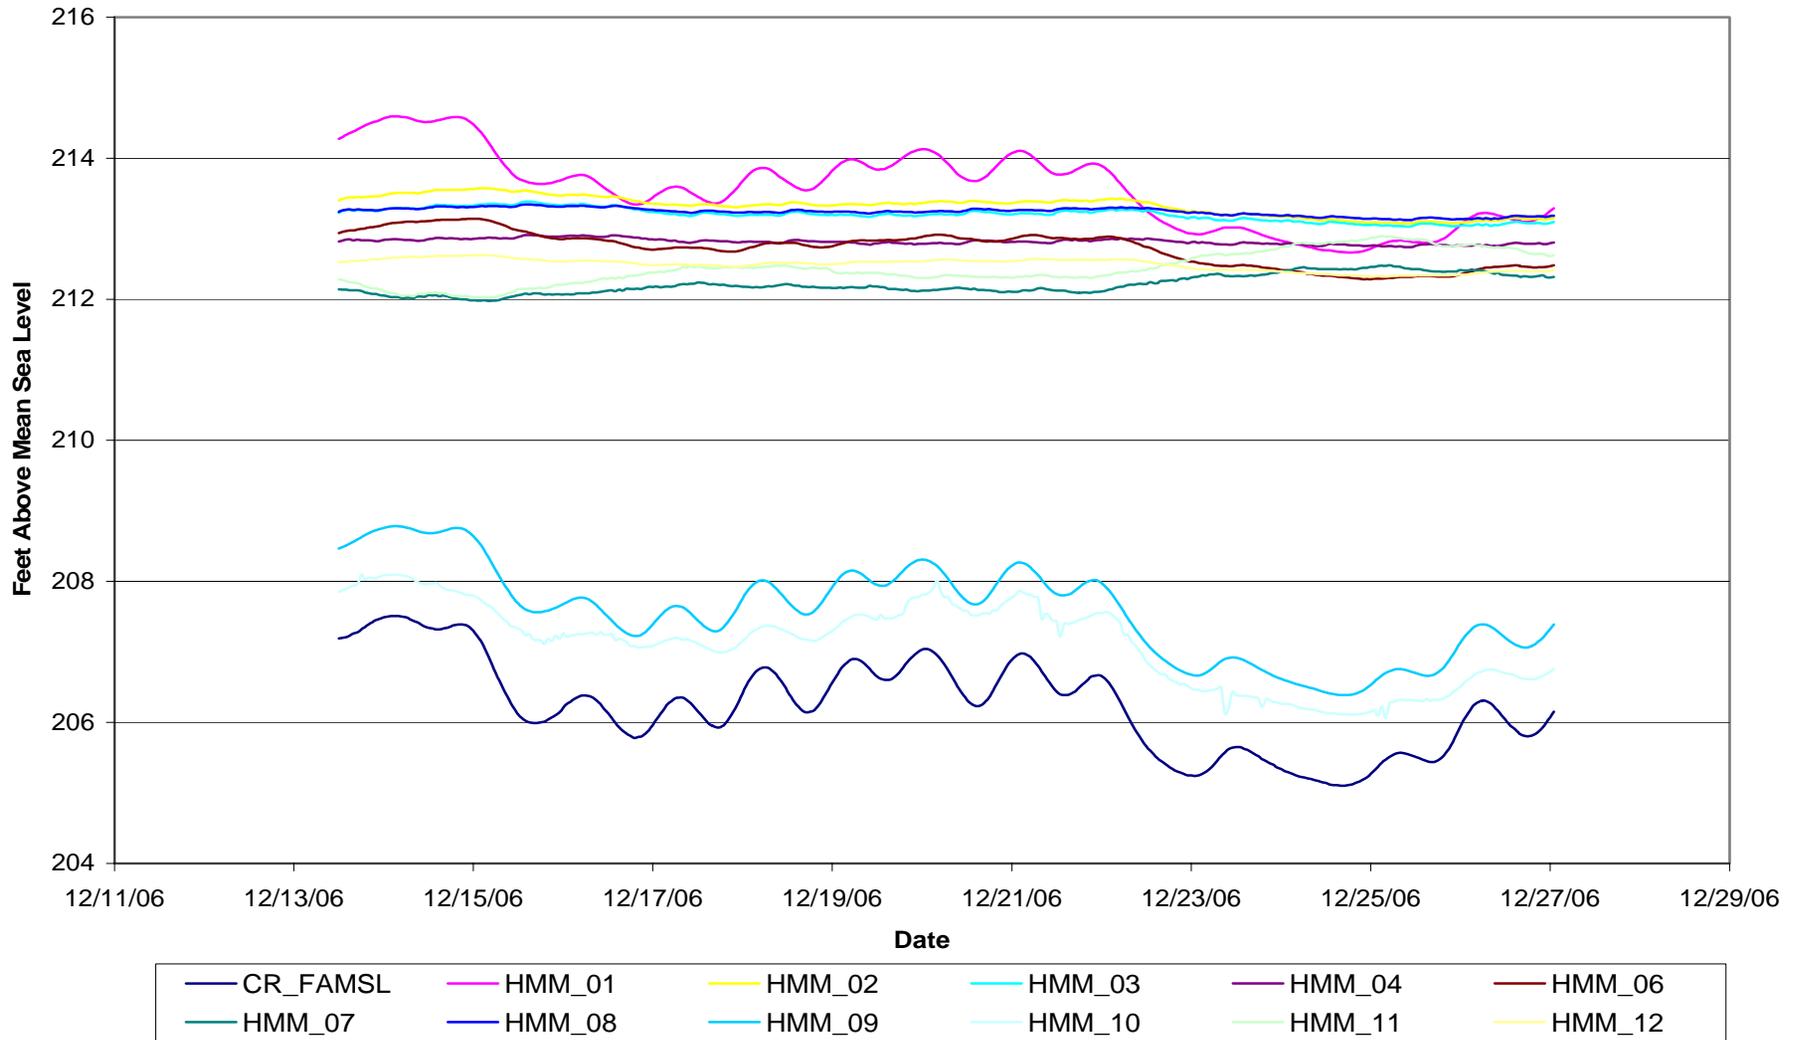
Hart Mine Marsh Water Surface Elevations: Monitoring Wells and Colorado River

Figure 4. Relative elevations of Hart Mine Marsh ground water monitoring wells and lower Colorado River (at Cibola Gage) demonstrate a clear connection between the LCR and groundwater between the LCR and the Arnett Ditch.

Furthermore, regression analysis indicates that the LCR river levels exert a control on groundwater levels to the east of the Arnett Ditch: monitoring well HMM_10 tracks WSEL of the LCR with an R^2 of 0.90. Statistical models for monitoring well HMM_06

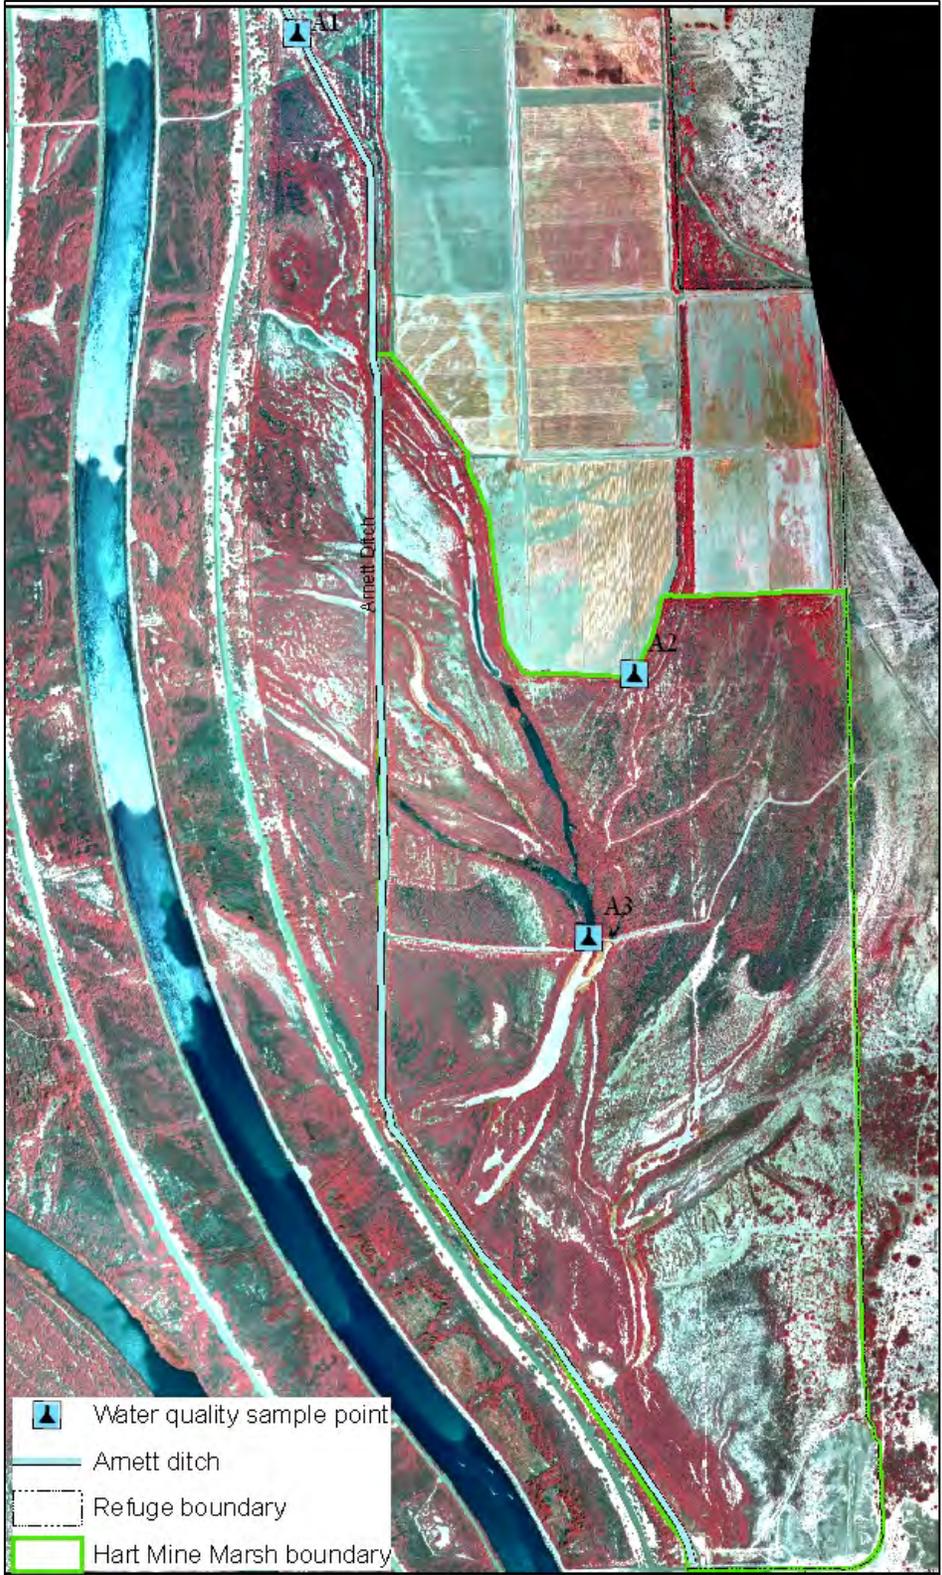
Figure 5. Location of water quality sample sites.

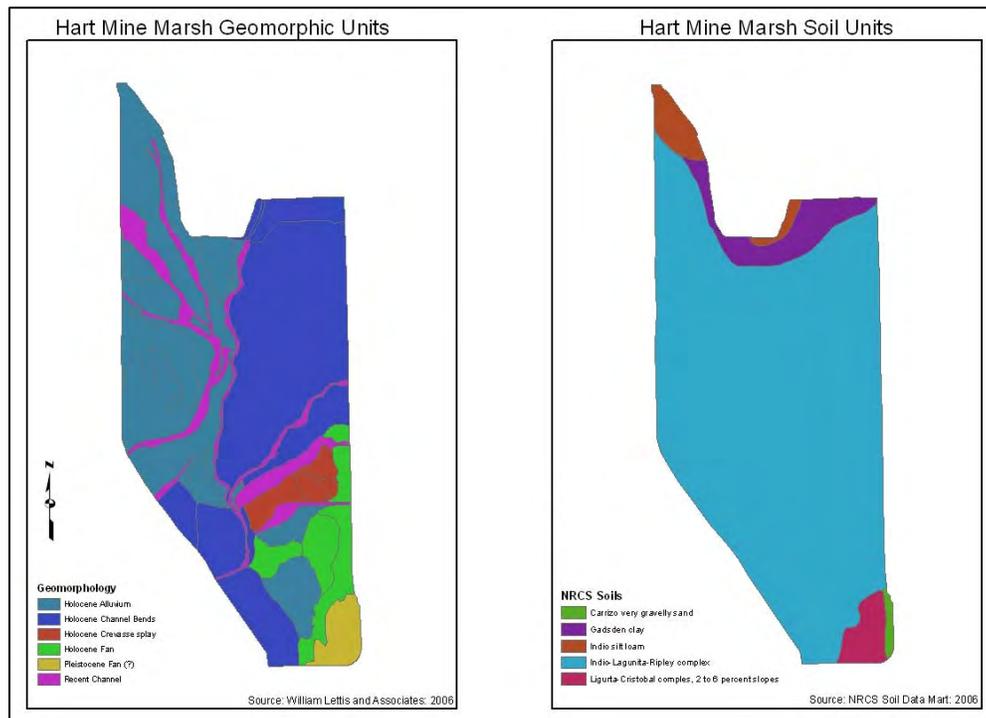
Figure 6. Comparison of surficial geology map (left) and NRCS soil map units (right) at the Hart Mine Marsh unit.

The soils mapped at the Hart Mine Marsh are typical for soils forming on alluvial fans and flood plains in the Sonoran Desert. The NRCS has mapped three main soil types at the Hart Mine Marsh. The locations of the map units are shown on Figure 6.

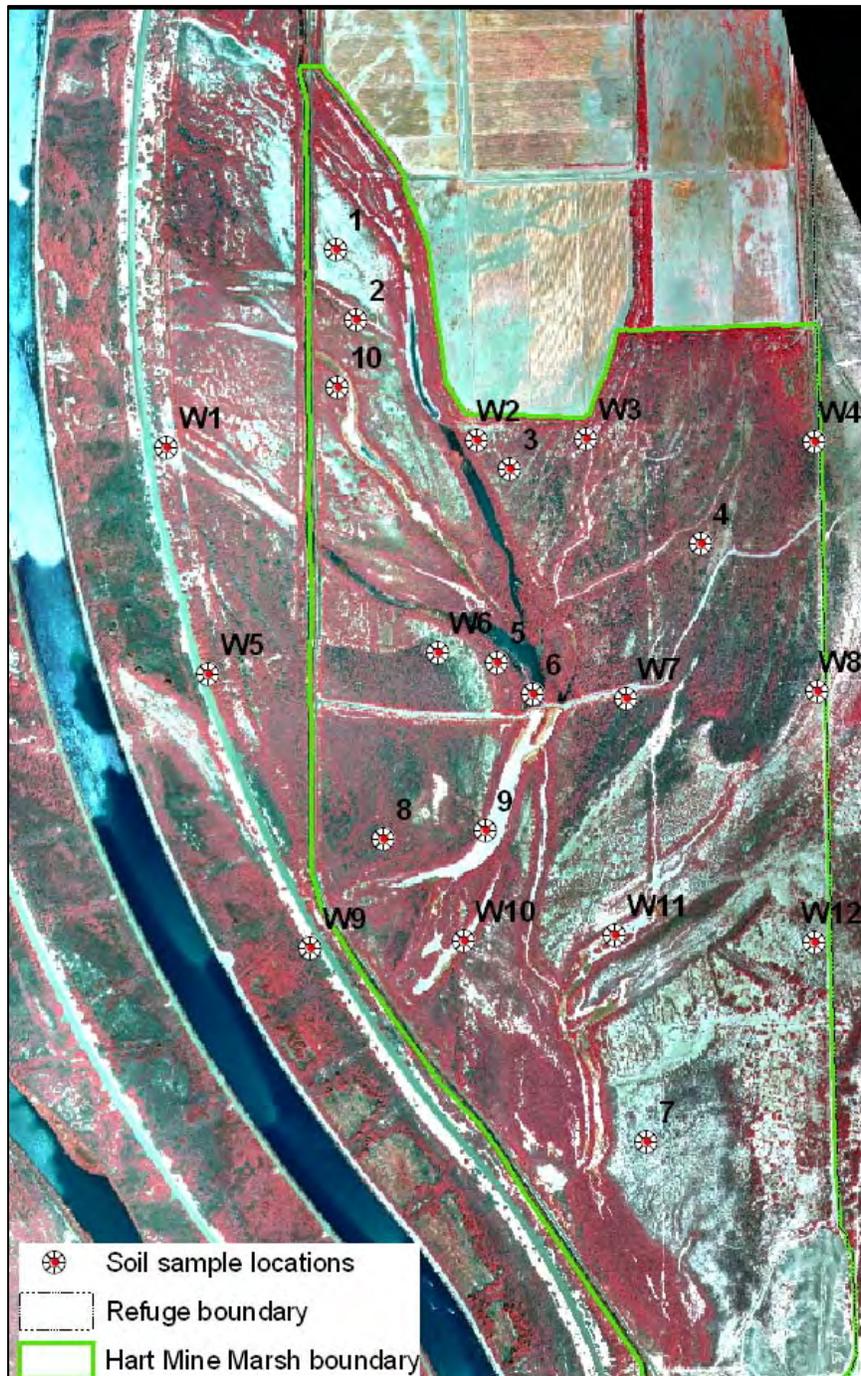
Figure 7. Soil sample locations, includes samples taken from soil pits and monitoring well drill holes.

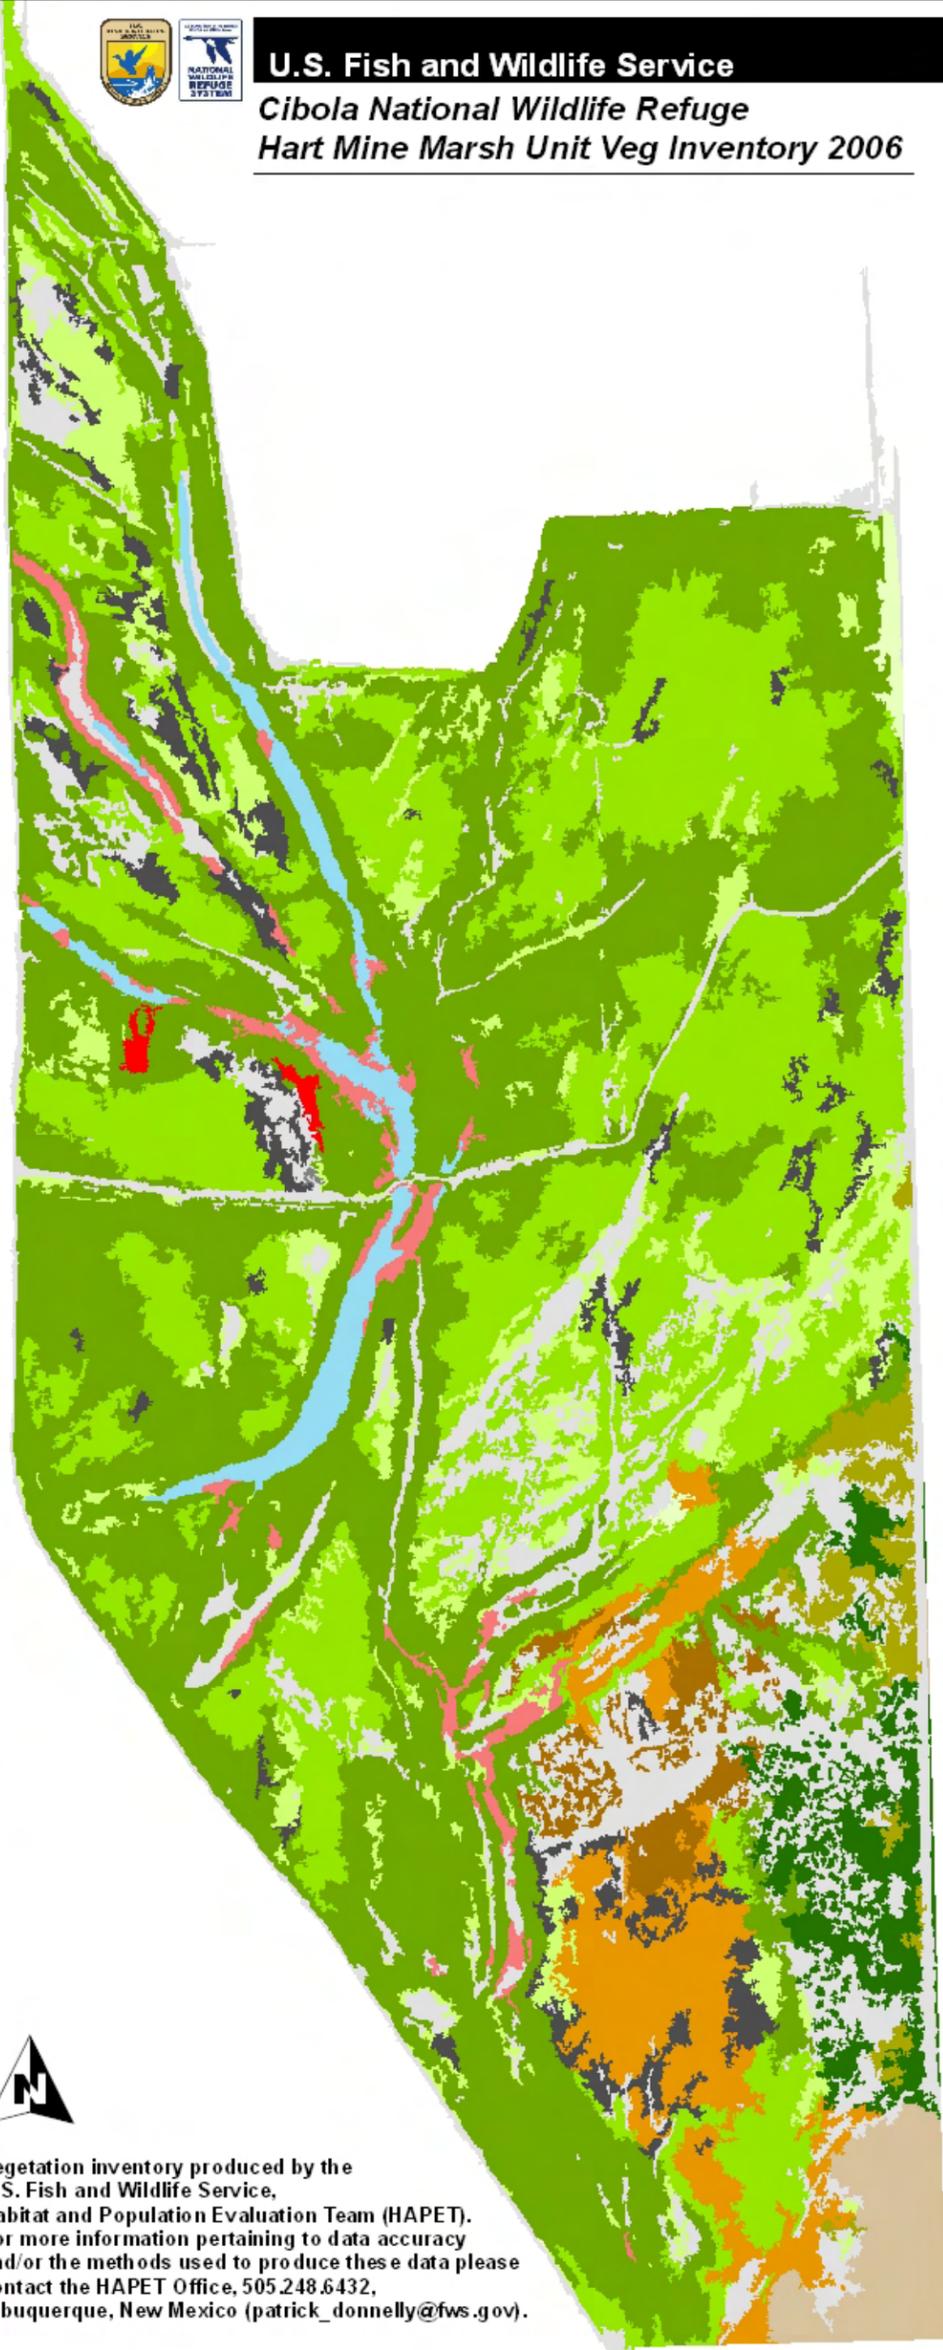
Figure 8. Vegetation Inventory of the Hart Mine Marsh

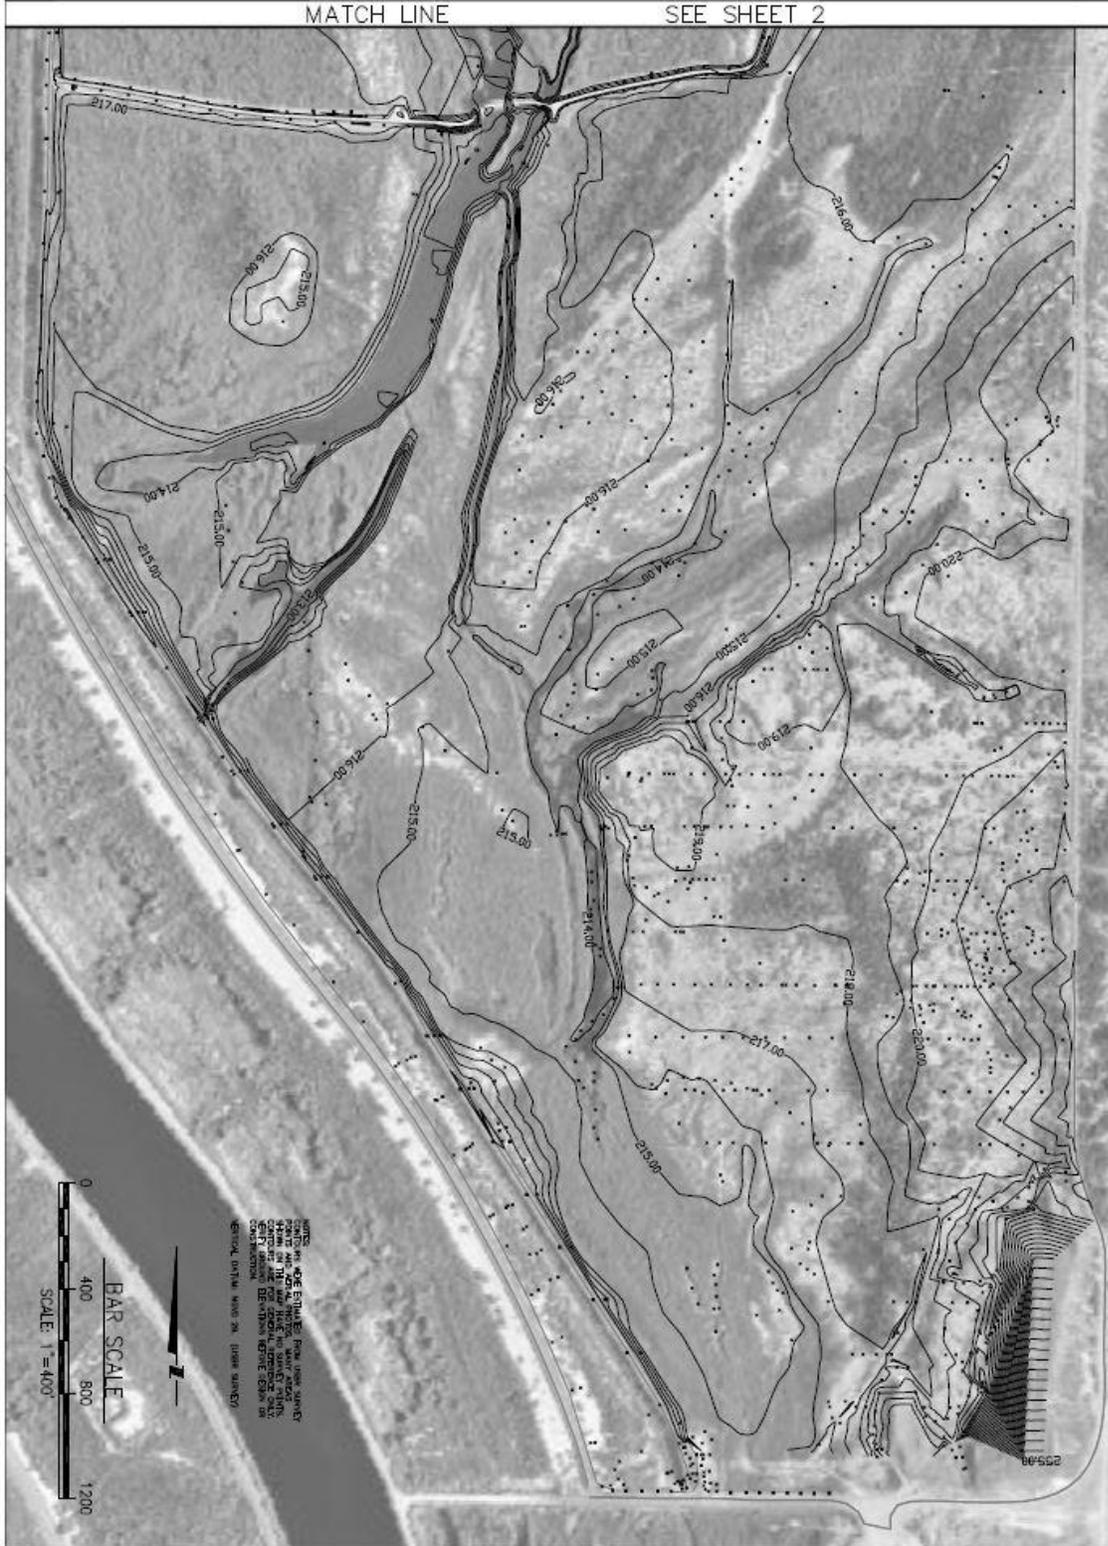
NOTES:
 1. CONTOURS ARE BASED ON THE FOLLOWING DATA:
 2. ALL DATA WAS OBTAINED FROM THE SURVEY OF THE
 3. HART MINE MARSH ESTIMATED CONTOURS
 4. CONTOUR INTERVAL: 1.00 FEET
 5. VERTICAL DATUM: NAVD 83
