Hart Mine Marsh:
Existing Conditions Report
April 30, 2007

Interim Report:

*Work Done to Date Regarding Evaluating the Potential of Restoring
the Cibola National Wildlife Refuge's Hart Mine Marsh Unit*

Supplied to USBR Lower Colorado
(Gregg Garnett)

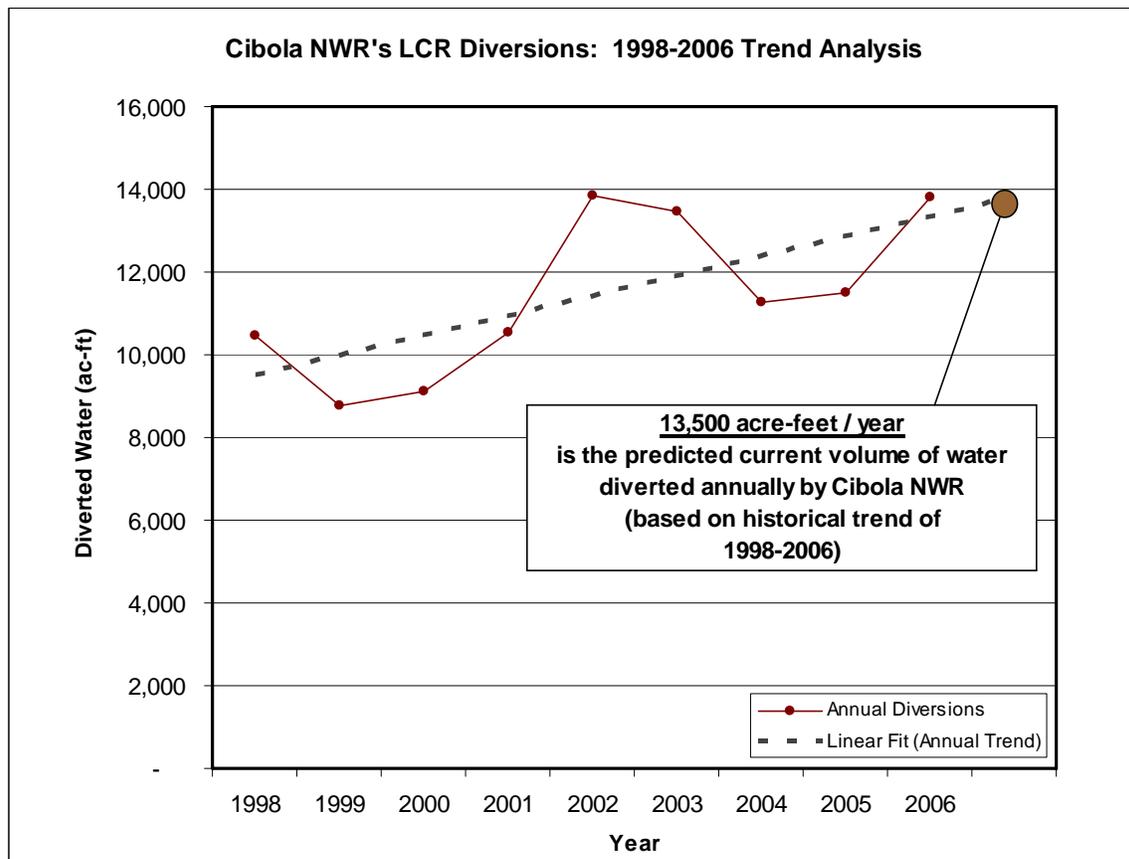
Figure 2. Cibola NWR's lower Colorado River water diversions from 1998 to 2006 showing an overall increase in use due to the addition of new habitat units.

Since 1998, the refuge has added several acres of new habitat, primarily in Farm Unit 1 and the Island Unit. New habitat projects have included riparian vegetation and moist soil units. Predictably, the annual use of water at Cibola NWR has generally increased during that period. Figure 2 illustrates a trend of steadily increasing water consumption.

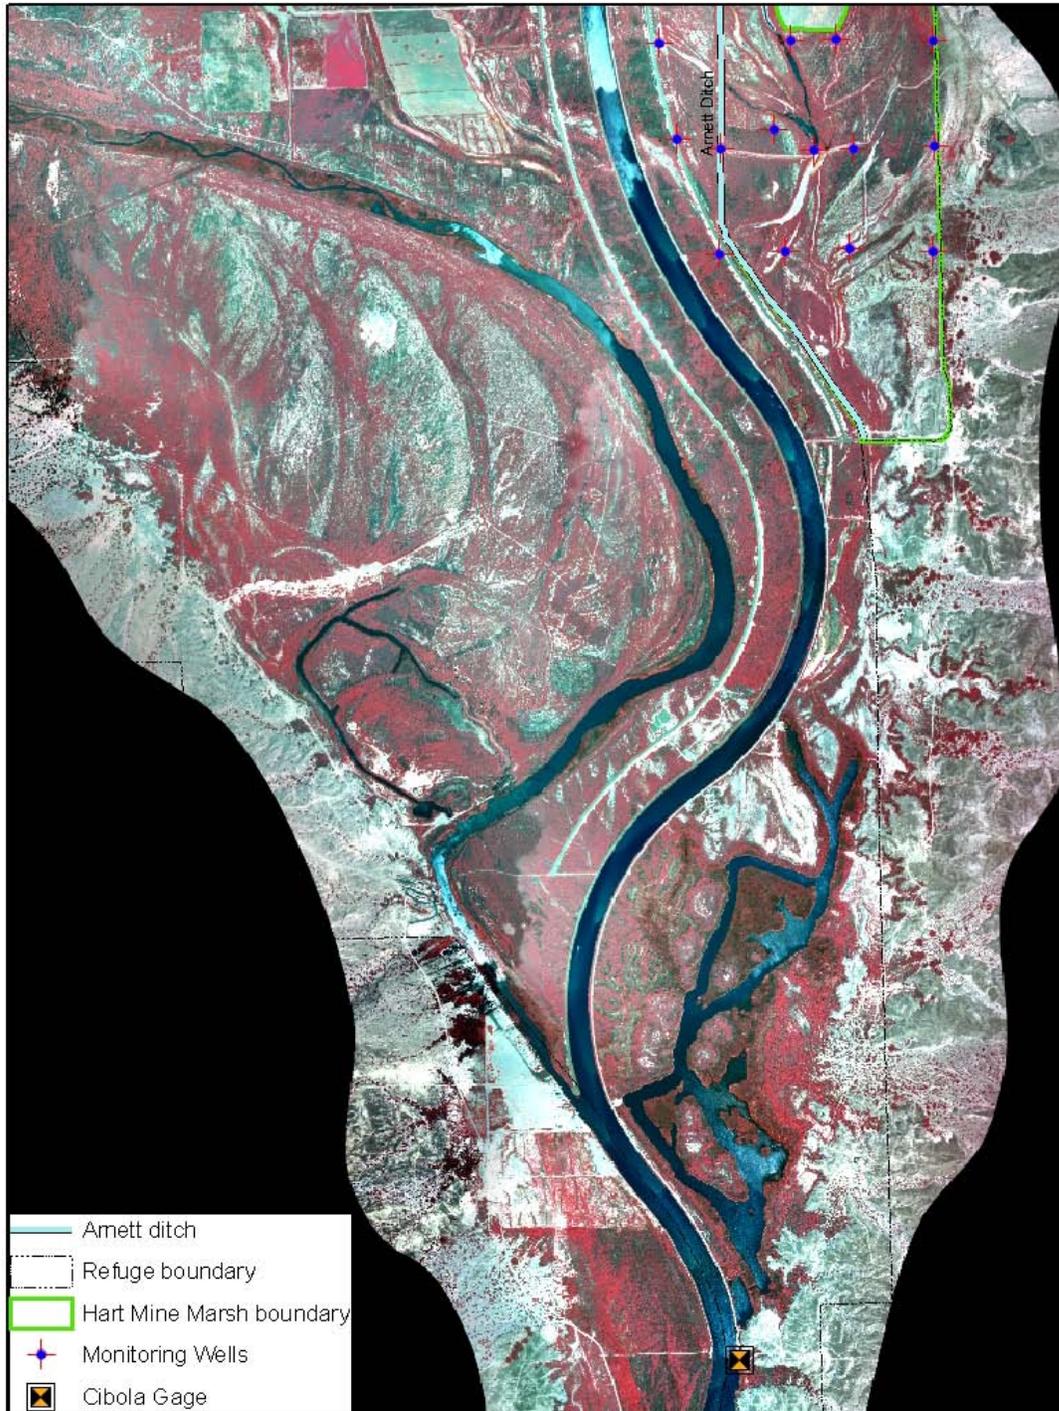
Figure 3. Location of monitoring wells and surface water dataloggers. The USBR's Cibola Gage is located at the lower extent of the image.

At this initial stage of data collection, hourly data from an approximately two week period, from December 13 – 27, 2006, were analyzed. The LCR's role as a control on ground water hydrology was examined using regression analysis. The reader should note that while regression analysis is often used as a statistical model to examine surface and ground water interactions, the approach does suffer from limitations as a statistical model. Hydrologic efficiency, or the "dampening" of surface water fluctuations as reflected by ground water elevations, often creates a scenario where the multiple coefficient of determination (R^2) values may suggest that there is not a link between dependant and independent variables when one actually exists. With that said, regression analysis of WSEL data from the LCR and ground water monitoring wells indicates that for the period of time examined, the river is a dominant control on groundwater levels between the LCR and the Arnett Ditch. Monitoring wells HMM_01 and HMM_09, located between the LCR and the Arnett Ditch, closely track WSEL of the LCR, with R^2 values of 0.94 and 0.98, respectively.

Furthermore, regression analysis indicates that the LCR river levels exert a control on groundwater levels to the east of the Arnett Ditch: monitoring well HMM_10 tracks WSEL of the LCR with an R^2 of 0.90. Statistical models for monitoring well HMM_06

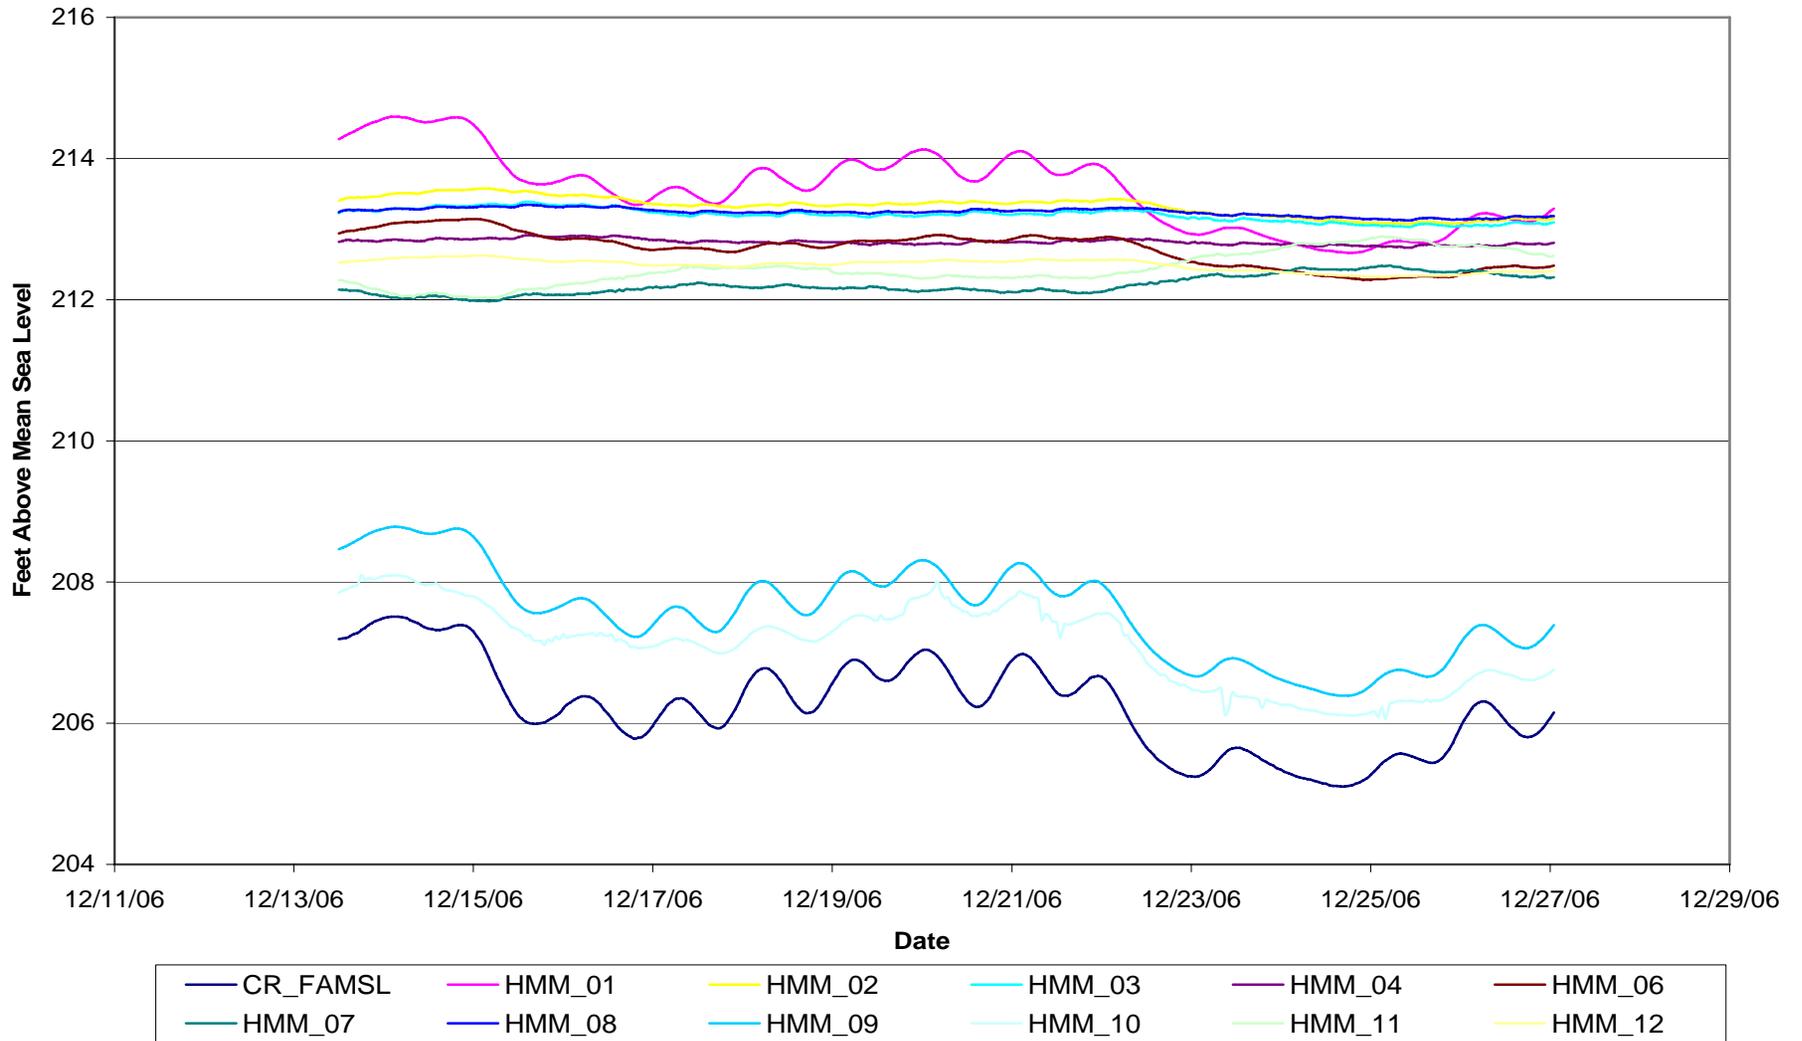
Hart Mine Marsh Water Surface Elevations: Monitoring Wells and Colorado River

Figure 4. Relative elevations of Hart Mine Marsh ground water monitoring wells and lower Colorado River (at Cibola Gage) demonstrate a clear connection between the LCR and groundwater between the LCR and the Arnett Ditch.

visa-vie the LCR did not produce as good a fit ($R^2=0.70$). The general shape of the WSEL curve for monitoring well HMM_06 suggests that it is also tracking the WSEL of the LCR, but that there is an overall dampening of the curve. This dampening may be the result of some hydrologic property related to the subsurface matrix. Wells HMM_02 and HMM_08 follow the overall WSEL trend, suggesting further dampening of the LCR WSEL curve. The properties of wells HMM_02, HMM_06, and HMM_08 discussed here are mostly speculative and will be subject to further analysis.

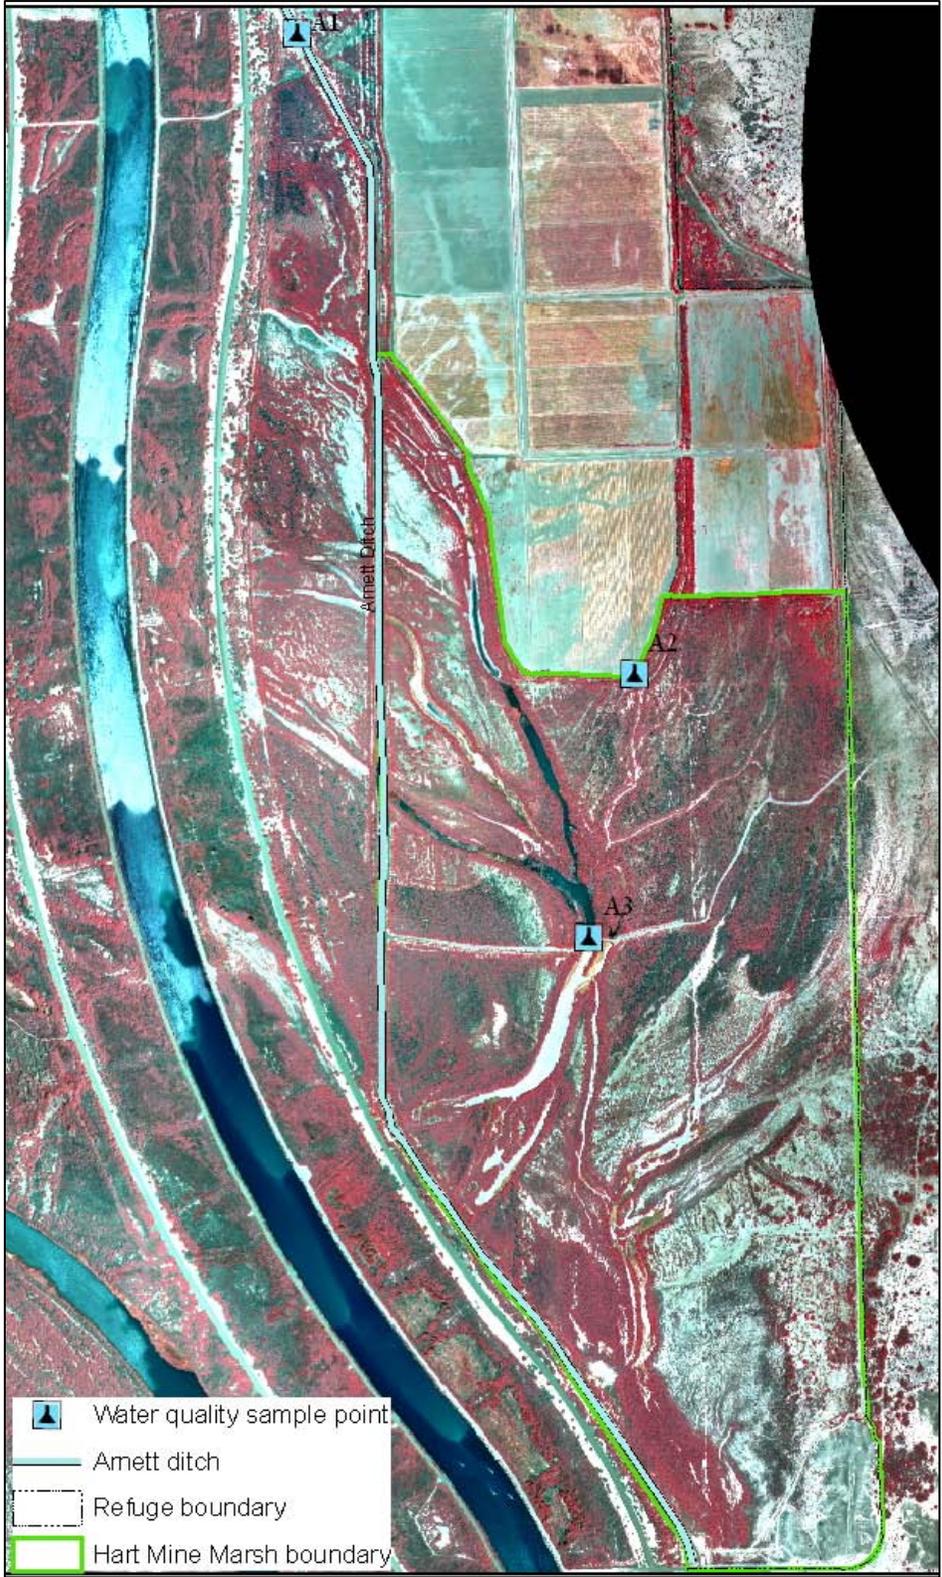
Figure 5. Location of water quality sample sites.

As an aquatic ecosystem, water quality conditions at the Hart Mine Marsh management unit play a significant role in the functioning of existing habitat. To assist with site characterization, water quality conditions were sampled at multiple points in time at the Arnett Ditch, the Farm Unit 2 drain, and the Hart Mine Marsh. The Arnett Ditch is an agricultural drain, and serves as a main source of surface water at the Hart Mine Marsh (precipitation, alluvial fan runoff are other contributors). The ditch originates outside of the Hart Mine Marsh; it forms the western boundary as it flows through the Marsh, and terminates at the southern end of the Hart Mine Marsh. The Farm Unit 2 drain forms the northern boundary of the Hart Mine Marsh.

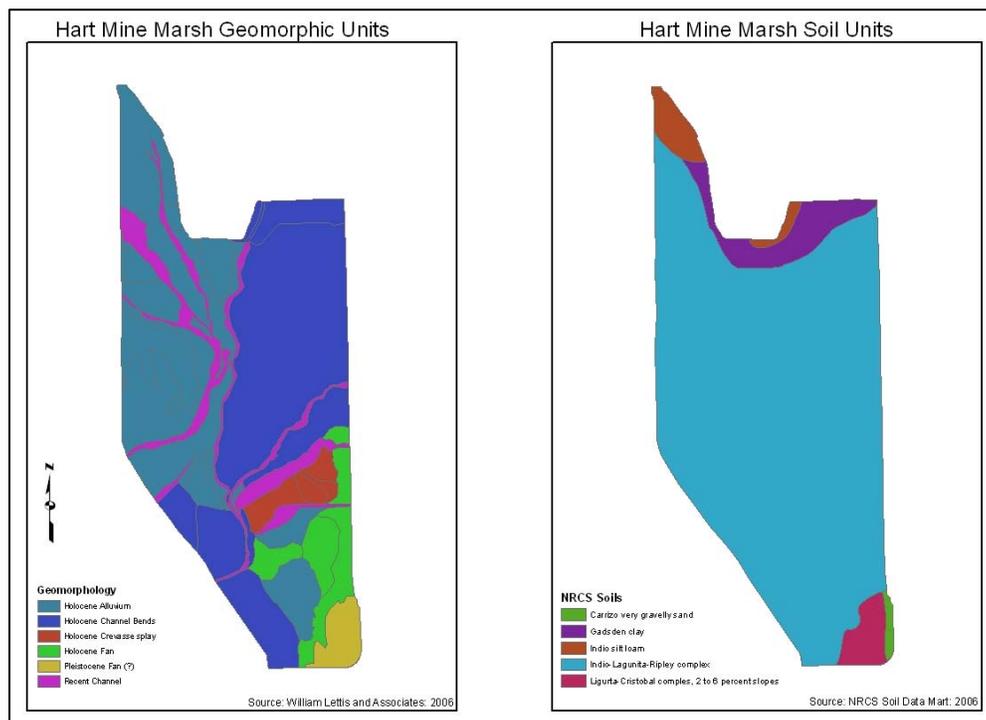
Figure 6. Comparison of surficial geology map (left) and NRCS soil map units (right) at the Hart Mine Marsh unit.

The soils mapped at the Hart Mine Marsh are typical for soils forming on alluvial fans and flood plains in the Sonoran Desert. The NRCS has mapped three main soil types at the Hart Mine Marsh. The locations of the map units are shown on Figure 6.

Gadsen Clay-(Map Unit 8)- this soil is found on flood plains (slopes are 0 to 1 percent). It is a deep soil; typical profile has a clay texture to 60 inches and the depth to a restrictive layer is greater than 60 inches. Gadsen is rated as having no limitations for use in creating ponds. The high content of shrink swell clays in this soil leads to severe limitations for use creating levees or embankments (See Attached Ponds and Embankments (CA).

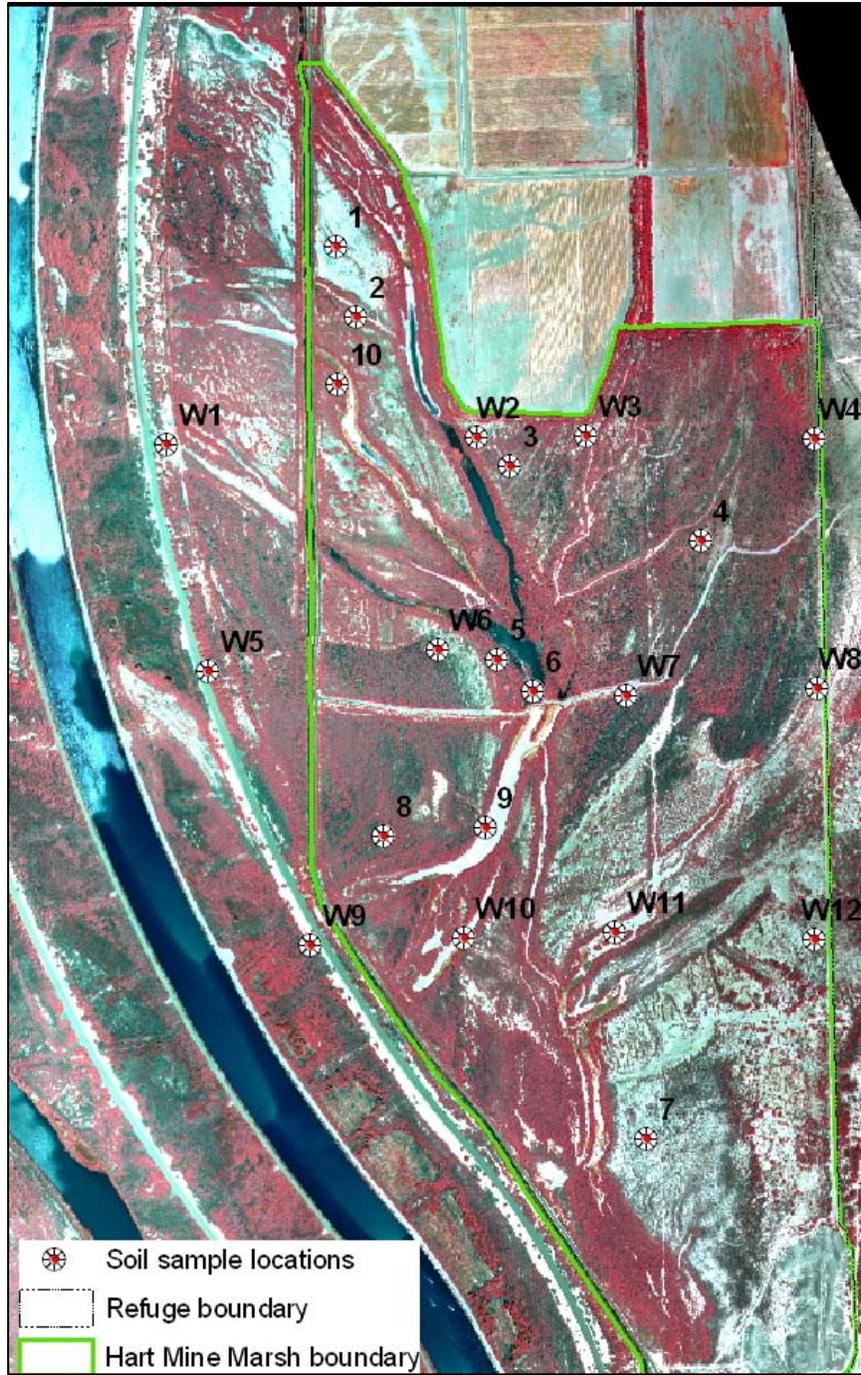
Figure 7. Soil sample locations, includes samples taken from soil pits and monitoring well drill holes.

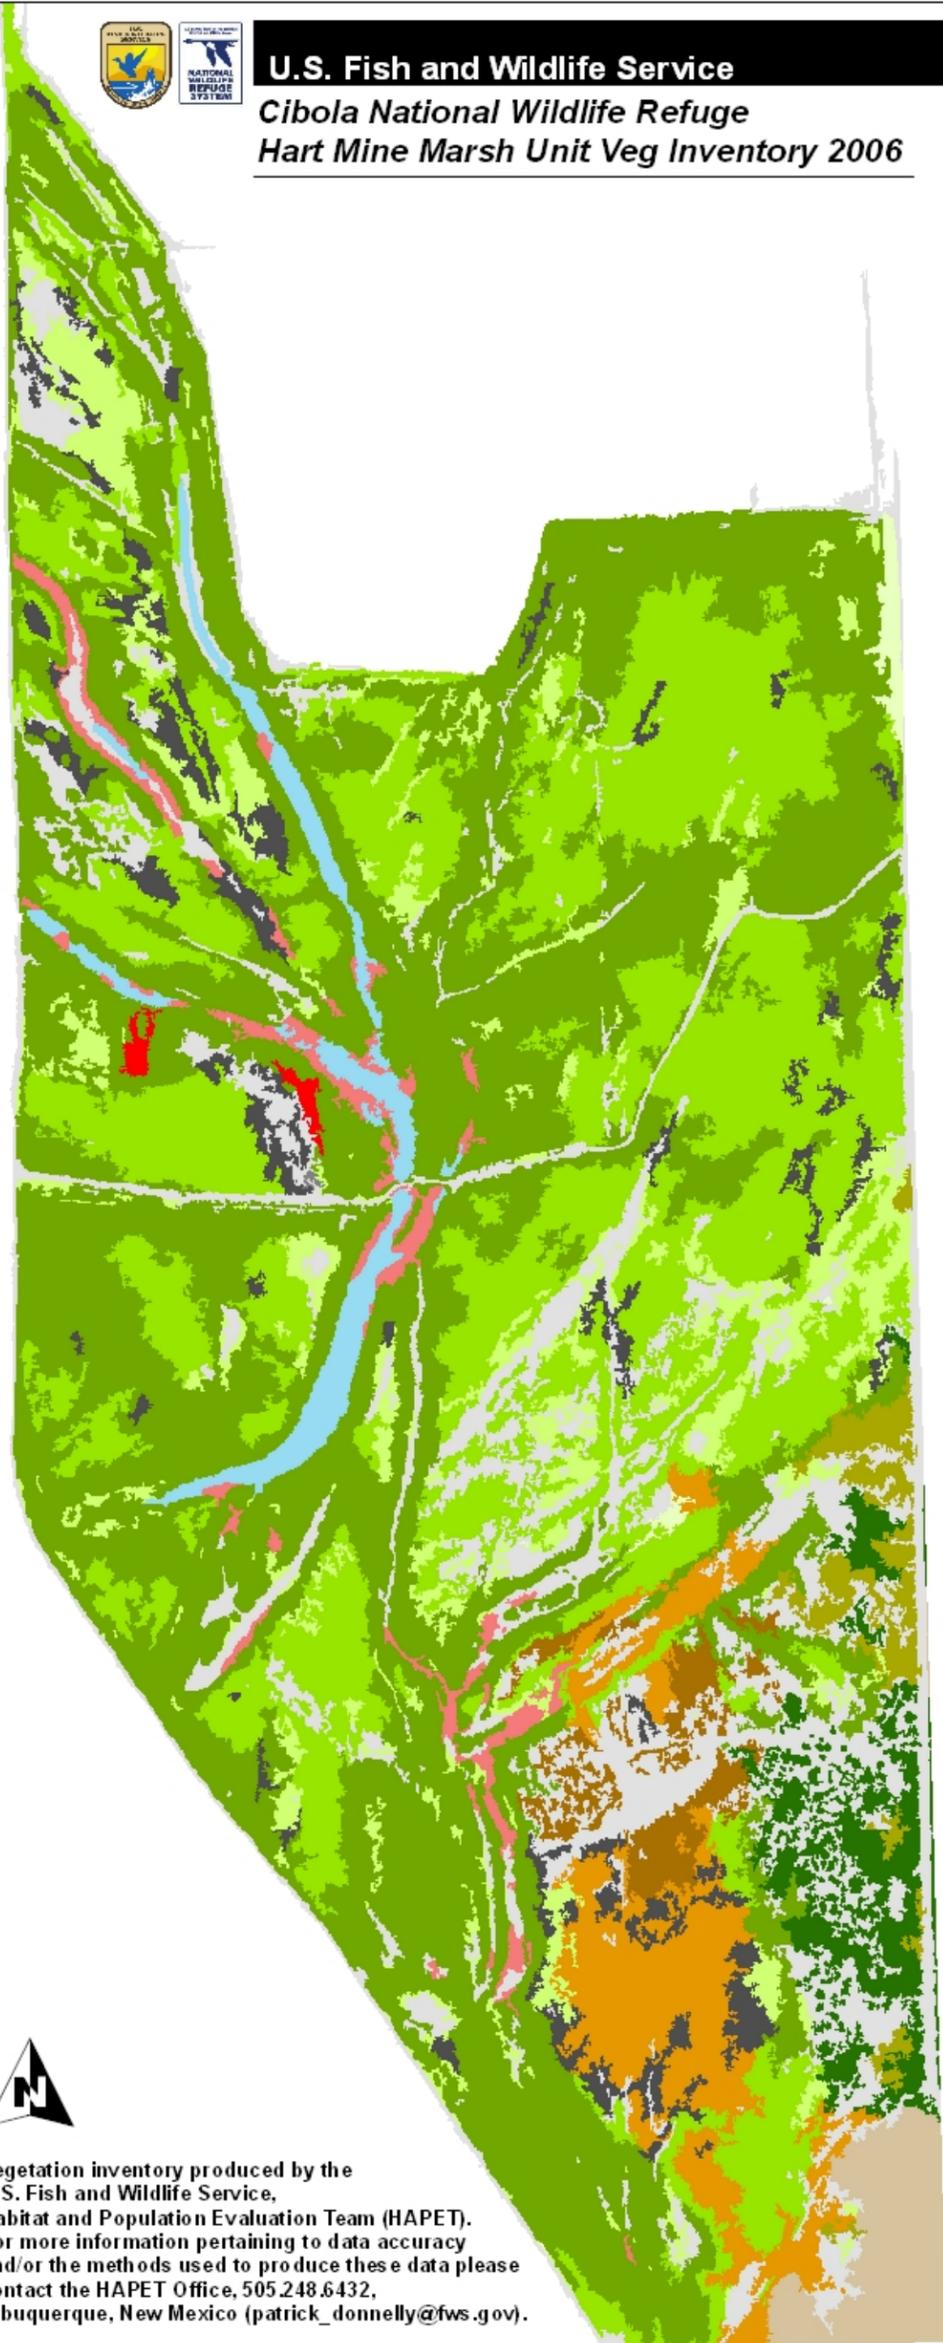
Figure 8. Vegetation Inventory of the Hart Mine Marsh

A total of 8 different plant communities were identified and associated with 3 distinct landforms occurring in the unit (Figure 8). The majority of the Unit encompasses the historic Colorado River floodplain. Over 80% of this area has been invaded by mixed and monotypic stands of Salt Cedar (*Tamarix sp.*). The densest and most robust stands of Salt Cedar were found the areas adjacent to active water channels and in lower elevation areas that appeared to pool surface water. Areas directly adjacent to open water or currently active channels contained areas of tall emergent plant communities

dominated by Cattail (*Typha ssp.*) and (*Schoenoplectus ssp.*) Bull Rush (See Appendix 5 for a table of vegetation communities and acreage).
