Lower Colorado River Multi-Species Conservation Program

Beal Lake Riparian Restoration 2009 Annual Report

February 2013

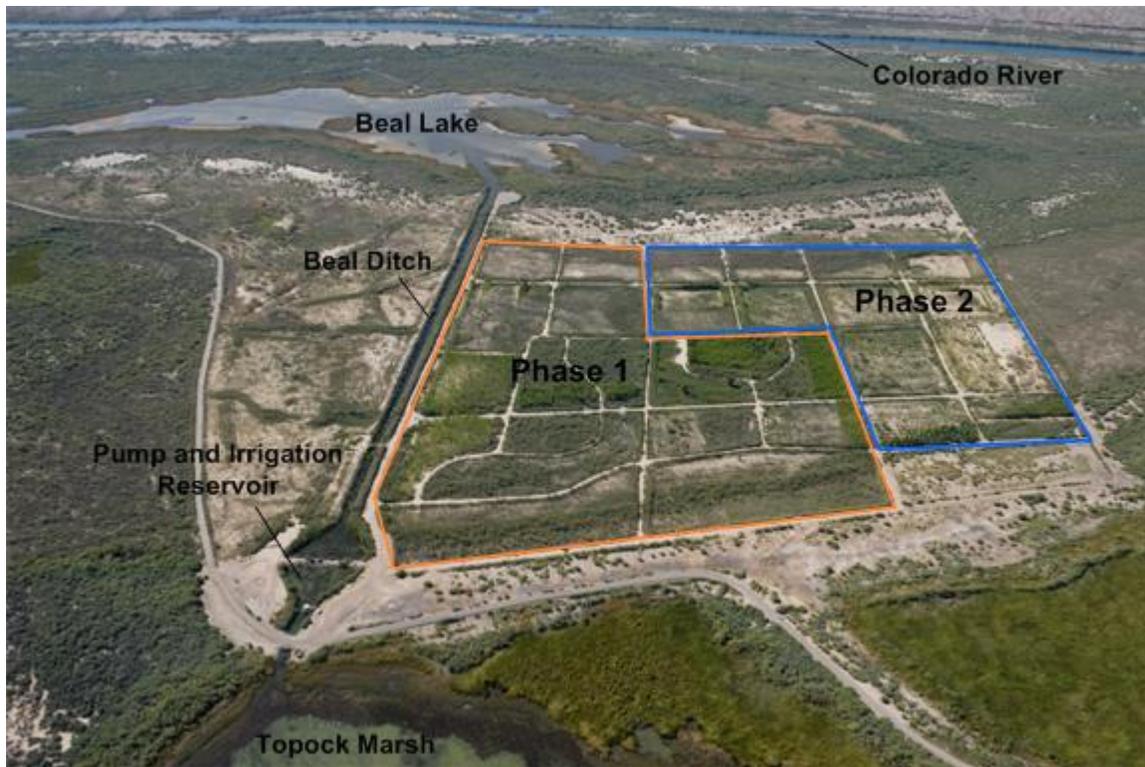
Figure 2. Aerial photo of the project, October 2008.

Beal Lake Riparian is located in Reach 3, between Beal Lake and lower Topock Marsh, on HNWR, near Needles, California. It is within the historic floodplain of the lower Colorado River (LCR) and adjacent to River Mile 237 on the Arizona side (Figures 1 and 2).

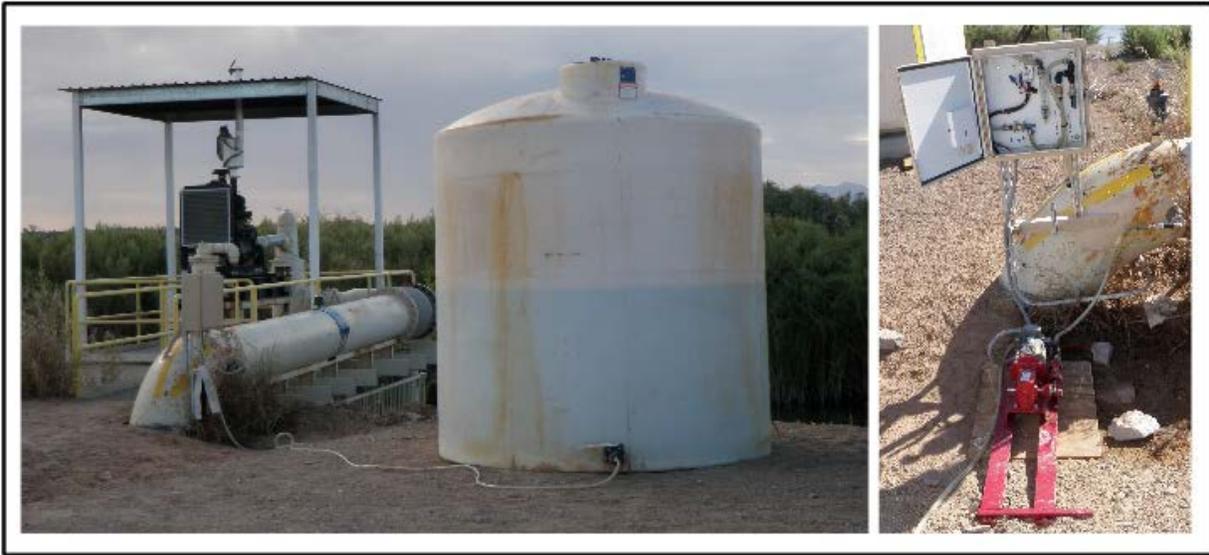
Figure 3. (Left) 1,500 gallons of fertilizer were delivered and connected to irrigation delivery pipe. (Right) Pump and tubing that deliver fertilizer into irrigation water.

During May 2009 soil samples were taken in cells P and I and analyzed by a contracted crop consultant. The samples indicated Nitrate, Phosphate, and Zinc levels had risen due to last year's aerial application of fertilizer, but had not yet reached optimal levels (Table 1). A mixture of UN-32, 10-34-0, and Zinc Chelate was prescribed and applied using the recently installed fertigation system (Figure 3) during June and July 2009.

Both the flow meter and the engine hour meter were replaced. A new fertigation system was installed and fertilizer was applied to the fields through the irrigation water. The irrigation pump was operated for an estimate 848 hours during FY09 compared to 680 hours in 2008. Routine maintenance was performed on the pump throughout the year. Berms between fields were repaired as needed. Saltcedar (*Tamarisk* spp.) eradication continued on site when time permitted.

The check valve and fertilizer adapter were installed in the irrigation line.

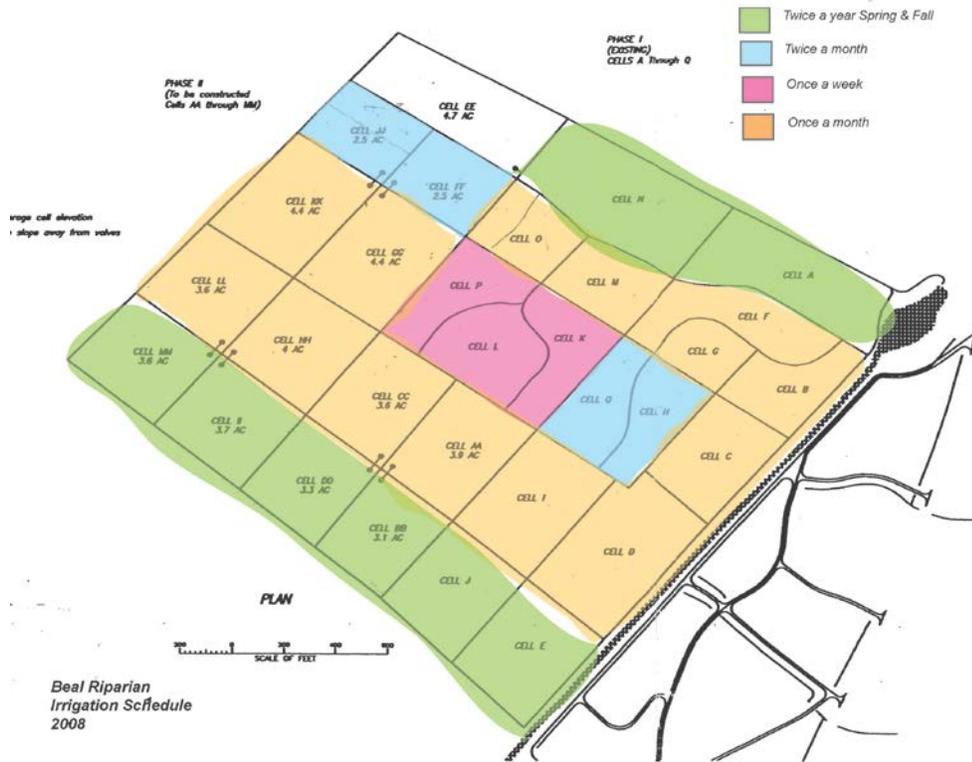
Figure 4. 2009 Irrigation Schedule.

Beal Lake Riparian is flood irrigated with one alfalfa valve per field (Reclamation 2006). Fields are irrigated on different schedules to minimize irrigation while keeping the central area wet (Figure 4). In an effort to attract southwestern willow flycatchers to the site, the three fields center fields (K, L, P) are irrigated once a week throughout the breeding season to keep ambient conditions under the tree canopy moist. Irrigation regimes for the surrounding fields are based on vegetation species requirements or planting dates. Cottonwood and willow were irrigated more frequently than mesquites and fields planted more recently are irrigated more frequently than older, established vegetation. A total of 1,244 AF were applied to the project in 2009 (Table 2) compared to 1,098 AF in 2008.
