Lower Colorado River Multi-Species Conservation Program

Cibola Valley Conservation Area 2010 Annual Report

January 2011

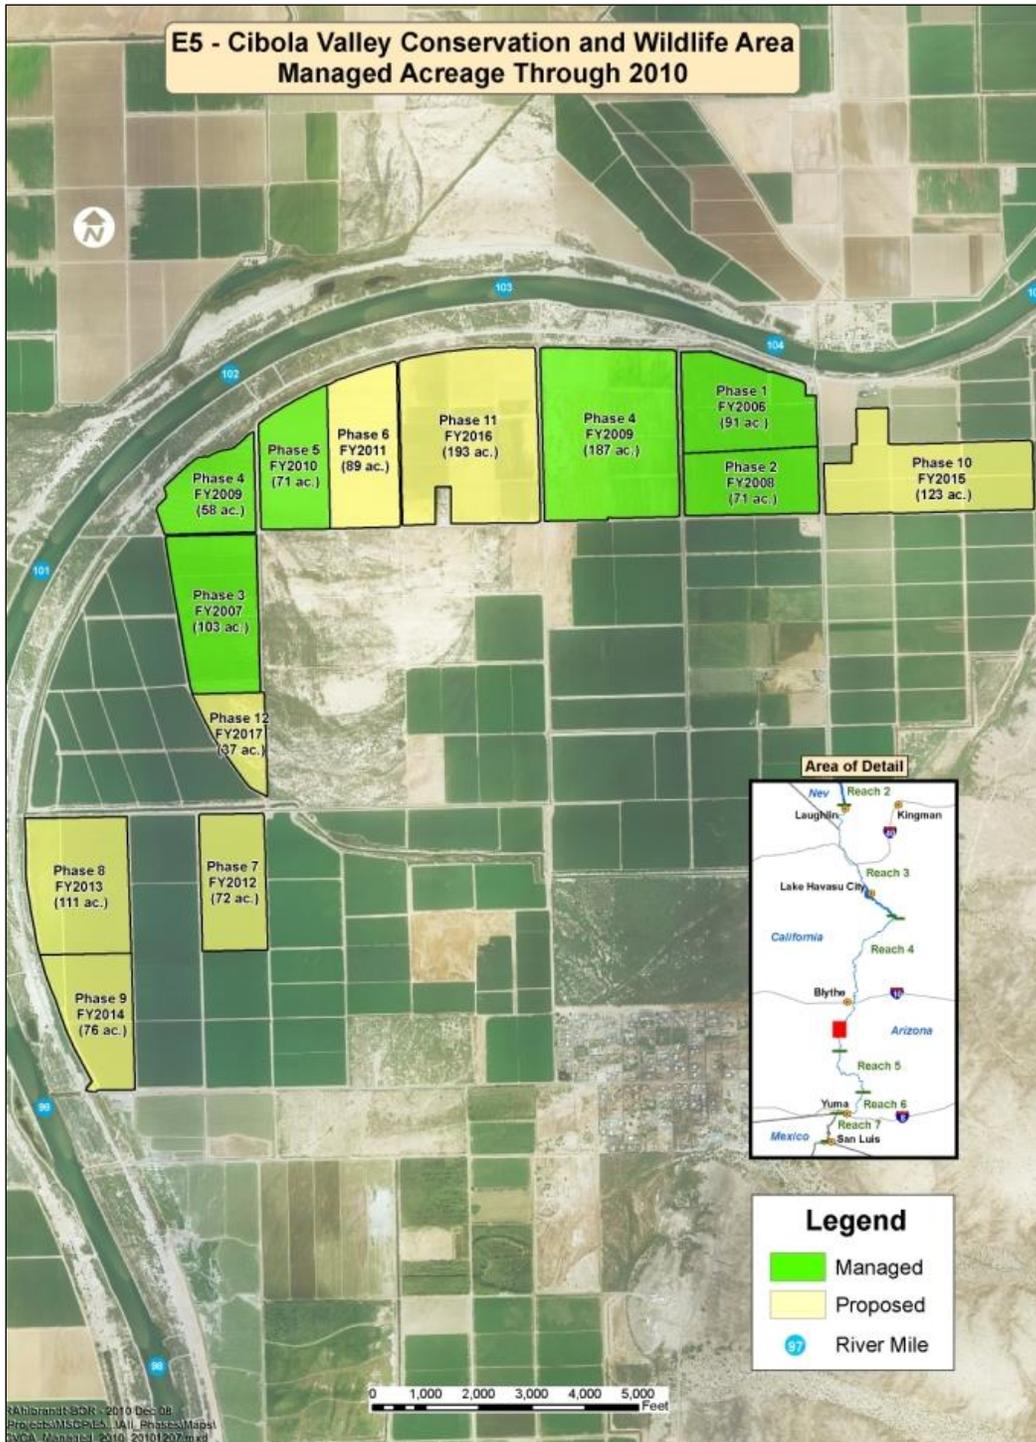
Figure 1.—Current phase map of Cibola Valley Conservation Area.

Large habitat restoration sites such as CVCA are developed over a number of years, with restoration activities divided into phases as shown on figure 1. The report entitled *Cibola Valley Conservation Area Restoration Development Plan: Overview* (Reclamation 2007a) provides a summary of site and projected phase implementation.

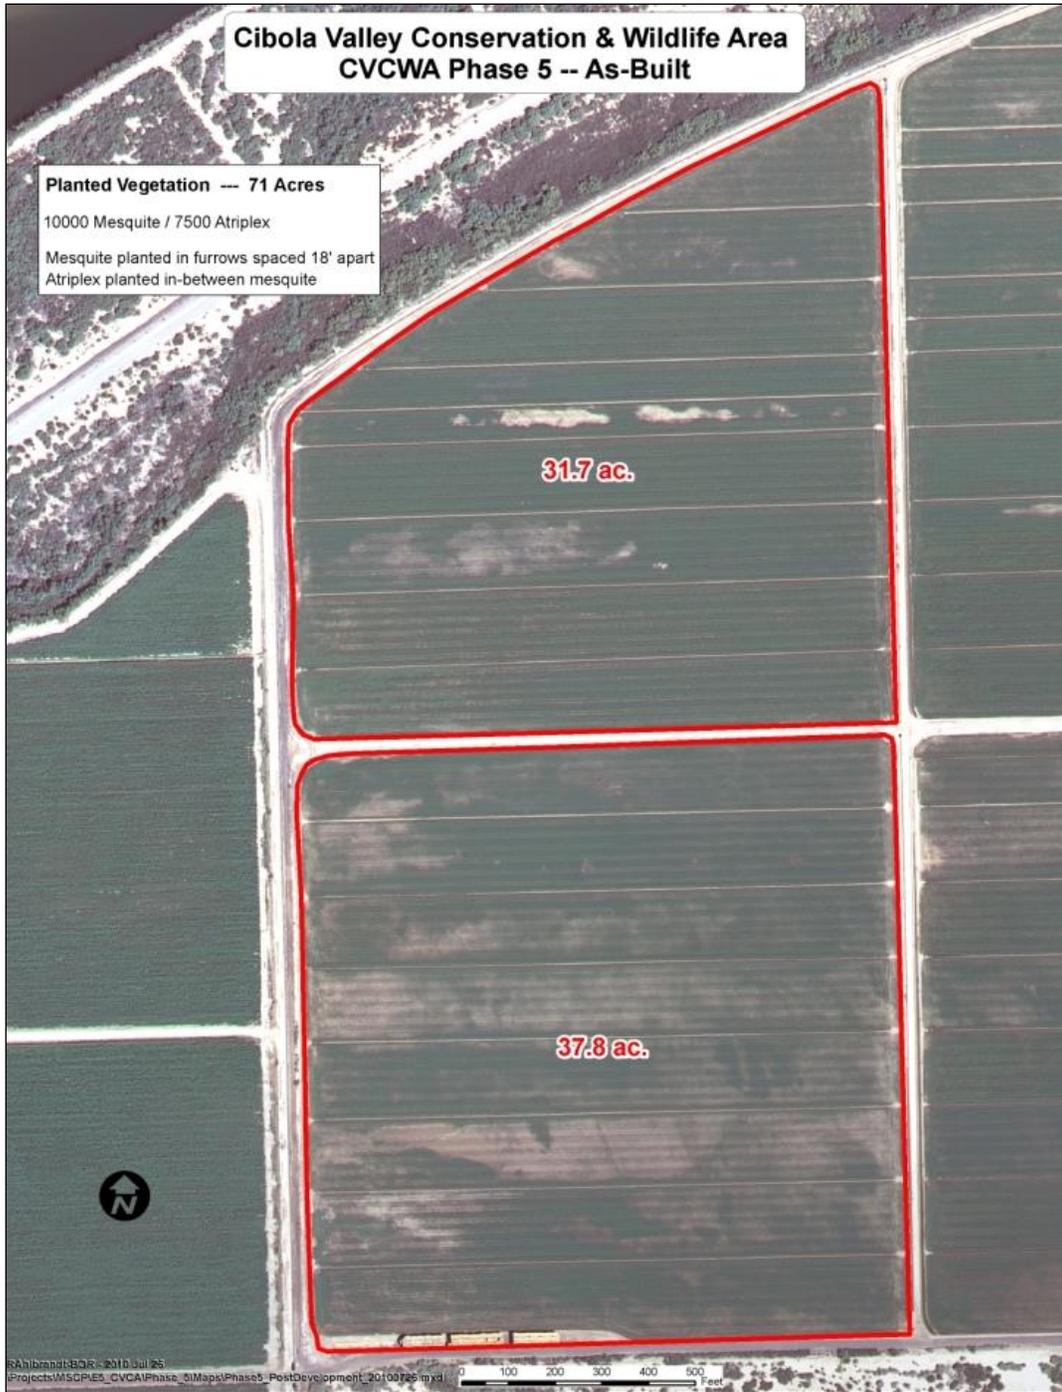
Figure 2.—As-built of Phase 5.

Honey mesquite was planted over 71 acres in Phase 5 of the development of CVCA. This phase is designed to mimic the historical landscape patterns of plant communities along the lower Colorado River (LCR) and create an integrated mosaic of habitats. Phase 5 was first planted with winter wheat in January 2009 at the request of AGFD. Wheat was used as a cover crop to help keep the site weed free and as a wildlife forage crop. Phase 5 was planted in March 2010 with approximately 10,000 honey mesquite trees (*Prosopis glandulosa* “torreyanna”) and 10,000 atriplex (*Atriplex lentiformis*). Phase 5 was divided into two fields (or checks), rather than the eight originally stated in the development plan, since furrows were being utilized (figure 2).

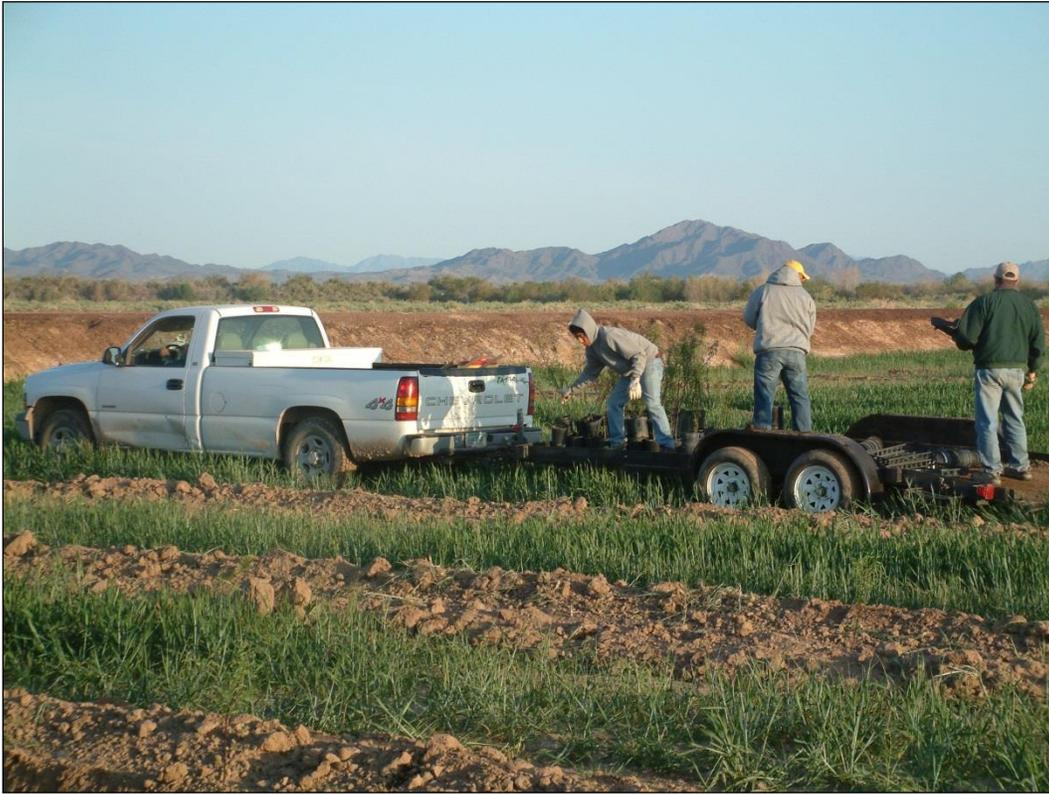
Figure 3.—Planting in furrows.

In Phase 5, native plants were planted in 2-foot-deep furrows with an in-line spacing of approximately 15 feet and a furrow row spacing of approximately 18 feet. One-gallon potted honey mesquites were hand planted in the trough of the furrow. Atriplex seedlings were planted just inside the furrows, near the top of the furrow, between each mesquite tree. This wide furrow spacing saves irrigation water and provides adequate room for a tractor to disk invasive saltcedar and volunteer cotton, which grow between the planted furrows (figure 3).

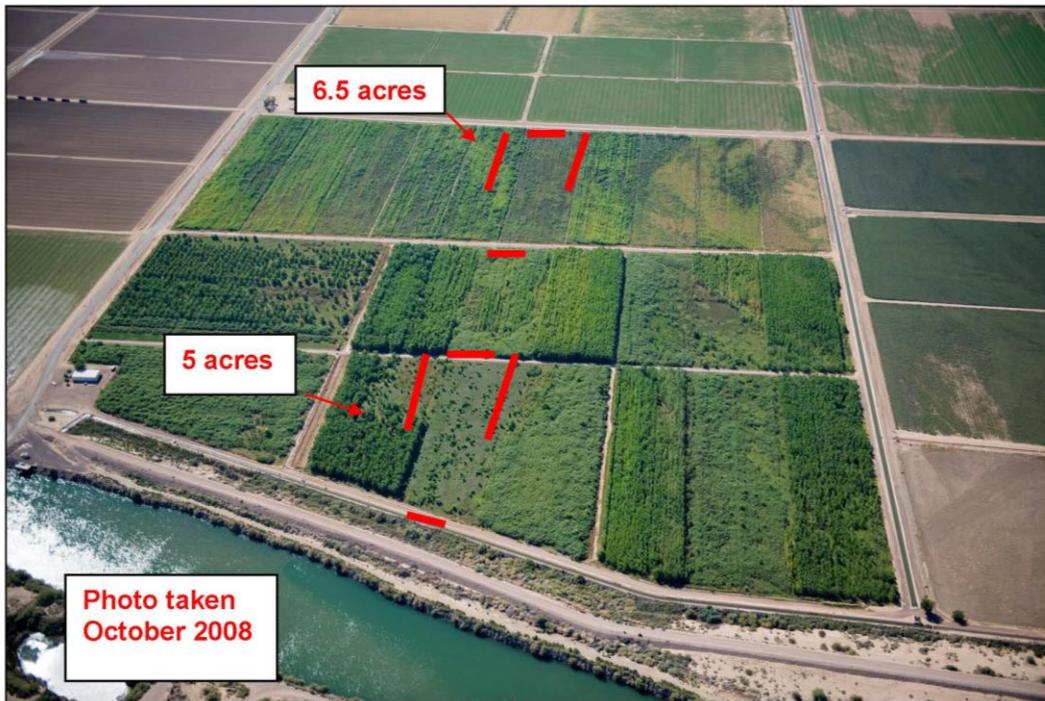
Figure 4.—Aerial view of herbicide application in Phases 1 and 2.

Ivyleaf morning glory was present again in the fields of both Phases 1, 2, and, to a smaller degree, in Phase 3. The incursion was not as widespread as in the previous year. In an attempt to control the morning glory, a trial application of Harrell's granular herbicide 75 was aerially applied in field B-2 (5 acres) in Phase 1 and fields 2-5 (6.5 acres) in Phase 2 (figure 4). The manufacturer recommended two separate applications on each field. The two treatments did not noticeably affect the morning glory's growth.

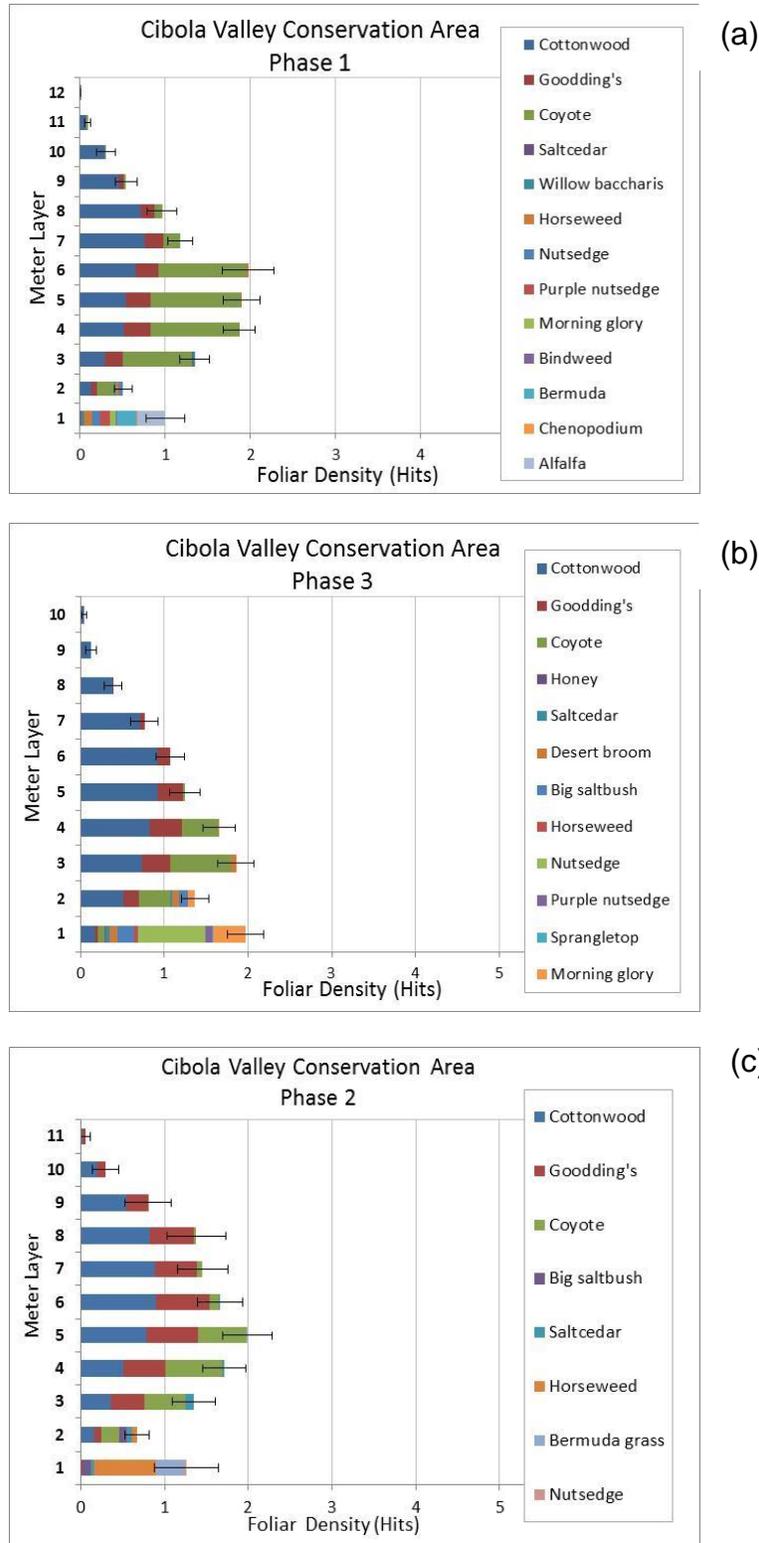
Figure 5a.—Vertical foliage density by species and meter layer (\pm SE) at Cibola Valley Conservation Area: (a) Phase 1, (b) Phase 3, and (c) Phase 2 presented in order of planting year.

(Note: CVCA3 was planted before CVCA2.)

Cottonwood and Goodding's willow dominated the upper canopy in Phases 1 through 3 (figure 5a). Coyote willow dominated the mid-canopy in Phases 1 and 2. The shrub canopy dominated in Phase 3. Honey mesquite dominated the three mesquite-planted phases (4E, 4W, and 5) (figure 5b).

Foliar density reflects the distribution of vegetation in vertical layers within the habitat. Figure 5a (a–c), shows FD in Phases 1–3, and figure 5b (d–f) shows FD in Phases 4E, 4W, and 5. The highest density of vegetation at CVCA1 was in the 5–6 meter layer (16.4–19.7 feet), at CVCA2 in the 4–5 meter layer (13.1–16.4 feet), and at CVCA3 in the 0–1 meter layer (0.0–3.3 feet). At the mesquite phases, vegetation occurred mostly in the first 2 meters (6.6 feet). Vegetation volume and FD are likely to increase as the sites mature and additional species establish at each site.

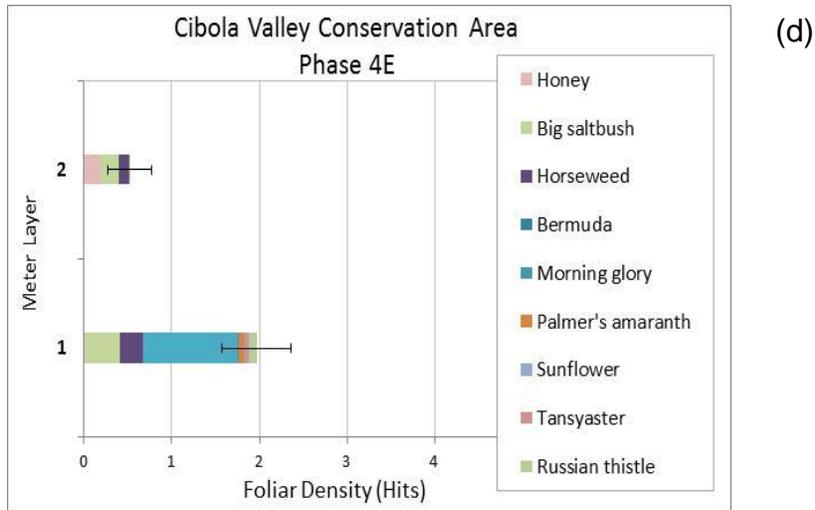
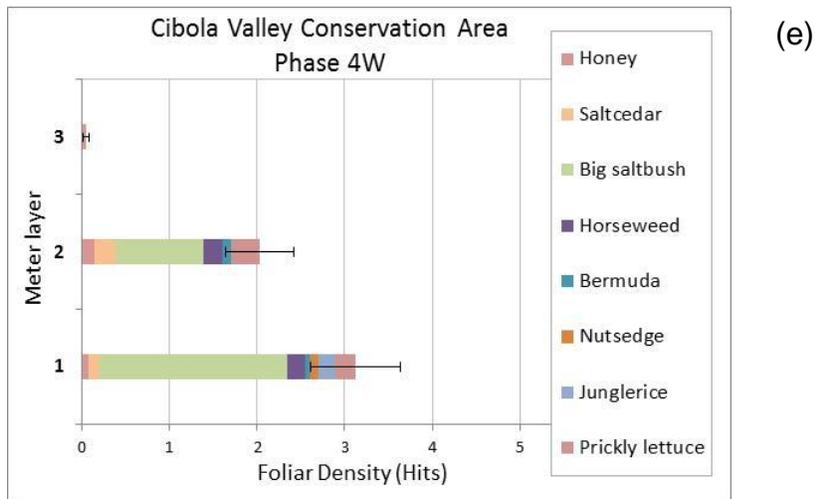
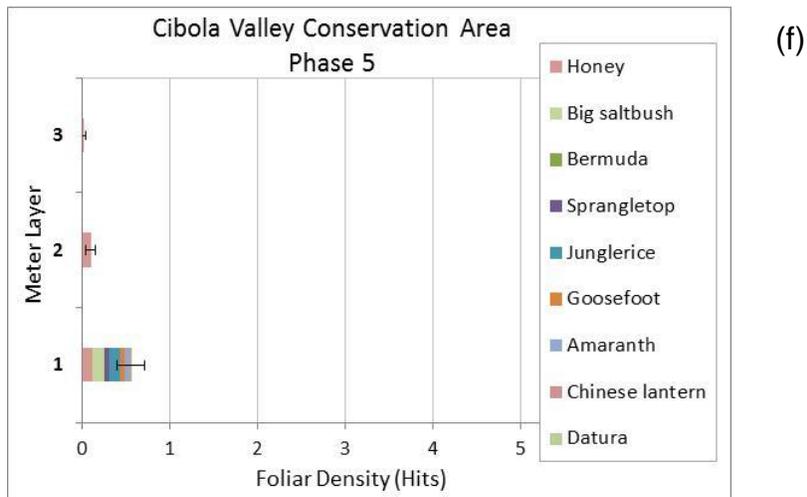
Figure 5b.—Vertical foliage density by species and meter layer (\pm SE) at Cibola Valley Conservation Area: (d) Phase 4E, (e) Phase 4W, and (f) Phase 5.

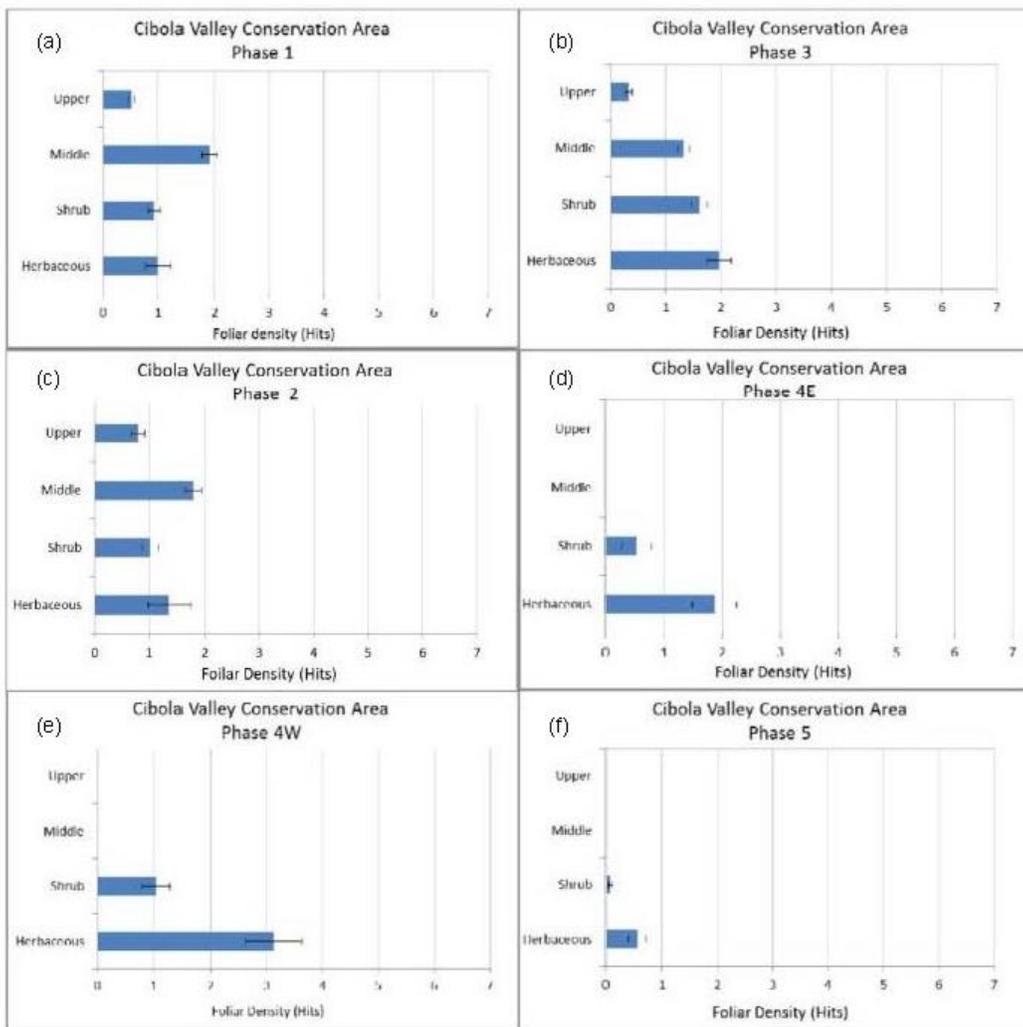
Figure 6.—Vertical foliage density in the herbaceous, shrub, middle, and upper canopy layers at Cibola Valley Conservation Area (\pm SE).
Herbaceous = 0–1 m, shrub = 1–3 m, middle = 3–6 m, and upper = >6 m.
(a) CVCA1, (b) CVCA3, (c) CVCA2, (d) CVCA4E, (e) CVCA4W, and (f) CVCA5. Note: CVCA3 was planted before CVCA2.

Figure 6 shows the vertical distribution of vegetation averaged across canopy layers identified as important distinctions in structure for several bird species: shrub canopy (1–3 meters), middle canopy (3–6 meters), and upper canopy (>6 meters). The herbaceous layer (0–1 meter) was separated from the actual canopy “layers” so as not to overestimate the shrub canopy; the “herbaceous layer” is not exclusively herbaceous species.
