Lower Colorado River Multi-Species Conservation Program

Beal Lake Conservation Area

2012 Annual Report

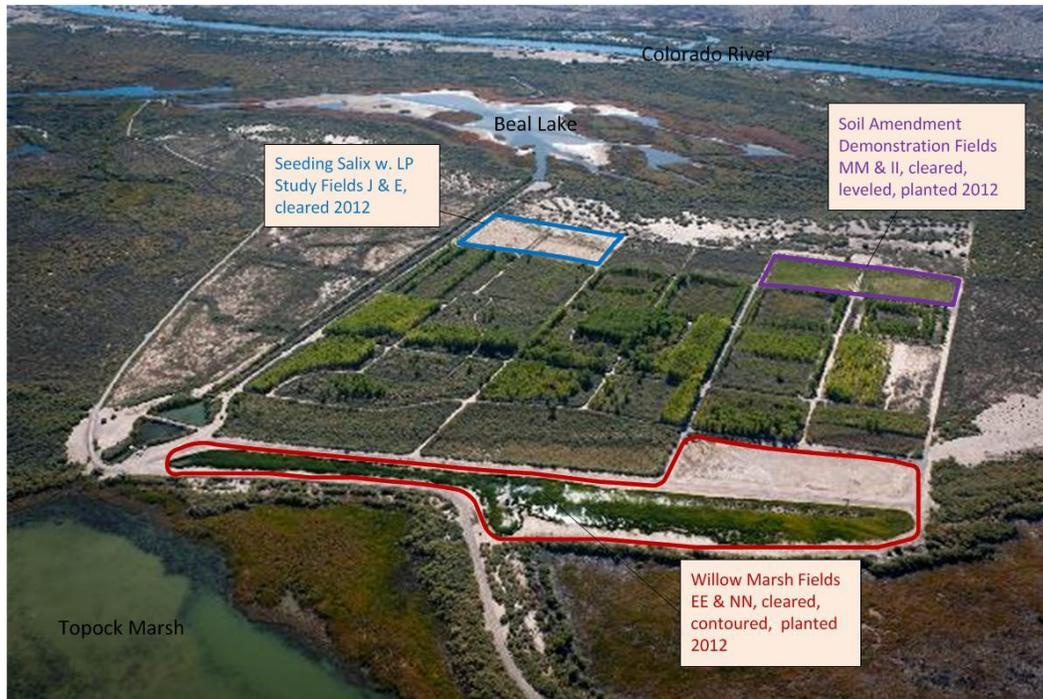
Figure 3.—Aerial photo of BLCA with 2012 actions designated. Photo taken October 29, 2012 (# B1878-300-28783).

In 2012, three project areas were developed: the willow marsh fields (EE and NN), the soil amendment demonstration fields (MM and II), and the Seeding *Salix gooddingii* with Lassenite Pozzolan Soil Amendment Study fields (J and E) (figure 3).

Clearing, grubbing, and contouring of the 14-acre willow marsh began in November 2011 and finished in January 2012. In addition to the earthwork, two culverts were installed to allow for management of the marsh water levels if necessary. The acreage was planted in March 2012 with bulrush and salt grass in the marsh cell and Gooding's and coyote willow in the riparian field. Both cattails and cottonwoods voluntarily established onsite.

In conjunction with the willow marsh construction effort, Fields MM and II were cleared to demonstrate the feasibility of using the soil amendment Lassenite Pozzolan at the field scale. Field II was left as a control, while Field MM was

treated. Treatment consisted of tilling in 5-percent (%) Lassenite Pozzolan by volume into the top 6 inches of the soil. The demonstration was conducted to determine if the product could significantly increase irrigation efficiency as well as the retention of moisture within the soil.

Additionally, Fields J and E were cleared to prepare them for the Seeding *Salix gooddingii* with Lassenite Pozzolan Soil Amendment Study, which aims to determine if the amendment at an application rate of 5% in the top 6 inches of soil will enhance the germination success of Goodding's willow. More information on the study can be found under Work Task C42.
