RECLAMATION

Beal Lake Habitat Restoration

Abstract

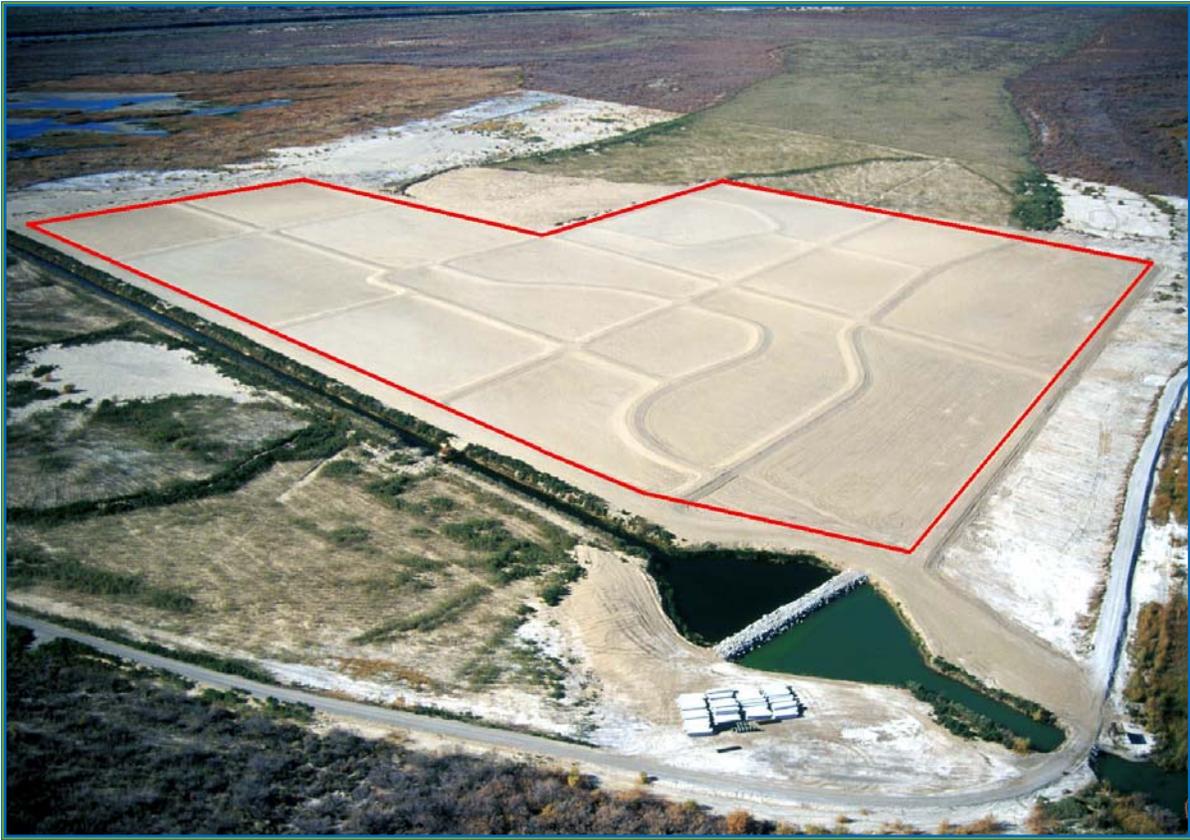
Figure 1. Beal Lake Restoration, Phase 1, Havasu NWR, Needles, C A. View looking south with Beal Lake at the top of the picture and the reservoir used to irrigate the fields at the bottom. Fall 2003.

18 inches to remove saltcedar roots. The 55 acres were then laser leveled and divided by berms into 17 individual fields in order to irrigate each field separately (Figure 1). On 18 January 2003, 120 lbs of solum certified barley seed purchased from Fertizona, Buckeye, Arizona, was drilled in as a temporary cover crop on all fields. A non-invasive cover crop helps to stabilize the soils, prevent weed infestation, and, when it is disked into the soils, increases moisture retention and nutrients. A Rain-for-Rent sprinkler system was used to irrigate the cover crop beginning 18 March 2003.

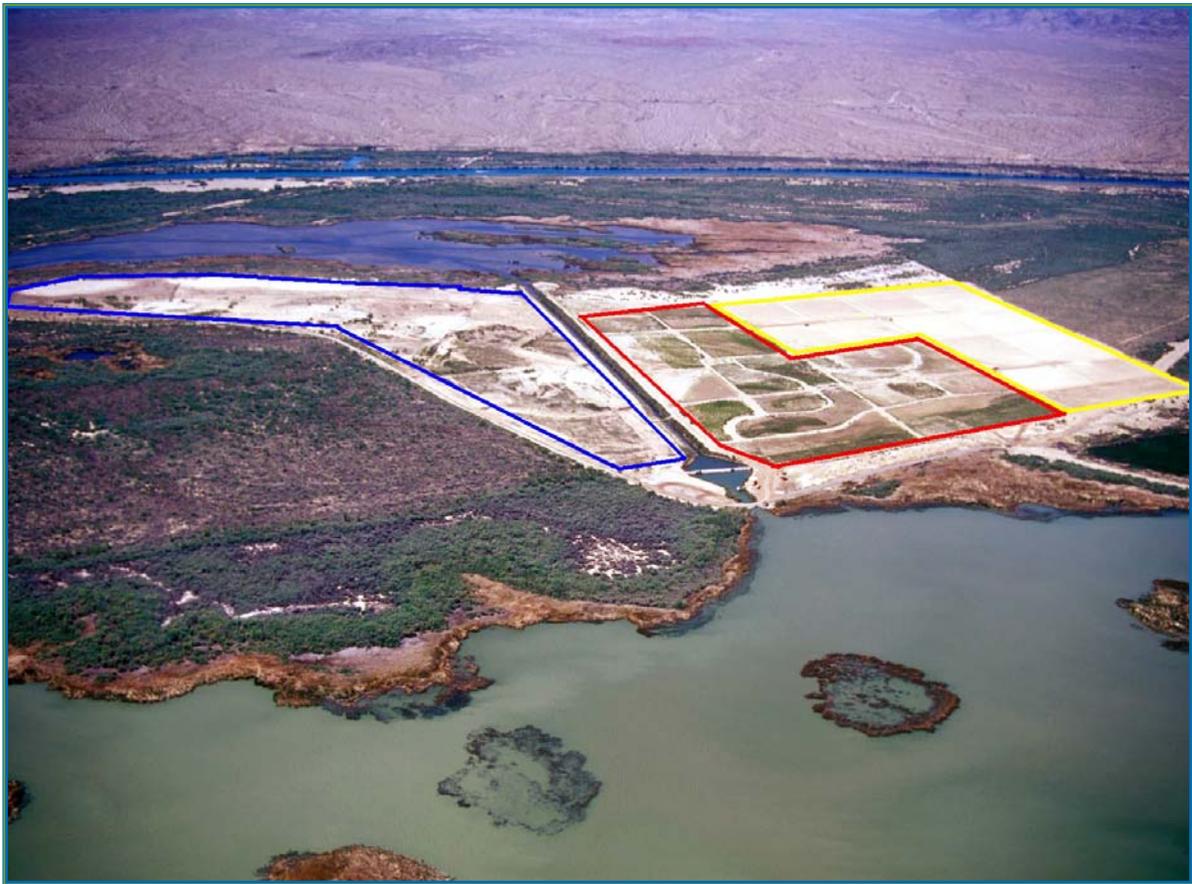
Figure 2. Beal Lake Restoration, Havasu NWR, Needles, CA Phases 1(red), 2(yellow) and 3(blue). View looking south with Beal Lake at the top, Topock Marsh at the bottom of the photo, Spring 2004.

and improving our efficiency and effectiveness in future projects under the Lower Colorado River Multi-Species Conservation Program (USBR 2004 in prep.). The re-vegetation of the site was divided into 3 phases. Phase 1, involves clearing and preparing approximately 55 acres for planting with native cottonwood, willow and various salt tolerant native shrubs and groundcovers (Figures 1 and 2). Phase 2 will restore another 48 acres of cottonwood and willow and Phase 3 will restore 100 acres of mainly honey and screwbean mesquite (*Prosopis glandulosa* var. *torreyana* and *P. pubescens*) (Fig.2).

This report is intended to be updated periodically as Phases 2 and 3 are completed and additional results of techniques become available. Currently, development for Beal Restoration, Phase 2 (Fig. 2, in yellow) is

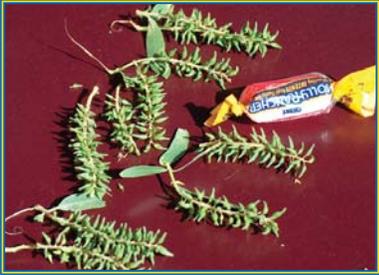
DEVELOPMENTAL STAGE	DESCRIPTION OF DEVELOPMENTAL STAGE AND PHOTO	% GERMINATION
1	<p>All pods on tree very green and unopened when collected directly from tree.</p>

21%
2	<p>Pods were collected while completely green, none opened on tree, but opened later after collected.</p>

Classifications of the developmental stages of seeds are based on observations in the field during spring 2003 and 2004. Pictures of most developmental stages and corresponding description and germination rates are in Figures 5a and 5b and Table 7 (information and photographs continue to be collected). Once un-opened green seed pods were shipped (overnight mail) to the laboratory, treatment of them was not controlled and unfortunately, whether they opened fully prior to testing not documented. Age of parent tree, fertilization probabilities (presence of male trees in vicinity), temperature, humidity, storage conditions, and countless other vari-

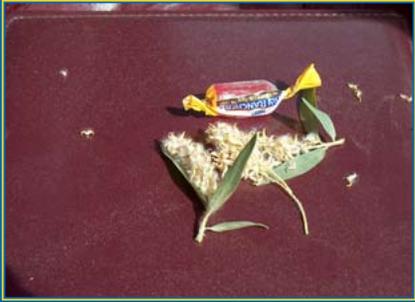
DEVELOPMENTAL STAGE	DESCRIPTION OF DEVELOPMENTAL STAGE AND PHOTO	% GERMINATION
5	<p>Few to no green pods remaining on tree, most seed dispersed, mostly brown, dry catkins with few seeds remaining.</p>

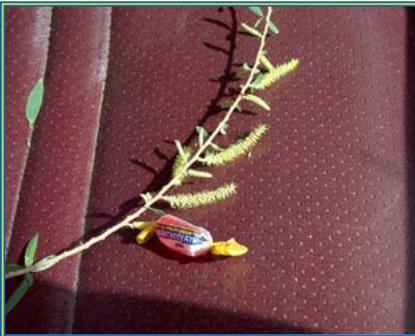
% N/A
6.	<p>Goodding Willow Cont. Male Flower</p>
